TRANSPOWER

22 February 2011 Christchurch earthquake Key findings and lessons learned

30 June 2011

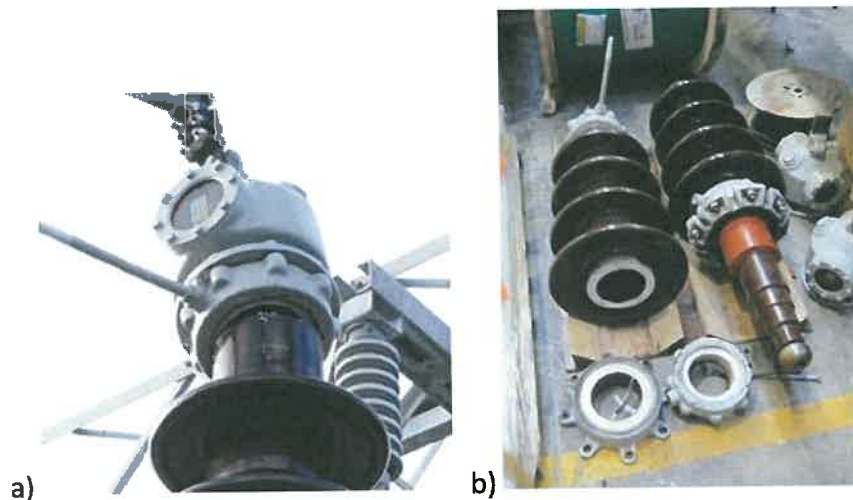
Damage to the 66 kV switchyards included two broken 66 kV transformer³ bushings (refer Figure 5 below) and failure of a 66 kV cable circuit.

Figure 5 : a) 66 / 11 kV transformer bushing (from T2 blue phase) with failure at the top of the insulator; b) the two broken bushings (from T2 red and blue phases), note the insulator from T2 red phase (on the left in the picture) break at the bottom (photos: Transpower)

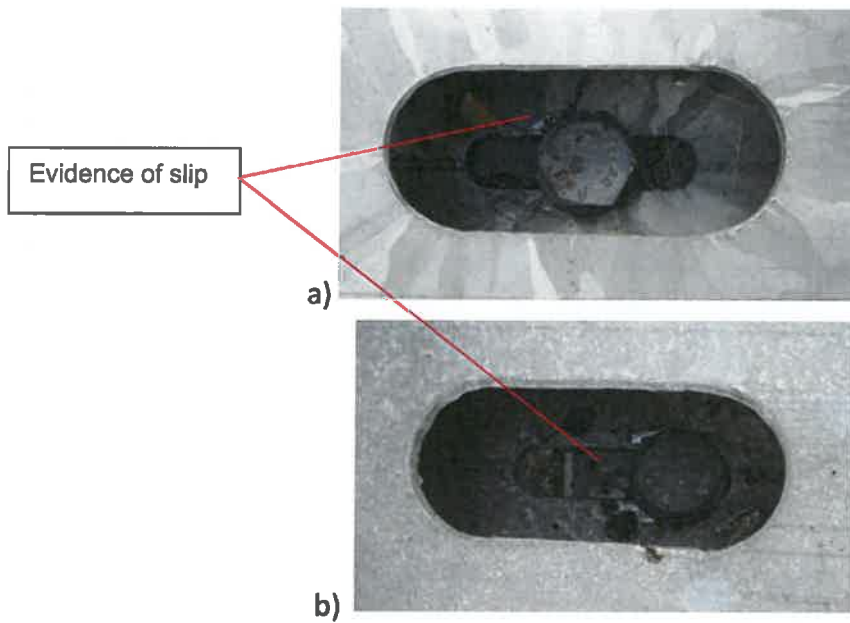
There was also evidence that the 66 / 11 kV transformers had moved on their supports and the cast iron housing of a tap changer drive on one of these transformers was broken probably as a result of the relative movement of the transformer with respect to its foundation, as shown in Figures 6 and 7. It is likely that these transformers would have been dislodged from their rails resulting in significant damage had seismic restraints not been fitted.

Figure 6 : a) and b): transformer restraint showing signs of movement (photos: Transpower)

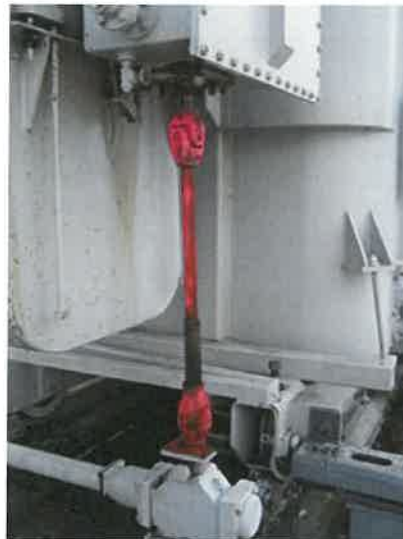
Figure 7 : 66/11 kV transformer – broken housing (photo: Transpower)

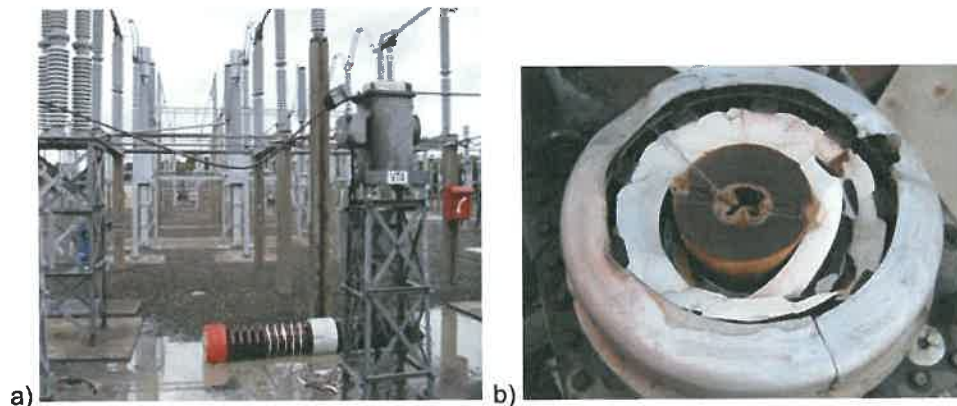
Damage to the 220 kV switchyard included a broken 220 kV capacitor voltage transformer (CVT)⁴, refer Figures 8, 9, 10 and 11 below. Other (newer) 220 kV equipment including circuit breakers, current transformers and disconnectors were undamaged. The rigid bus was also undamaged despite significant *liquefaction* in the vicinity of the foundations.

Figure 8 : a) and b): broken 220 kV CVT Insulator mounting showing finger clamps (photos: Transpower)

A very short straight connection between the CVT and rigid bus was identified as a possible cause of the failure. However, it is noted that the CVT insulator is held by finger clamps which are known to perform very poorly in earthquakes. Pressure from the finger clamps results in local stress concentration and clamping forces can vary from one clamp to another, so it is possible that the cause of failure is due to stress concentration around the finger clamps i.e. inherent structural weakness rather than due to interaction with the bus connection. It is also possible that the bus bar configuration influenced the failure; the CVTs of the adjacent phases did not fail and both are connected to bus bar supported by line traps quite close to the CVT. These line traps are not present on the phase of the CVT failure which is connected to a longer (more flexible) length of bus bar.

Although the droppers on the two intact phases have been replaced with connections with sufficient slack, it is recommended that all these CVTs (model and model specified above) are replaced as the finger clamp insulator mounting is known to be an earthquake risk. NB: Being about 40 years old, they probably will be replaced soon anyway.

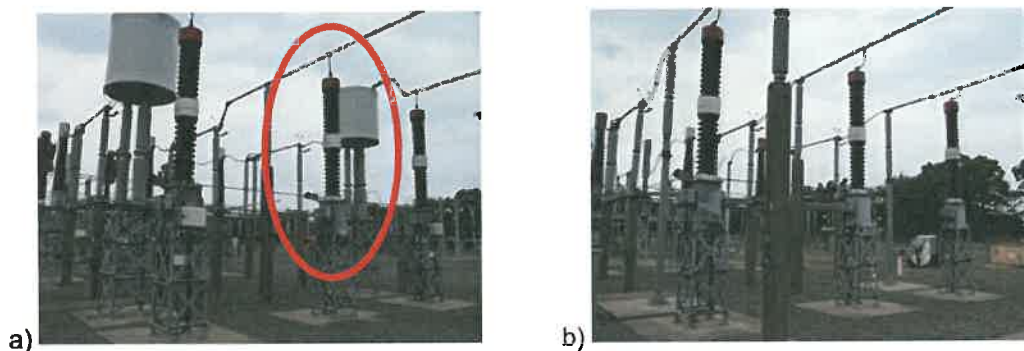
The original CVT4 straight dropper connecting the equipment to the busbar is an example of arrangement that performs poorly under seismic conditions.

As a general comment, the lack of standardised practice for the installation of flexible conductor and the amount of slack that should be provided was identified as an issue prior to the Darfield and Christchurch earthquakes. The installation of flexible conductor is generally done without proper shape specification other than substation layout drawings and the suitability of the final arrangement relies generally on the experience and judgement of the installation contractor.

Figure 9 : a) original CVT 4 dropper arrangement (circled is the equipment that failed during the earthquake); b) original CVT 5 dropper arrangement (photos: Transpower)

It is recommended that visual inspections be carried out in all substations to identify any flexible connections between equipment that are obviously too tight. It is understood that these inspections are already under way.

It is also recommended that flexible connection design and installation guidelines are completed to ensure appropriate slack is provided with consideration to seismic aspects and electrical clearances. A project has been set up to prepare these guidelines.

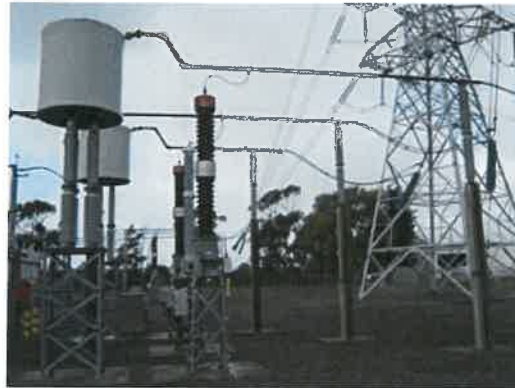
Figure 10 : New CVT 4 dropper arrangement and replacement CVT (photo: Transpower)

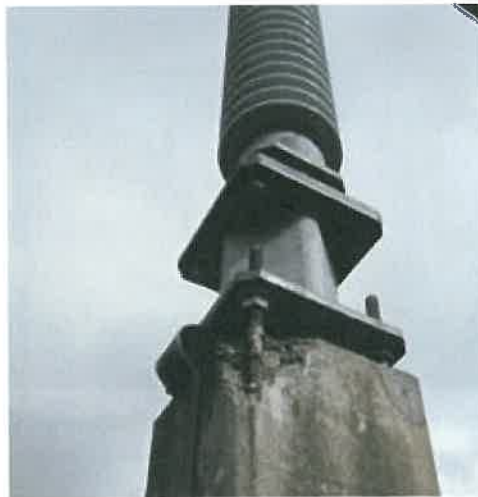
Minor spalling of concrete from some bus support stands was observed (Figure 12) but it is believed that this was caused by corrosion of the embedded bolts rather than as a direct result of the earthquake. Note evidence of previous repairs.

Figure 12 : Concrete spalling - 220 kV bus support stand (photo: Transpower)

It is recommended that these concrete posts be repaired or replaced.

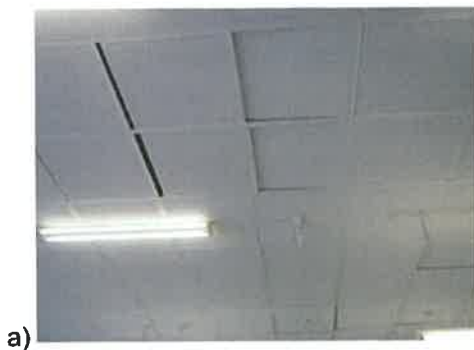
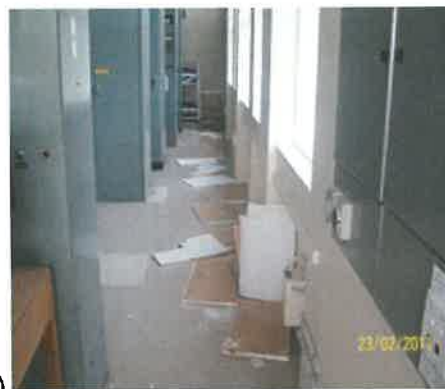
The control and relay building suffered minor structural damage (cracking of concrete), broken windows, fallen ceiling tiles as shown in Figure 13. One panel (Bay 37) of the 11 kV switchgear, which was racked out at the time of the earthquake, was damaged when the trolley became dislodged from its rails. There was also significant cracking and spalling of the concrete floor slab around the switchgear fixings (see Figure 14). The switchboard will be replaced by a new switchgear building later this year (see section 4.3.4).

Figure 13 : a) and b) dislodged ceiling tiles (photos: Transpower)

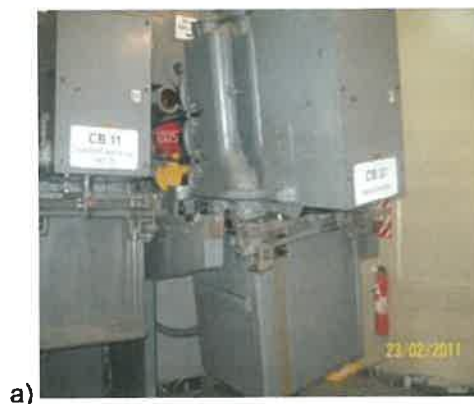
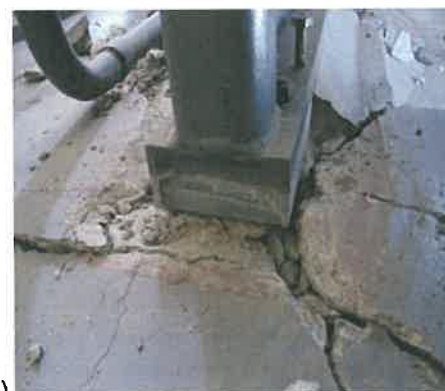
Figure 14 : a) and b) damaged 11 kV switchgear (photos: Transpower)

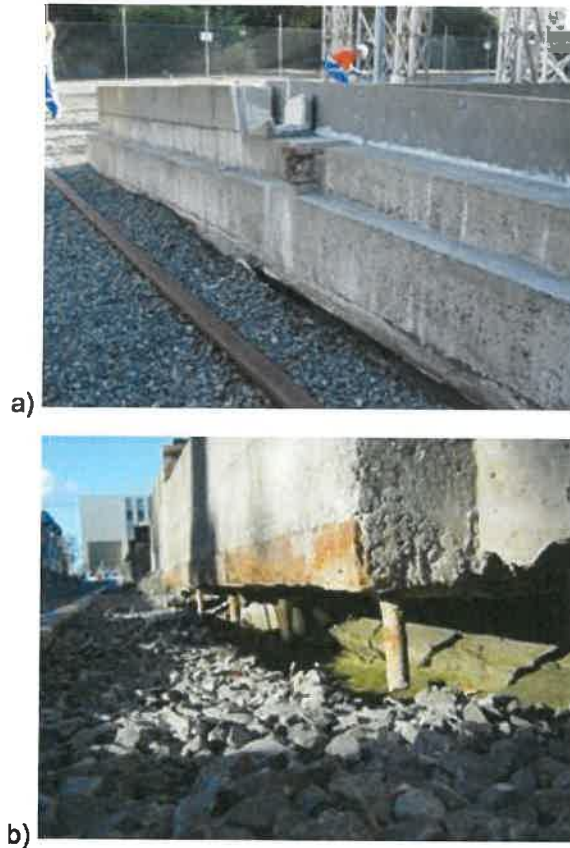
The transformer bunds around T4 and the spare transformers were damaged by settlement due to *liquefaction* (refer Figure 15) as occurred in the 4 September 2010 earthquake but the damage due to the 22 February 2011 earthquake was more severe.

Figure 15 : a) and b) settlement of transformer oil bund (photos: Transpower)

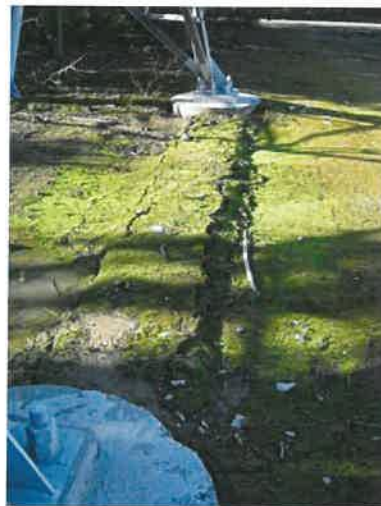
Further settlement occurred around the foundations of the two transmission line terminal structures, see Figure 16. The settlement does not appear to have affected the towers themselves.

Figure 16 : Settlement around transmission line terminal tower foundations (photo: Transpower)

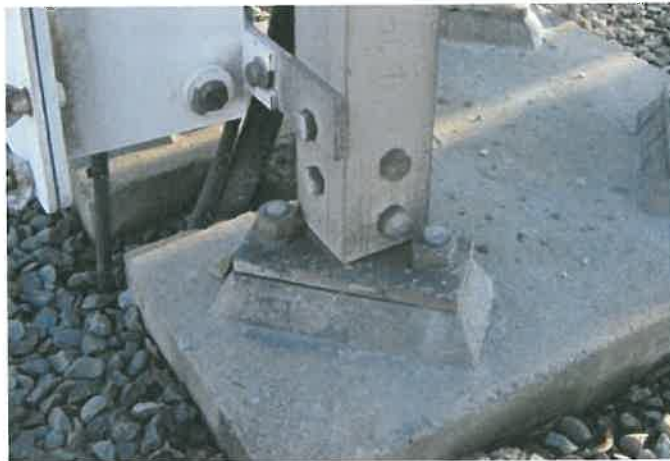
The base plates of some support stand legs have separated from their grout indicating that the bolts may have yielded (Figure 17).

Figure 17 : Support stand showing signs of base plate uplift (photo: Transpower)

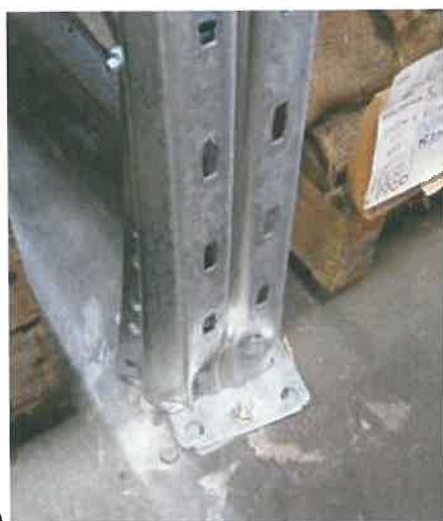
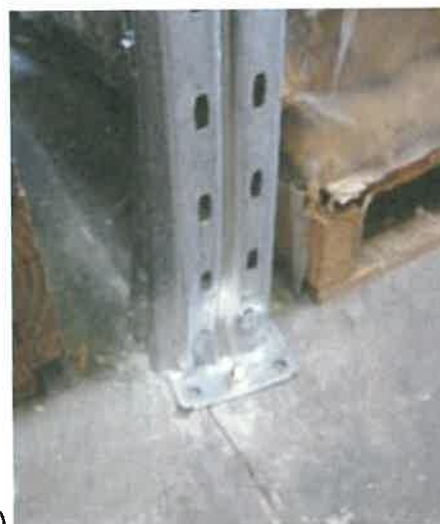
Damage at the Addington stores included local buckling of the pallet racking structures, collapse of one shelf, a number of local buckling of pallet rack columns (refer Figure 18 below), a broken bushing and fallen or dislodged items.

Figure 18 : a) and b) local buckling of pallet rack columns (photos: Transpower)

One area of damage that is easily overlooked is the connector tearing or perforations with bearing failure. The beams need to be taken off the racks to observe this. It is recommended that the extent of the inspection already completed be reviewed to see if this has been done. If necessary, load limits should be placed on the racks until Transpower are fully satisfied that the racks are structurally adequate.

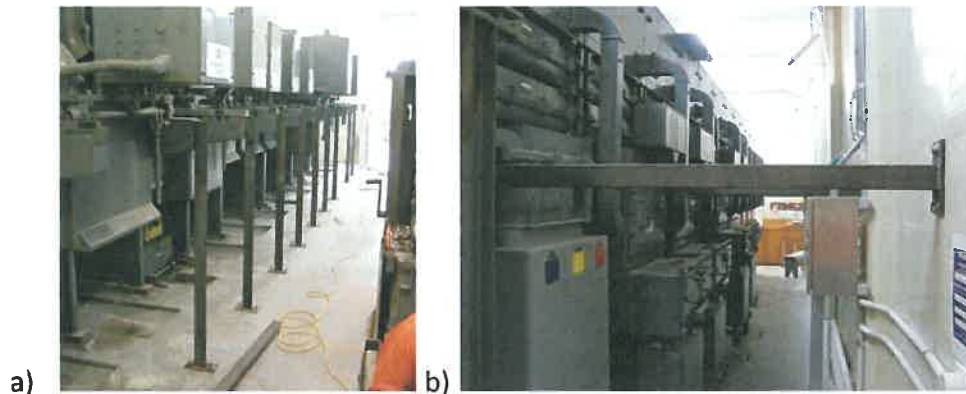
Interim measures were taken to ensure that the Bromley substation, an important point of power supply for the Christchurch region, remains in operation. Temporary repairs have been carried out to enable the equipment to be returned to service, and bracing has been installed at the front and rear of the panels to hold the switchgear onto the foundations, and to enable the circuit breakers to be safely racked out and isolated. Partial Discharge testing to evaluate the condition of the 11 kV switchboard following quake was carried out twice in February 2011 and four times in March 2011 and the result were satisfactory.

Figure 28 : a) and b) Bromley bracing installed at the front and rear of the switchgear panels (photos: Transpower)

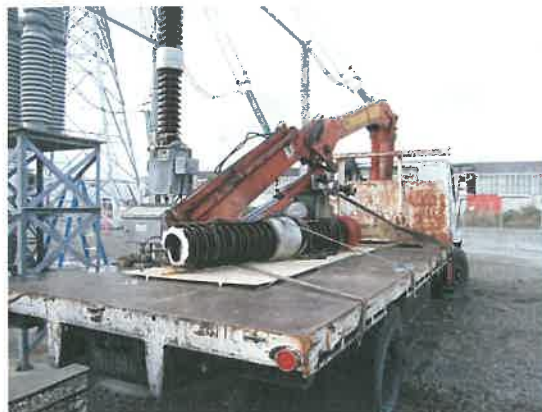
BRY Broken 220 kV Capacitive Voltage Transformer VT4 was recovered from site and sent to ABB ware house for scrapping.

Figure 29 : Broken capacitive voltage transformer, VT4, removed from Bromley substation and replaced (photo: Transpower)

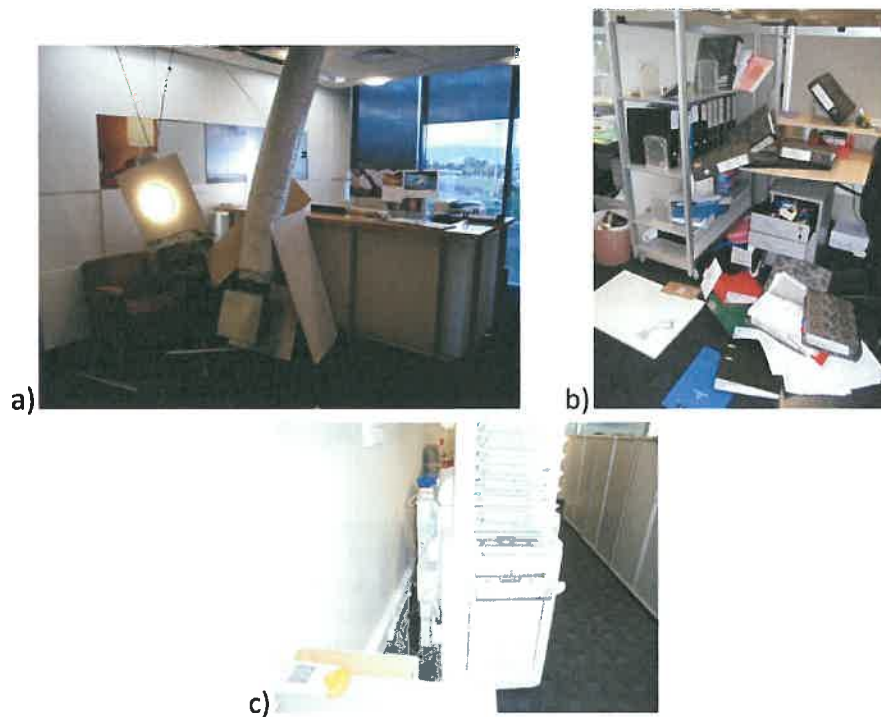
No injuries were sustained during the event, however, there was disruption to the office site with air conditioning ducting coming through the ceiling space in the reception area, papers sliding off desks and shelves, and unrestrained equipment moving from its usual location (refer Figure 32 below).

Figure 32 : a), b) and c) Transpower Christchurch office (photos: Transpower)

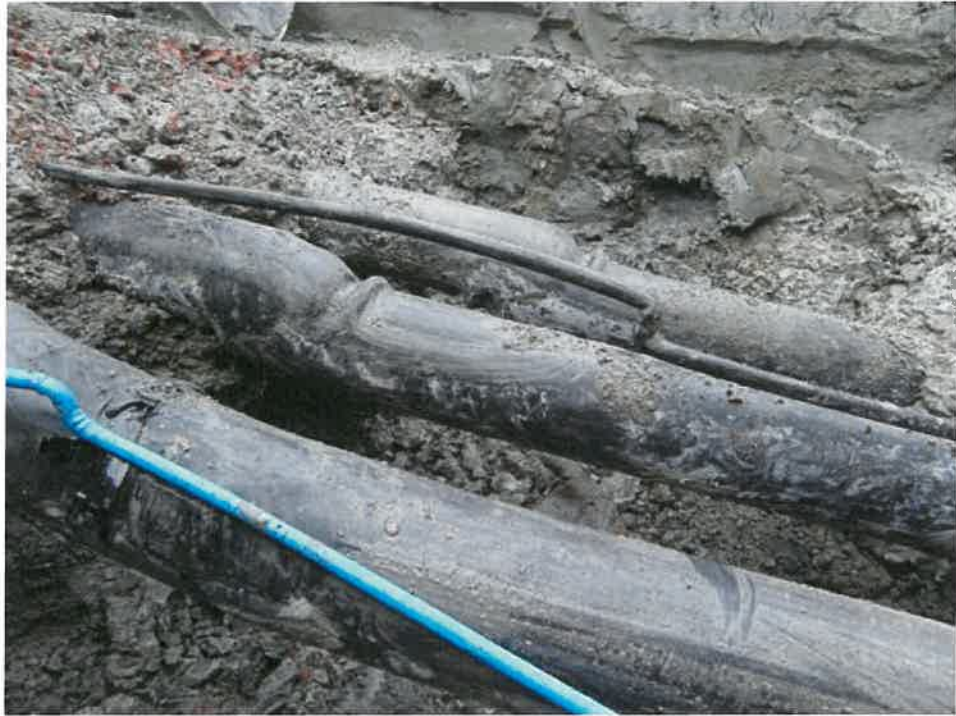
Figure 34 : 66 kV XLPE cable and associated protection optical fibre cables on Fitzgerald Avenue. Note: cable did not fault at this location (courtesy of Orion)

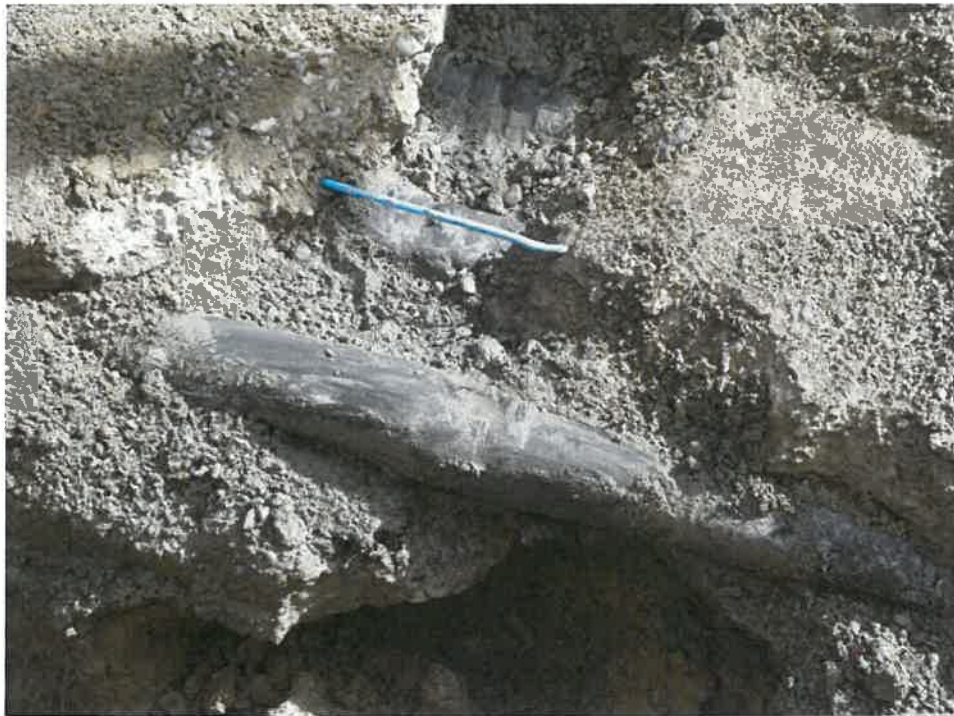
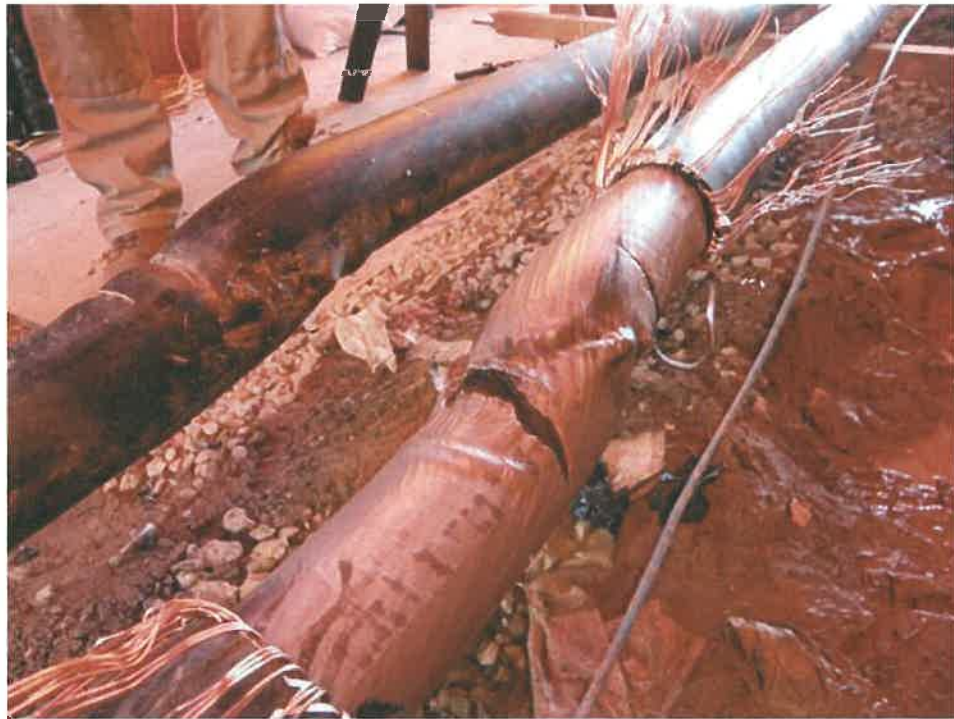
All types of cable suffered damage i.e. it was not possible to say that any particular cable variant was less susceptible to damage when compared to any other; and there was no discernible pattern to the areas/ground conditions where cables were effected. Below are a number of photographs of damage sustained (Figure 34, 35 and 36).

Figure 35 : 66 kV XLPE cable fault position, a) initial exposure and b) internal cable damage (courtesy of Orion)

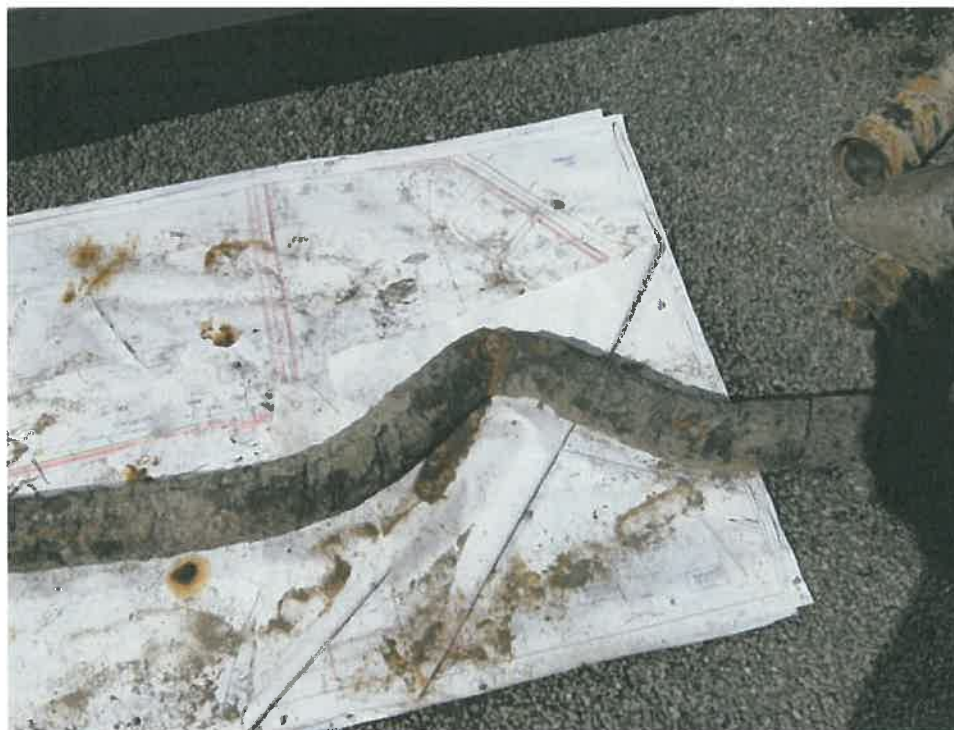
Figure 36 : Typical 11 kV Cable Damage (courtesy of Orion)

A number of these photographs have been shared with other overseas utilities and cable engineers and the consensus view is the extent and the type of damage is unique.
