Water Ways Consulting

Subject: Bush Gully Stream Ecological Assessment

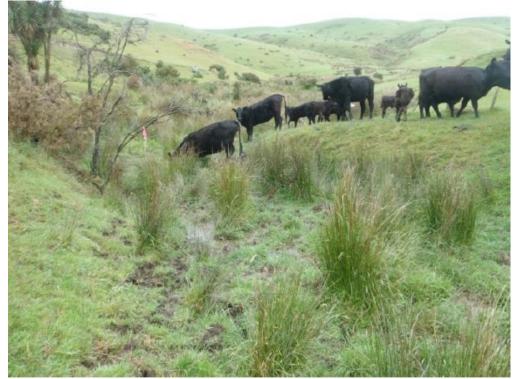
Bush Gully Stream was first sampled in the vicinity of the North ELF site by Golder Associates in November 2013 Golder (2014¹). This survey noted the stream was a series of poorly connected pools with no fencing allowing stock (cattle) access to the stream (Figure 1). The resulting stream habitat was heavily modified by the stock activity. Since the Golder Associates survey the survey area has been further modified by channel straightening and drainage works. This assessment of effects is based on the initial site conditions observed by Golder Associates rather than the current site conditions.

Figure 1: Bush Gully Stream in the vicinity of CC24, November 2013.
