Science Advice

Summary of Science investigation of elevated manganese in Timaru District Council’s Opihi water intake

The scope of this advice note is to document Environment Canterbury’s findings related to river and groundwater sampling around the Opihi water supply intake.

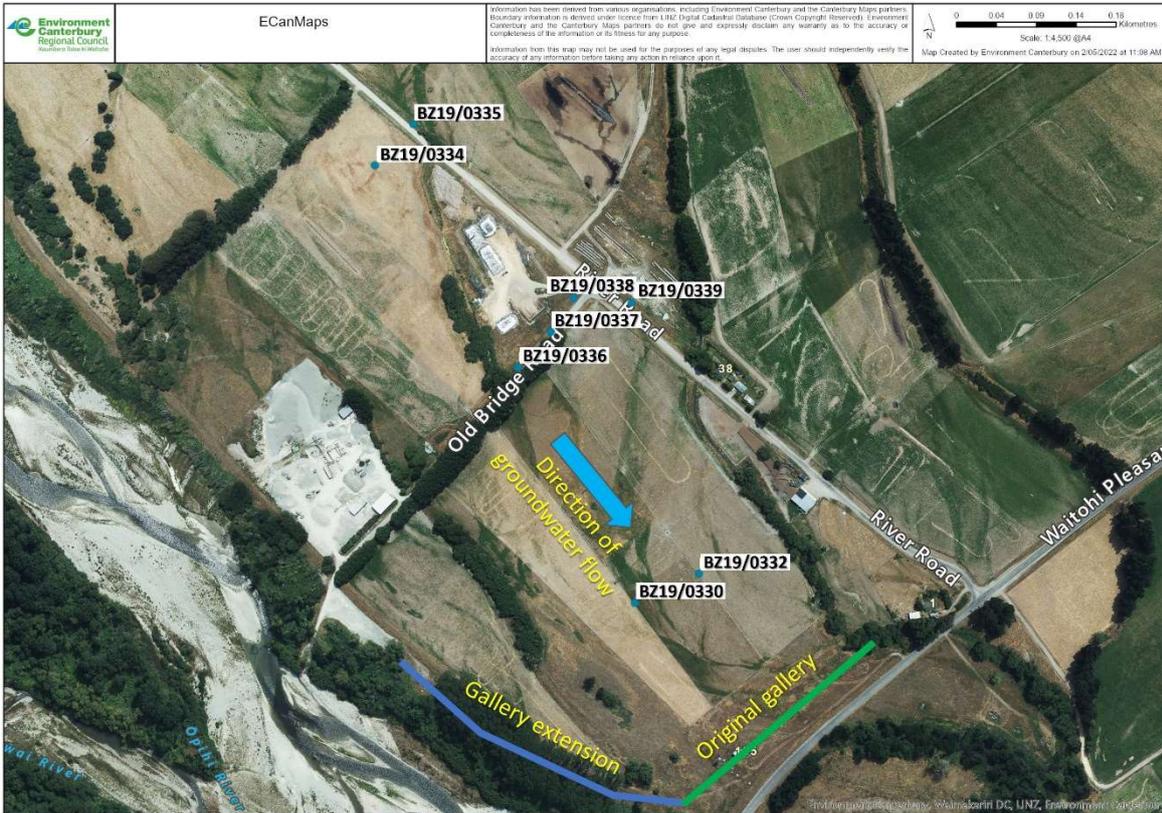
Figure 1: Location of monitoring wells and Opihi intake gallery.

From March to June 2022, ECan collected weekly samples from eight shallow monitoring wells, two upgradient and six downgradient, from the silage storage area (Figure 1, Table 3).

There is some variability observed in the rate of improvement in water quality in wells BZ19/0330 and BZ19/0332. The improvement in water quality is much quicker in well 330 compared to well 332. Figure 1 suggests that well 330 may be located on an old paleochannel where groundwater movement may be more rapid (presence of open framework gravels), with more rapid flushing by higher quality groundwater.

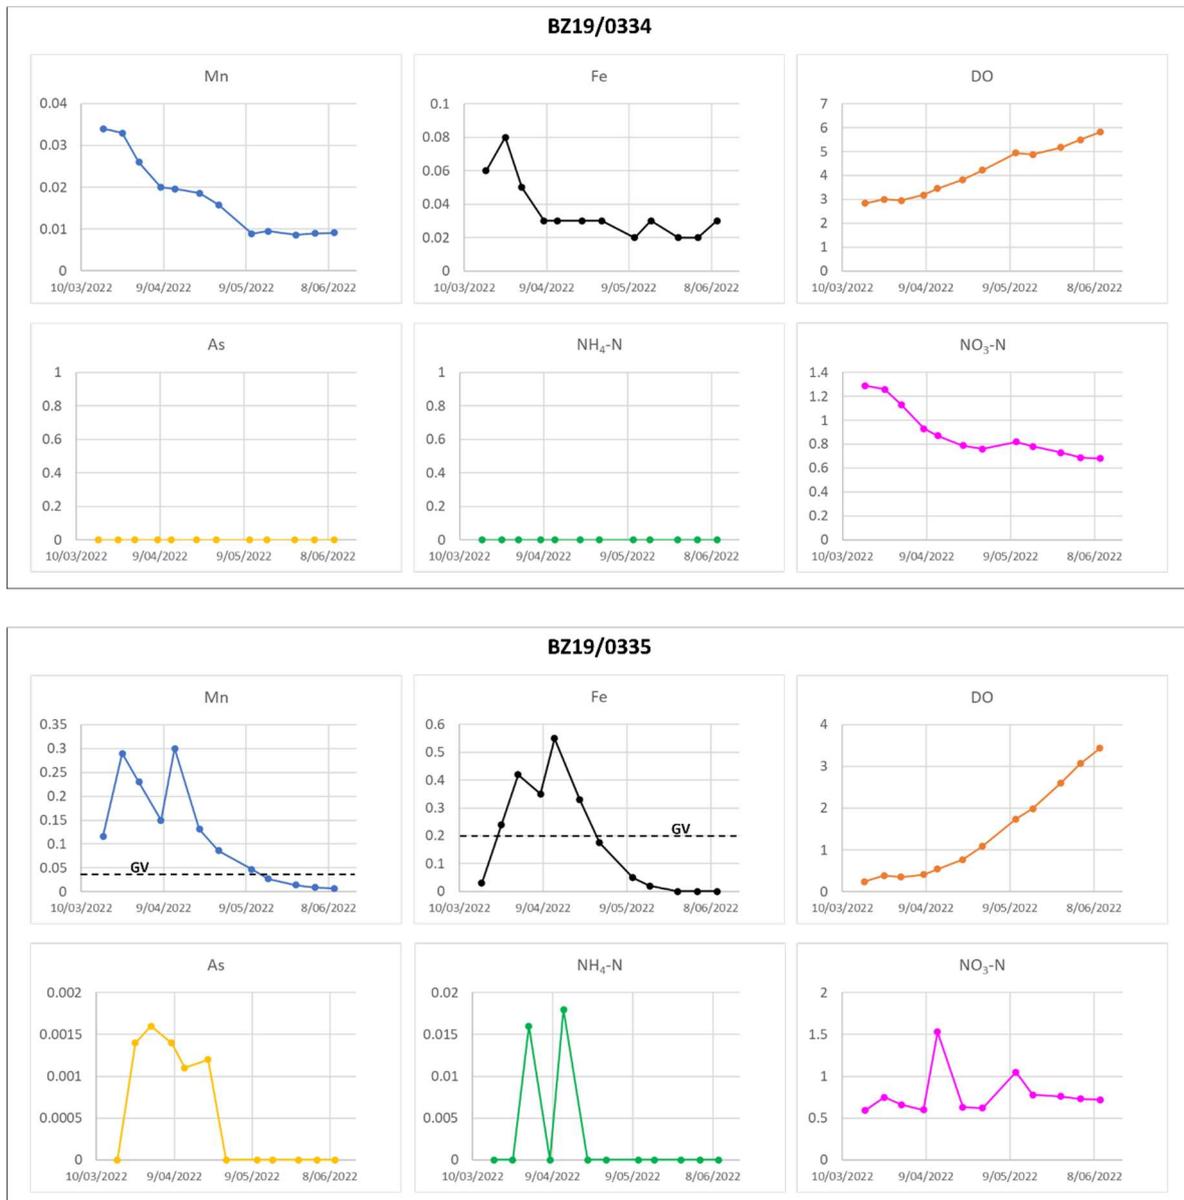
However, the two wells upgradient of the silage storage area (BZ19/0334 and BZ19/0335) also had low dissolved oxygen and elevated concentrations of iron and manganese, which changed over the sampling period. It is unclear whether the silage storage area had impacted groundwater in these upgradient wells, or if there might have been other source(s) of organic matter.

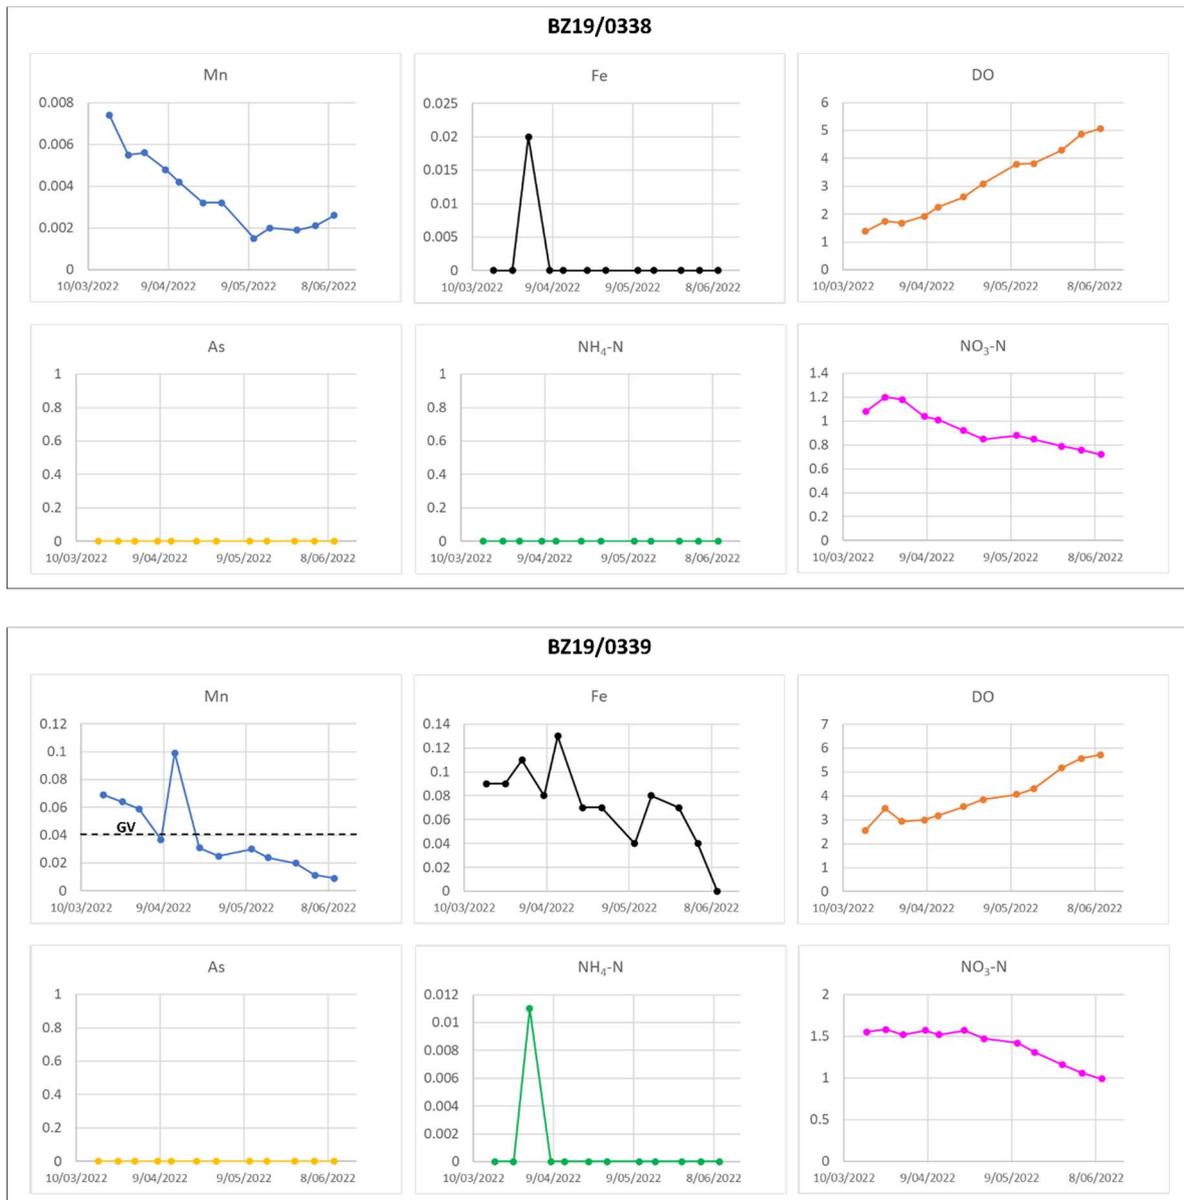
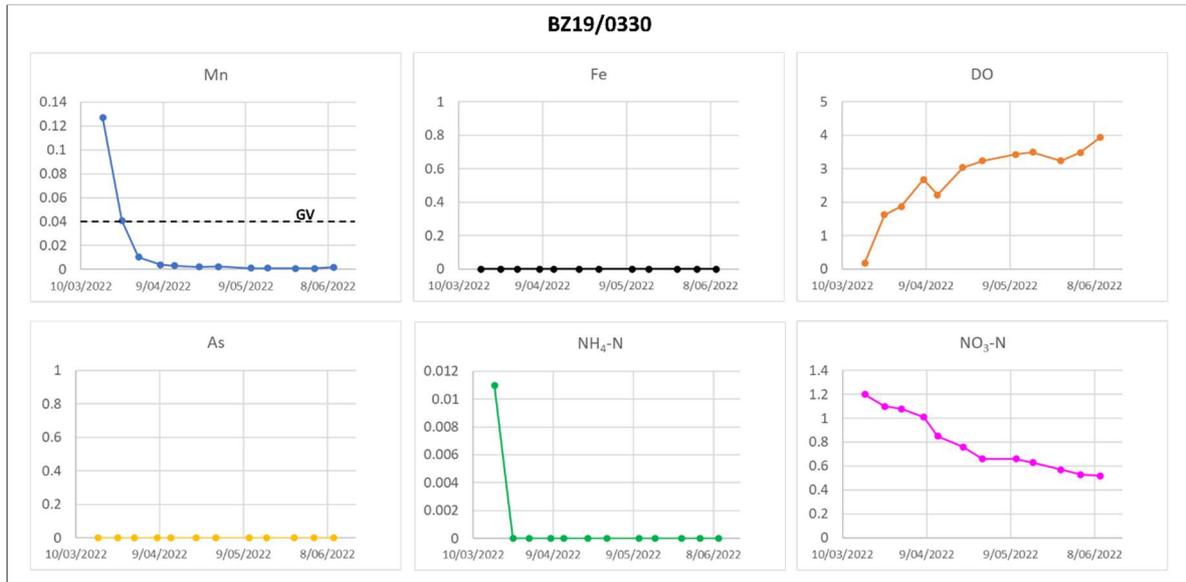
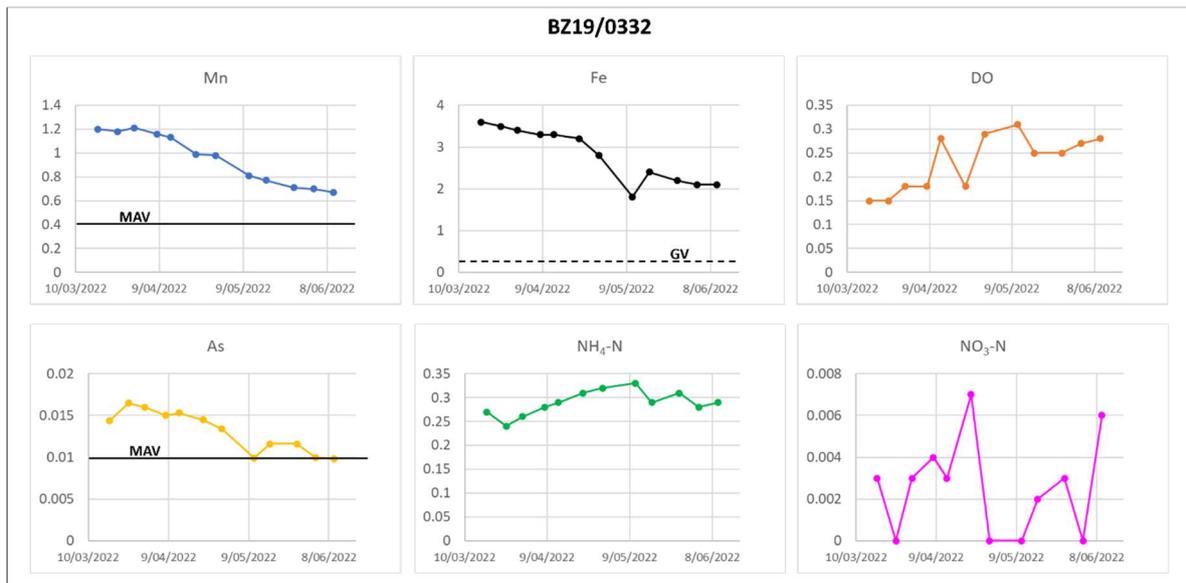
At the start of the groundwater quality monitoring programme in March, water sampling showed elevated concentrations of manganese, arsenic, and iron, and low dissolved oxygen and nitrate in some monitoring wells located downgradient from the silage storage area. Detectable concentrations of manganese and iron were also observed in the two upgradient monitoring wells, but at lower concentrations than in the downgradient wells. The results are presented in Figure 2 (monitoring wells upgradient from the silage storage area) and Figure 3 (monitoring wells downgradient from the silage storage area). In the groundwater samples from mid- to late March, we note that in some monitoring wells, manganese concentrations started to decrease before silage removal. This initial decrease might have been due to dilution caused by rainfall recharge ¹.

By late April, when silage removal was well underway, concentrations of manganese, iron and arsenic decreased, and dissolved oxygen increased in all monitoring wells. In some wells, the concentrations changed rapidly, while in others the decrease was more gradual. The groundwater quality continued to improve through May and June, with only one downgradient monitoring well (BZ19/0332) still having concentrations of manganese above the health-based drinking-water value of 0.4 mg/L. However, the consistent decreasing trend for manganese in this well suggests that the concentrations will continue to decrease (see manganese graph for BZ19/0332 in Figure 3).

These results indicate that the silage leachate was a likely contributor to the observed decrease in dissolved oxygen, and resulting increases in manganese, arsenic, and iron.

Overall, the groundwater sampling data shows decreasing concentrations of manganese, iron, and arsenic, and increasing dissolved oxygen, in all monitoring wells over the sampling period. In wells with < 1 mg/L dissolved oxygen as at June 2022 (wells BZ19/0332, BZ19/0336, and BZ19/0337), we consider that chemical reactions between dissolved iron and dissolved oxygen might be slowing the rate of dissolved oxygen increase. Alternatively, there might be organic matter (e.g., residual silage leachate, or organic matter from other sources) causing localised effects. Manganese concentrations might therefore remain elevated in these wells for some time. Nonetheless, groundwater quality is improving in the area upgradient from the Opihi intake gallery, and it is expected that groundwater quality will continue to improve as dissolved oxygen increases.
