CANTERBURY COAL: ELF PROJECT

BUSH GULLY ASSESSMENT

DATE: AUGUST 2016

REPORT NUMBER: 35-2016-A

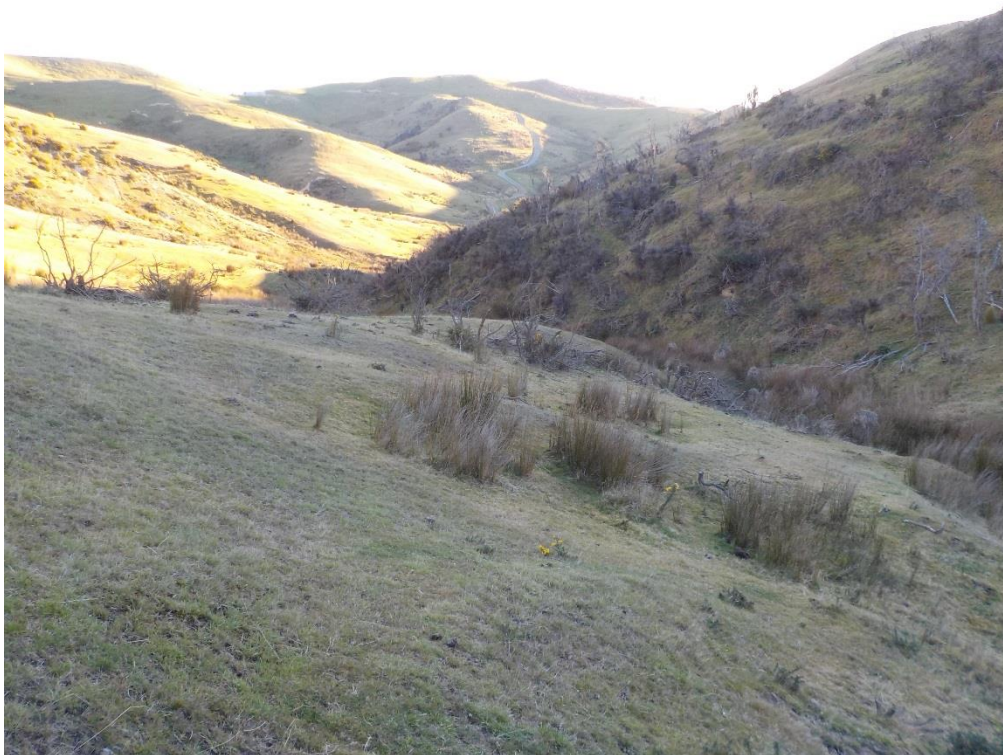
The Bush Gully tributary rises just below the ridgeline (420 m attitude) and descends to its confluence with Bush Gully at 320 m on the Bush Gully valley floor. The tributary sub-catchment is all rough grazed pasture. Woody shrubs; gorse, manuka, and coprosomas, are present although most these were dead presumably due to herbicide spraying (Figure 2). Wetter areas in the subcatchment are apparent and *Juncus* rushes are common across the hillside. A stream channel exists for much of the length of the gully with some wetland plants, the most of obvious of which was large but often dead *Carex secta* plants (Figure 3).

Figure 2: Bush Gully tributary catchment with dead woody vegetation and rough pasture.

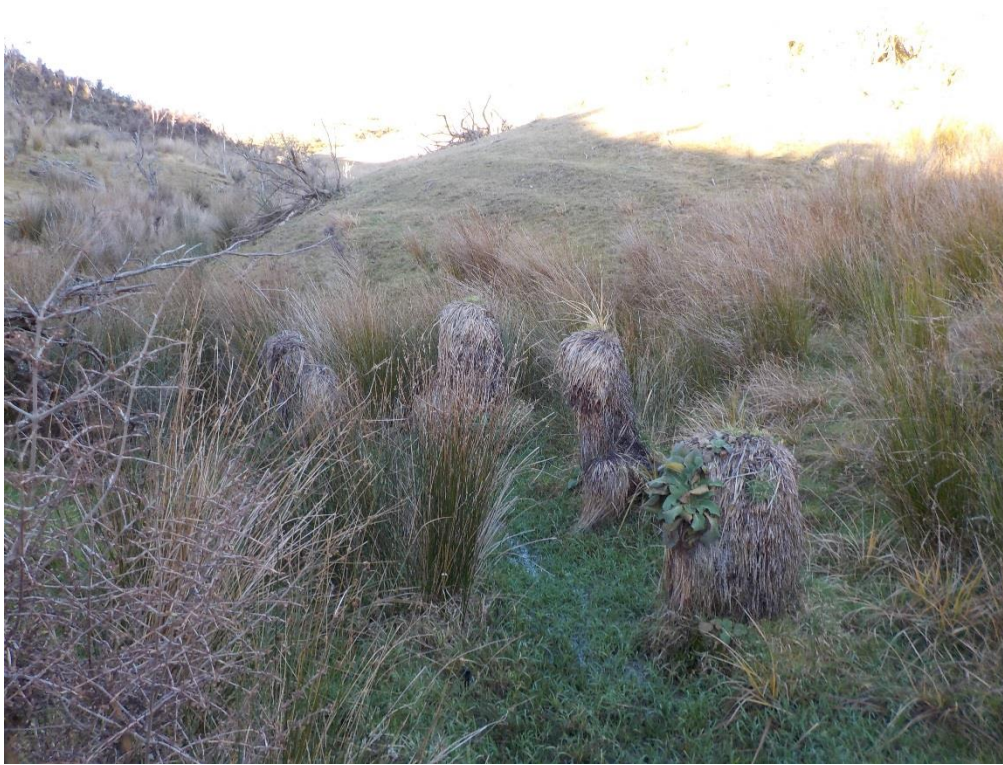
For the majority of the length of the Bush Gully tributary could be considered a wet seepage zone with water depths up to 2 cm deep. The seepage width varies and ranges from less than 0.5 m in the upper steeper reaches to approximately 2 m in the lower reaches where the valley floor widens before the confluence with Bush Gully Stream. The wet areas are generally firm and pasture grasses cover the channel. Three pools were observed in the lower reaches, all approximately 10 cm deep and well shaded by vegetation (Figure 4). Water was observed flowing at some sites along the channel and flow was estimated to be less than 1 L/s.

Figure 3: Bush Gully tributary with Carex and Juncus plants along the stream channel.

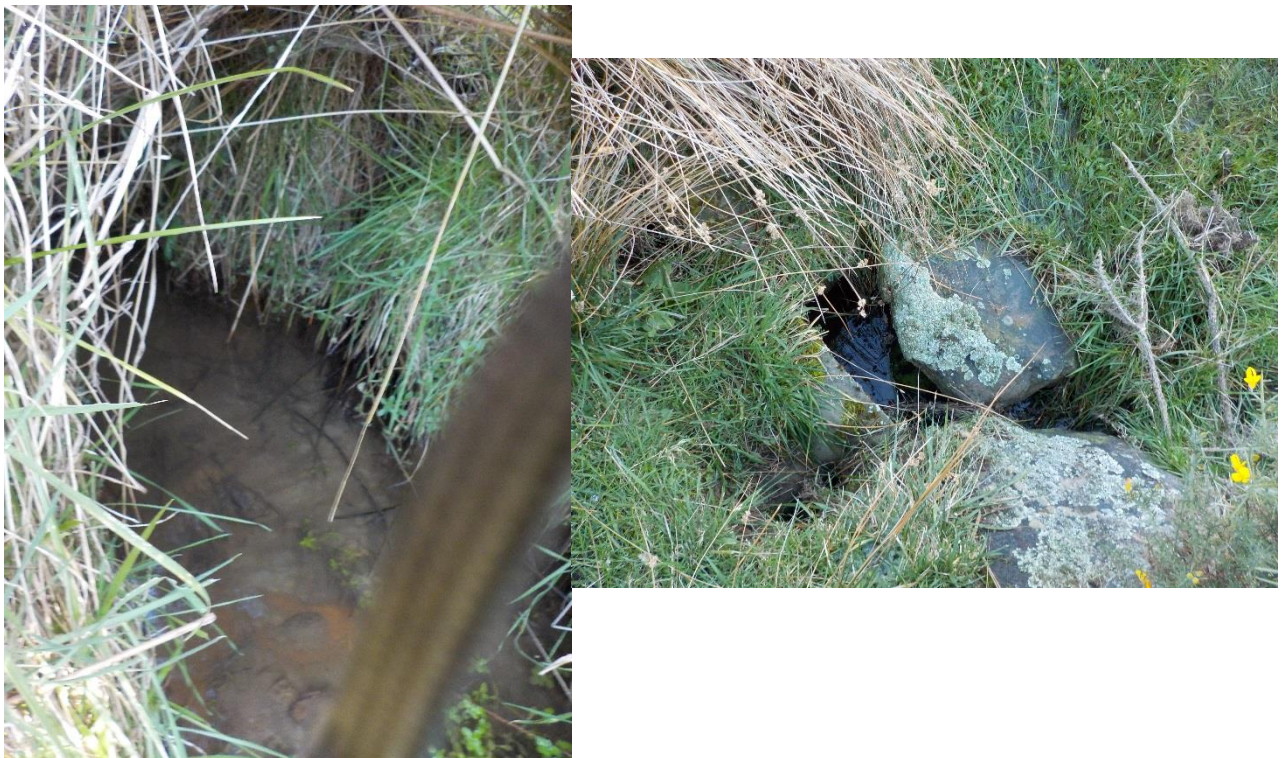
Figure 4: Pool habitat in the Bush Gully tributary.

Aside from these pools there was no habitat in the stream that appeared suitable for fish.

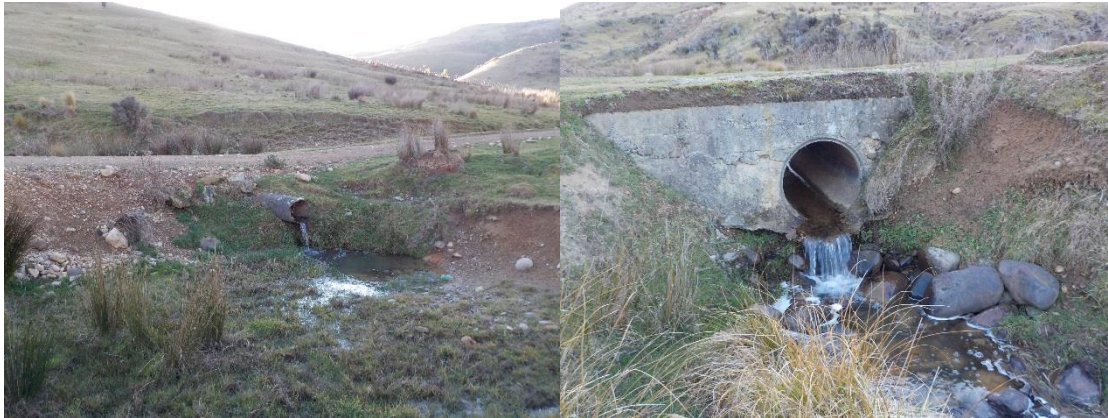
Prior to the fish survey Bush Gully was walked from upstream of the tributary confluence downstream for approximately 1.5 km. During this stream walk two key observations were made. The access tracks running along the valley floor crossed Bush Gully six times. The upper three

crossing all had perched culverts (Figure 5). The three downstream culverts currently provide good fish passage. In addition, a further perched culvert was present in the lower reaches of the Bush Gully tributary.

Figure 5: Perched culverts along Bush Gully.

The ELF facility is not expected to impact on the Canterbury mudfish population of Bush Gully Stream. In the event that no rehabilitation work is undertaken in Bush Gully to improve fish passage and reduce the effects of the current land use and stream management it is expected that Canterbury mudfish will cease to occupy the stream in the reaches closest to the ELF site. No mitigation for Canterbury mudfish for the construction of the ELF facility is recommended. With regard to the low dissolved oxygen outflow from the MSR monitoring of this should be undertaken and if required a reaeration structure such as a small water fall at the existing culverts could be enhanced to increase turbulence and reaeration.

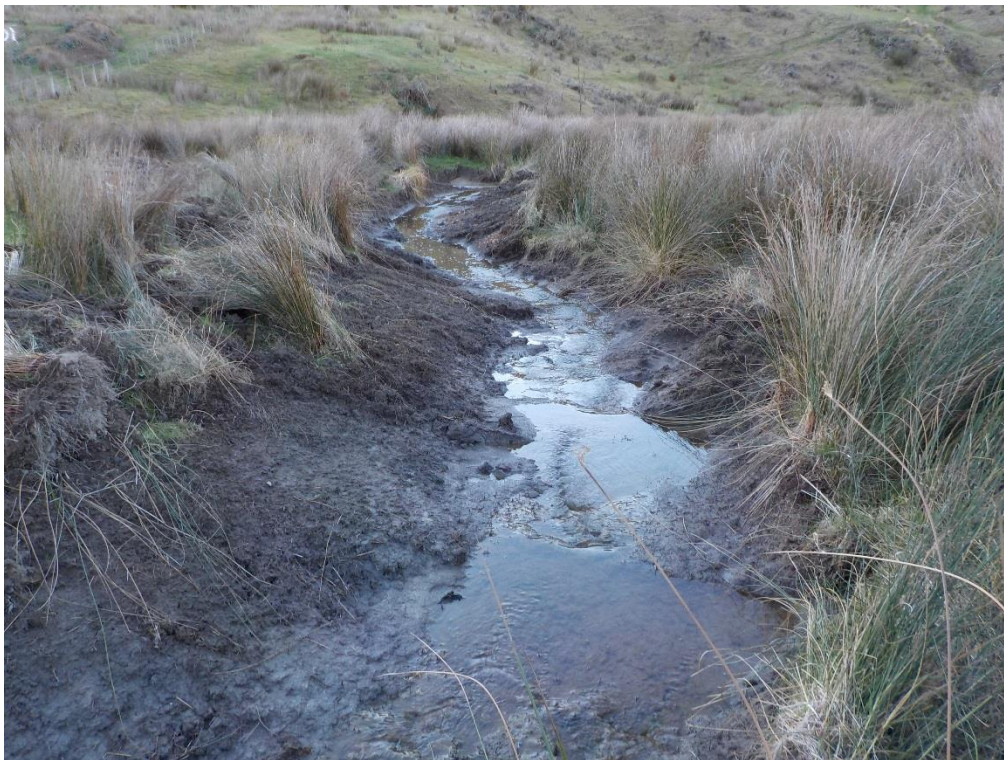
Recent stream channelization work had also been conducted along Bush Gully from approximately 5 m downstream of the middle perched culvert to the most downstream perched culvert (Figure 7). This reach starts about 40 m downstream from the confluence of Bush Gully and the ELF tributary. A short section of unmodified habitat is present downstream of the second perched culvert and this includes a 2 m long scour pool immediately downstream of the culvert. The channelization also extends an unknown distance upstream along the main upper branch of Bush Gully that was outside the intended survey area. Downstream of the perched culverts the stream morphology indicated that channel clearance work had previously occurred in a number of areas and little unmodified habitat existed in the survey reach.

Figure 6: The channelised section of Bush Gully.

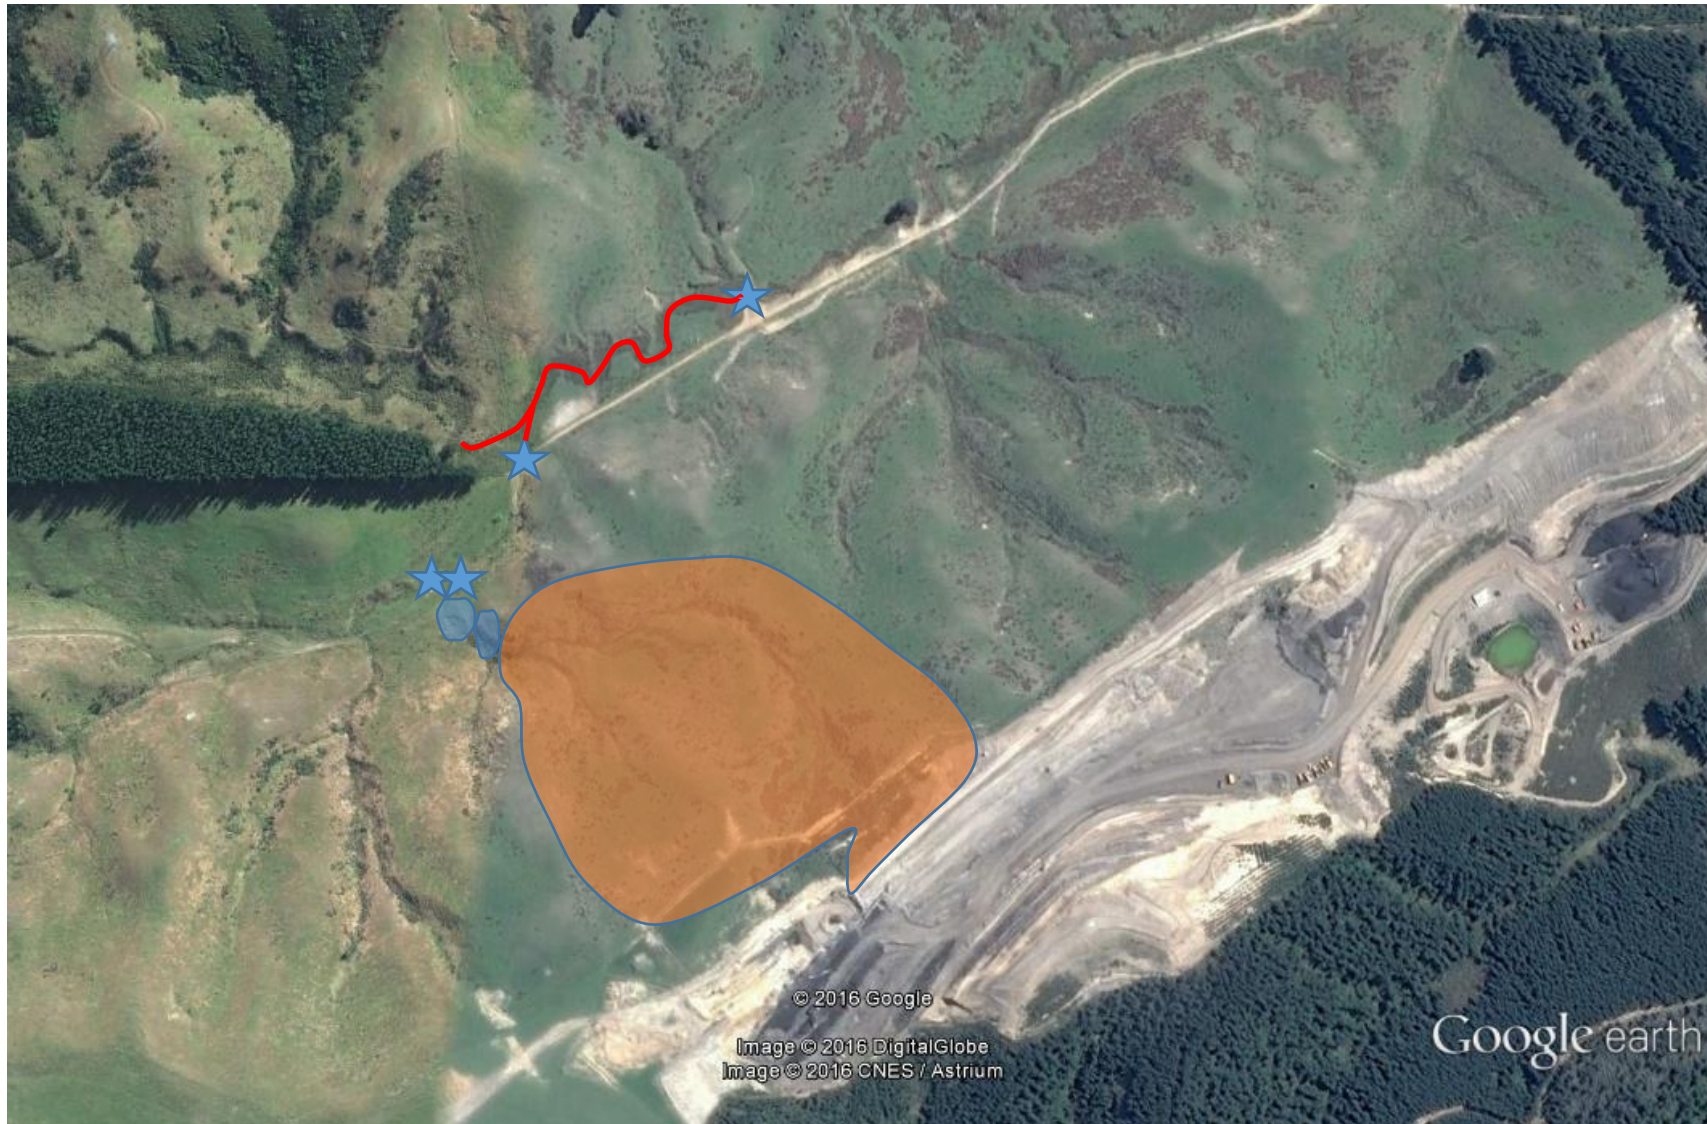
Figure 7: The location of perched culverts and channel modification areas.

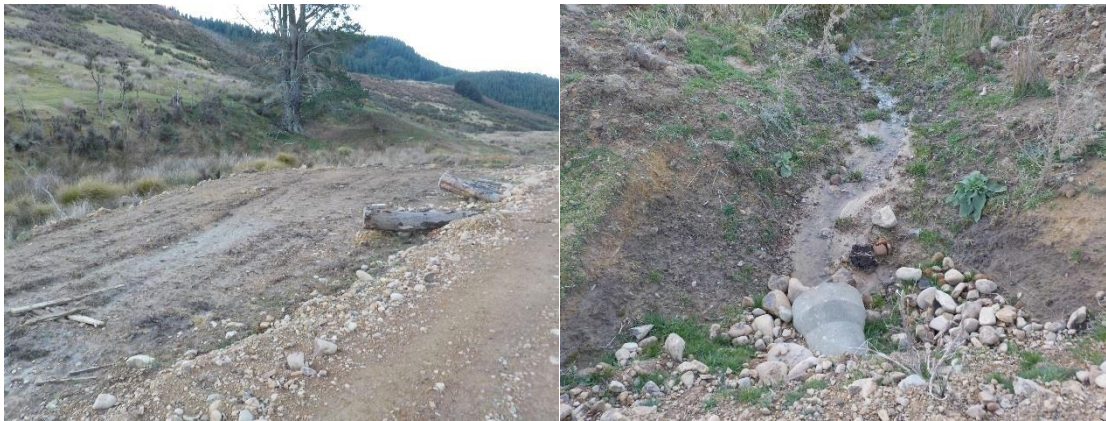
It was also evident that since the Golder (2014) survey of the upper reaches of Bush Gully a substantial access road has been constructed along the valley floor. This access road generally has unvegetated margins and there are also large areas of bare ground beside the road and alongside the stream (Figure 8). There are also several small channelized and culverted tributaries of Bush Gully along the access road (Figure 8). These areas combined with the instream works and upstream plantation forest harvesting have created large areas of eroding soils and appear to be responsible for the presence of large deposits of instream sediment that were common along the whole survey reach.

Figure 8: The access road and cleared ground (left) and channelised and culverted tributary (right).

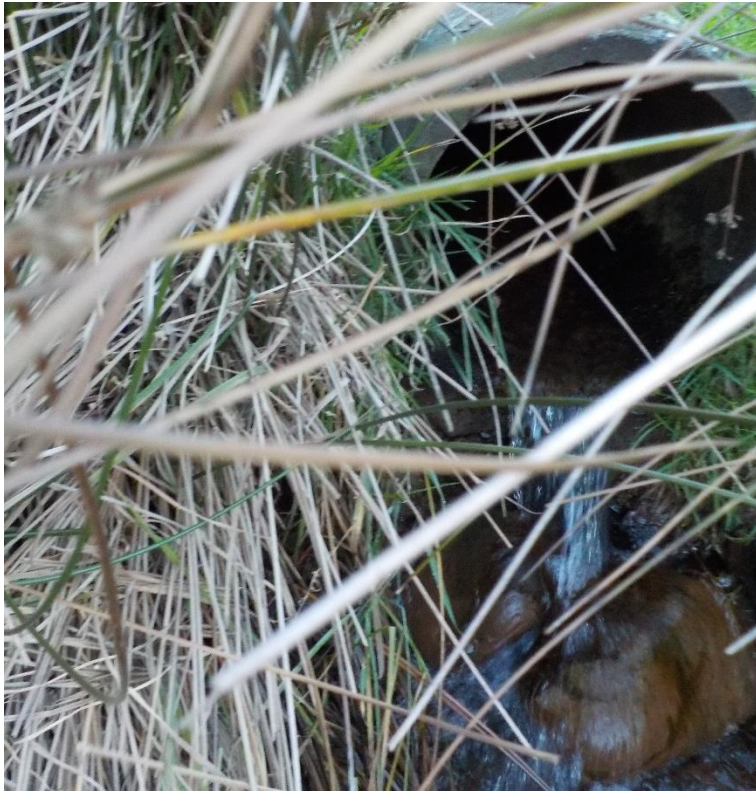
only discharge water when there is flow in the tributary, for instance, after rainfall. At these times there will be flow in the large tributaries and mainstem areas of Bush Gully Stream. With reaeration and dilution the dissolved oxygen level of the water will increase before it reaches any Canterbury mudfish habitat. It is note worth that the Golder (2014) low dissolved oxygen measurement occurred when Bush Gully Stream was reduced to a very low flow conditions, a time when discharges from the ELF would be minimal if present at all. Finally, before entering the Canterbury mudfish reach the ELF water flows through two culverts, the second of which has a free fall drop that should aid reaeration (Figure 9).

Figure 9: Free fall outflow from culvert upstream of Canterbury mudfish habitat.
