# Coopers Creek Ecological Values and Flow Requirements

Report Number. 0978110107\_002\_R\_Rev0

## COOPERS CREEK ECOLOGICAL ASSESSMENT

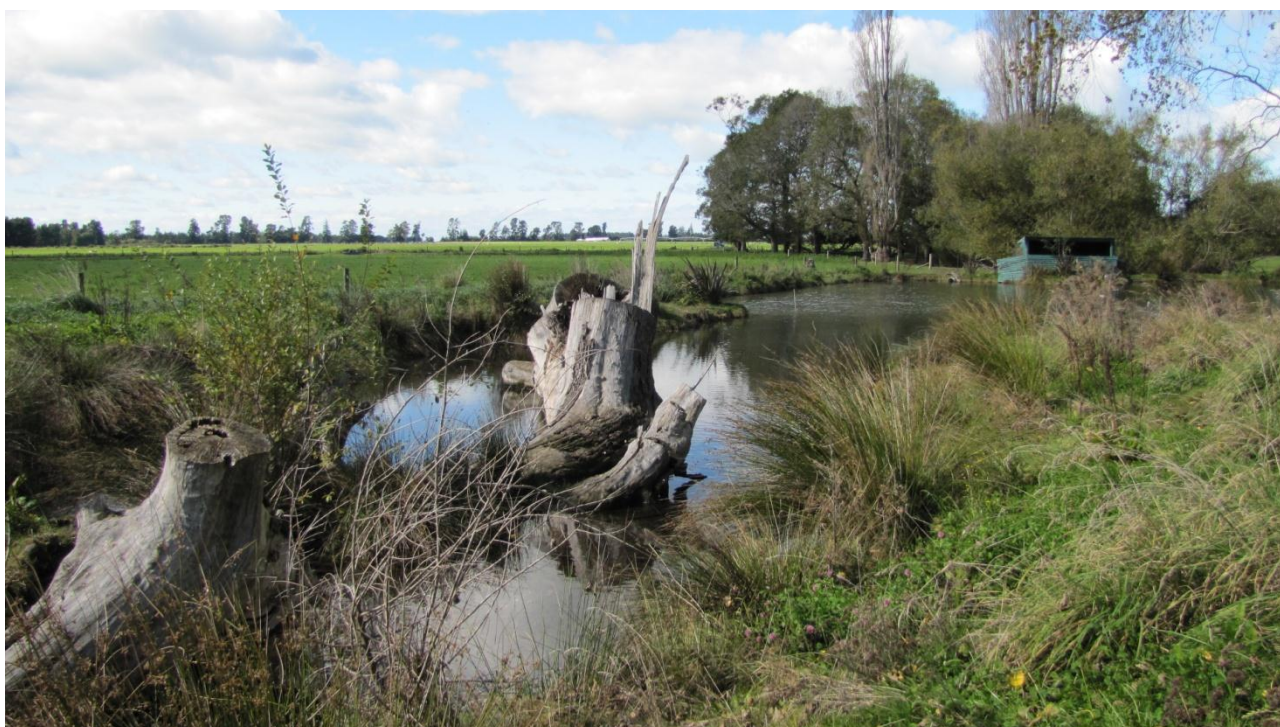
*Figure 2: The large pond at the head of Coopers Creek looking downstream from the spring upwelling point. May 2011.*

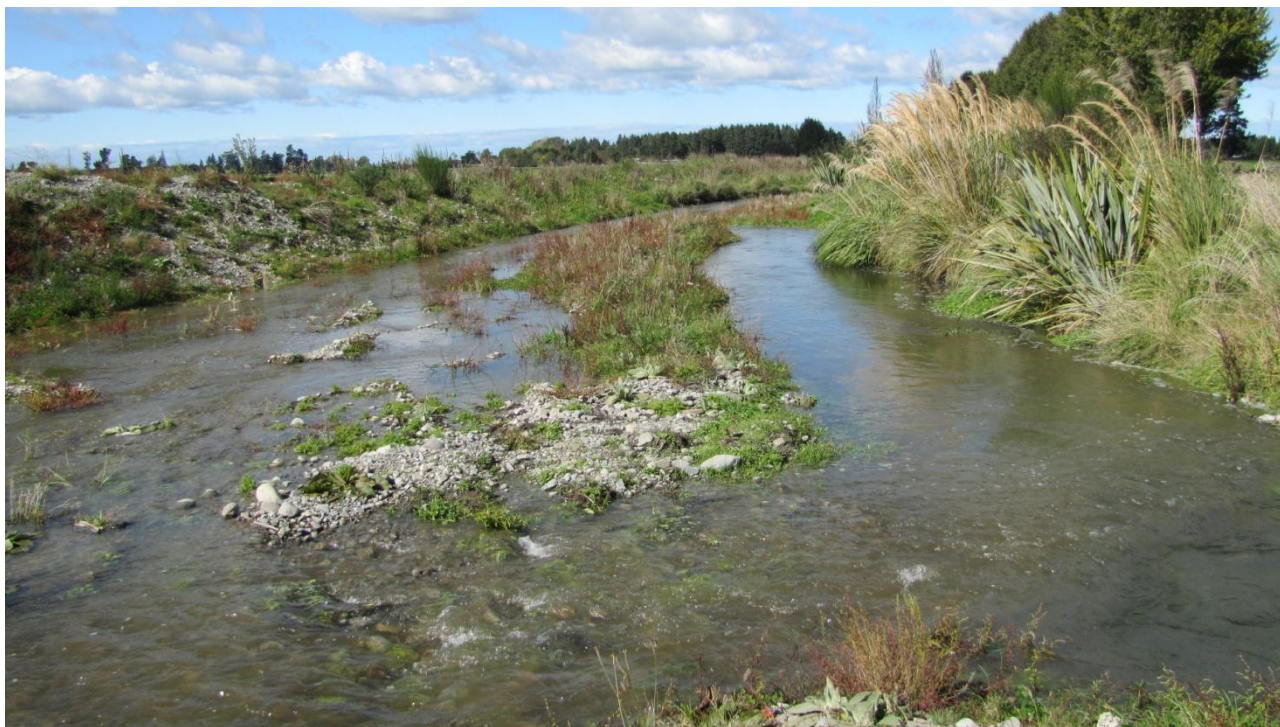
Figure 3: The confluence of the Scotsburn (left) and Coopers Creek looking downstream during a period of flow in the Scotsburn Stream. May 2011.

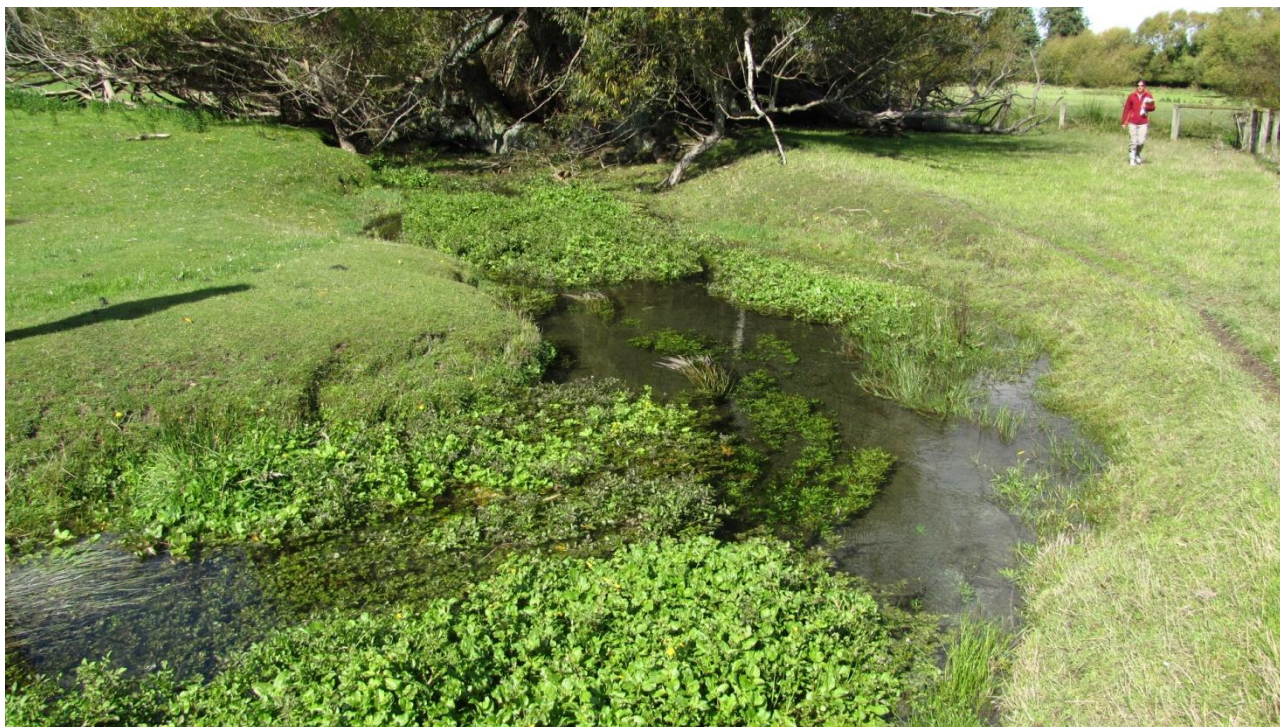
*Figure 4: The upper full habitat assessment site on Coopers Creek. May 2011.*

Moving upstream from the Geraldine - Arundel Rd (SH72), toward the confluence with the Scotsburn Stream, Coopers Creek is channelised between flood banks. At the lower habitat assessment site, where detailed instream habitat data was collected, the stream bed was dominated by cobble-gravel substrates and alternated between pools, runs and riffles bordered by substantial growths of the macrophytes *Lepidium* sp. and *Mimulus* sp (Table 1). The stream is partially shaded by a range of exotic and native vegetation. Along the reach immediately below the confluence with the Scotsburn Stream, Coopers Creek has a gravel cobble substrate, but was severely choked with macrophytes such that the stream bed could not be easily observed. Above the confluence with the Scotsburn Stream the bed of Coopers Creek is predominantly covered with a thick (>5 cm) layer of fine sediment and continues to be dominated by thick growths of aquatic macrophytes (Table 1). The stream is no longer channelised and the wetted channel is broad and flow sluggish. After approximately 200 m the spring splits into three tributaries of approximately equal size. The southerly pair of streams arise from up-welling points within tree lined paleo-channels adjacent to Spring Farm, while the third stream flows along a short channelised section before meandering across paddocks to an impoundment. The spring source is located in swampy ground at the head of a pond. The entire lengths of the three streams are alternately lined in exotic trees, primarily willows, *Salix* sp., or surrounded by exotic pasture. There is no riparian fencing to prevent stock access to the upper reaches of the main spring, except around the pond, which looks to be used for duck shooting. Flow is generally sluggish along this upper reach of the spring and the stream bed is dominated by a thick layer of fine sediment. Cobble gravel substrates are present beneath the silt layer and can be readily exposed by disturbing the fine sediment. A number of small springs and up-welling points join the primary streams close to their spring heads. The farm pond has a piped outlet and appeared generally shallow with a silty bottom. The pond contained some *Potamogeton* sp., aquatic plants and long filamentous green algae were abundant.

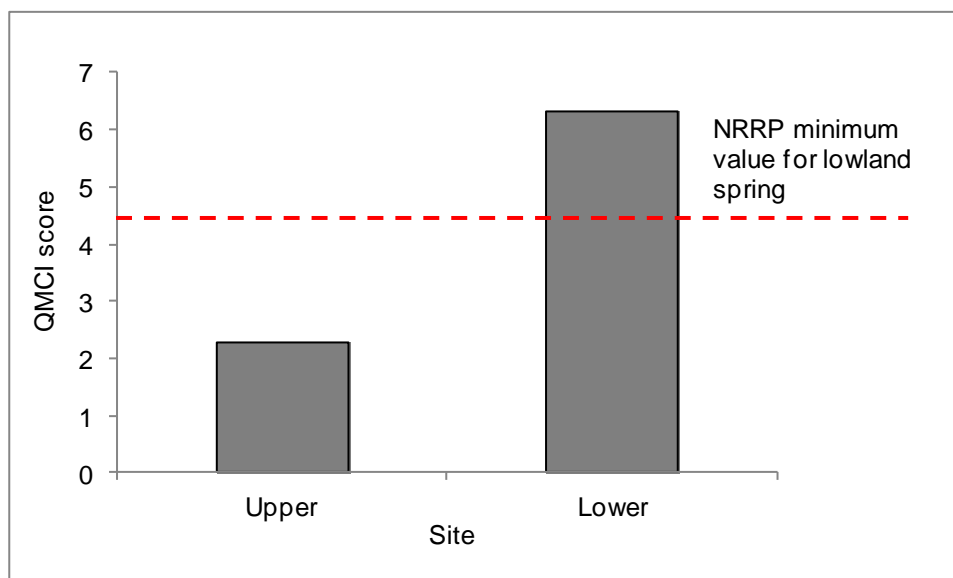
Figure 6: QMCI scores for sites along upper Coopers Creek. The horizontal red line show the desired NRRP (2011) water quality outcome for Canterbury spring-fed plains streams.

The QMCI is an invertebrate community index designed to indicate water quality in a stream based on the diversity and abundance of aquatic invertebrates living within it (Stark 1985). The desired water quality outcome for Canterbury spring-fed plains streams suggested by the NRRP (2011) is a QMCI greater than 4.5. This target was achieved at the lower Coopers Creek site where invertebrate communities were indicative of clean water (Stark 1998) (Figure 6). However, the upper site had an invertebrate community indicative of probable severe pollution and did not approach the NRRP guideline.

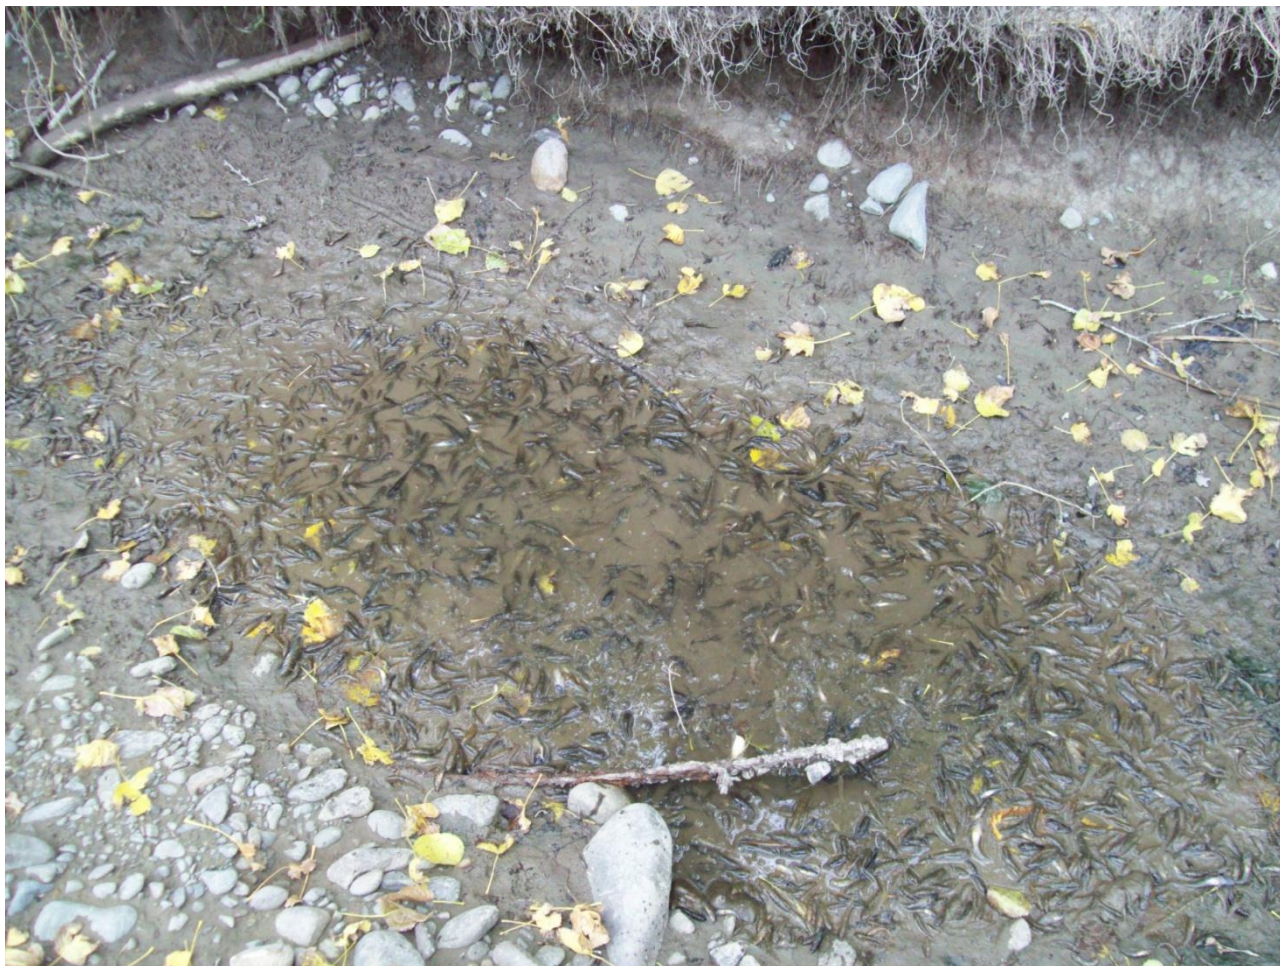
*Figure 7: Stranded upland bullies in a dry Coopers Creek at the SH72. March 2010.*

An anecdotal account from Ad Sintenie (8 February 2012) who lives adjacent to Coopers Creek, at the lower habitat assessment site, indicated a decline had occurred in the diversity and abundance of fish communities over the last 20 years. According to this account large (40+ cm) trout and eels, abundant bullies and galaxiids were regularly observed in the creek, but had been notably absent during the last 3-4 years commensurate with a decline in flow (Figure 7).
