# Historic Flood Events in Canterbury

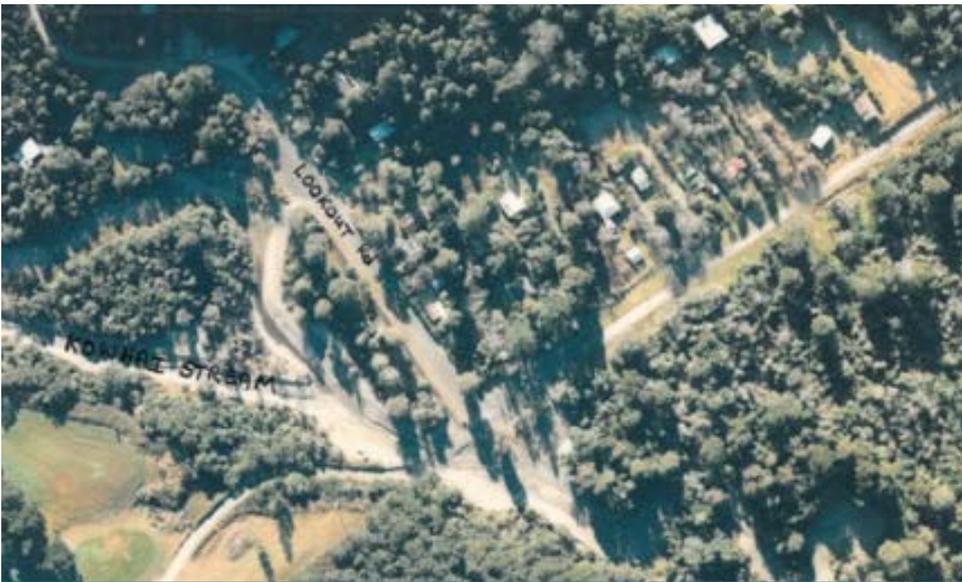
Aerial Photograph of Blandswood Settlement – Kowhai Stream runs from left to right.

On the 28 January 1975, an extreme, localised dump of rain fell over the Kowhai Stream catchment, ultimately causing a surge of debris-laden floodwater to overwhelm the stream banks and severely inundate Blandswood settlement resulting in the tragic loss of four children staying in one of the nearby holiday homes.

Blandswood is a settlement of approximately 60 - 70 allotments, with 10 of those located on the floodplain of the adjacent Kowhai Stream. Kowhai Stream is a steep, highly mobile, gravel stream that runs dry for much of the time but can rapidly flood in response to heavy rain and blockages caused by erosion of vegetation and debris from the streams steep mountainous sides.

By 6pm on the 28th January, Kowhai Stream was in flood and had become strongly discoloured. The flood flow scoured stream banks causing debris/vegetation dams to form temporarily, before bursting and sending two large surges toward the settlement. The first, and smaller of the two surges, swept a footbridge from its foundations and pinned it against a large tree further downstream. The second and larger surge sent metres of water out of the stream banks and across Lookout

These surges carried debris, silt, vegetation, heavy logs and even deposited a boulder 550mm - 650mm in diameter outside of the streambed. The second surge completely overwhelmed stream banks, surged into the settlement, demolished one house, severely damaged another, and flooded all the other dwellings located "on the flats" to depths of up to 1.5m.

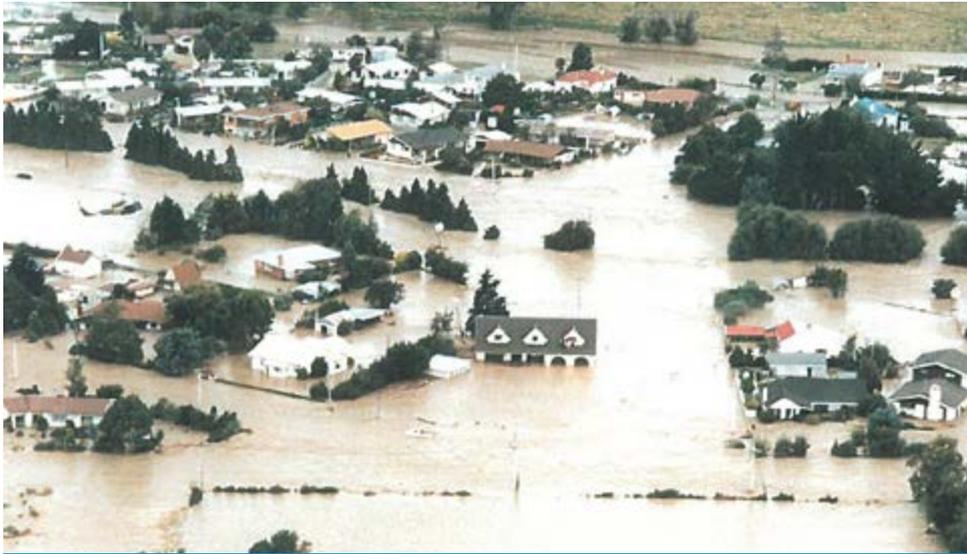
13 March 1986 flood - flooding of property and houses in South Canterbury.

The March 1986 flood flows were the largest recorded in the south Canterbury foothill rivers over the 20th century.

They caused damage of around \$120 million (2010 dollars) to property, roads, river control works, and loss of crops and livestock. Hundreds of homes had water through them but remarkably just one life was lost. Had the flooding peaked in the night, it is widely believed that many more lives may have been lost as the rescue and evacuation of people

Flooding of property and houses occurred in many locations around South Canterbury but most notably in Pleasant Point Township and the hut settlements adjacent to the Ophi River, Levels Plains and Seadown, parts of Geraldine and Fairlie townships, the Washdyke industrial area, the Pareora Valley and Pareora Huts, Waihao Valley, Willowbridge and Morven areas and Hakataramea Township.

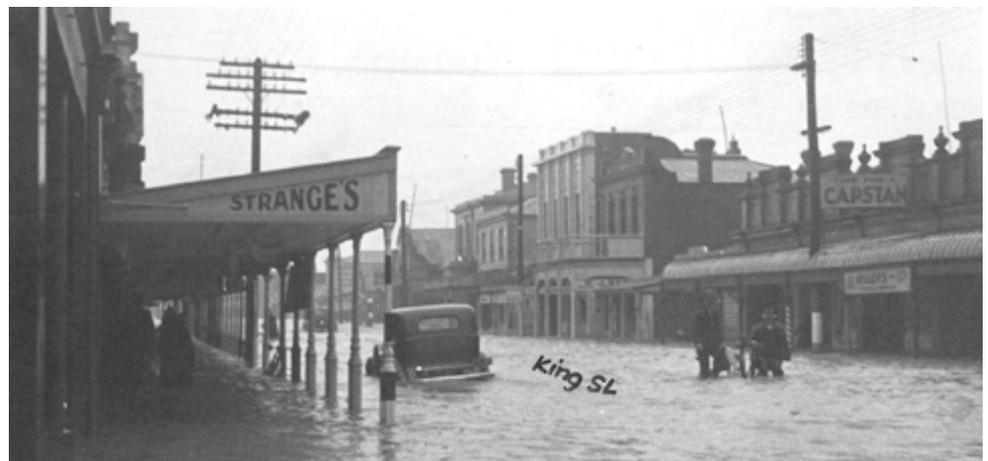
1945 Flood - two feet of water flowing down Temuka's main street

Up to 600 mm of water flowed through Geraldine township and 30 homes were evacuated. Twelve bridges in the County were completely destroyed, 11 were badly damaged and impassable and a further 25 had washouts to the bridge approaches. In Temuka, two feet of water flowed down the main street and more than 100 people
