**Evaluating the effectiveness of  
riparian plantings on water quality:  
A case study of lowland streams in  
the Lake Ellesmere catchment**

A thesis  
submitted in partial fulfilment  
of the requirements for the Degree of  
Master of Resource Studies

at  
Lincoln University  
by  
Kathryn Elizabeth Collins

Lincoln University  
2011

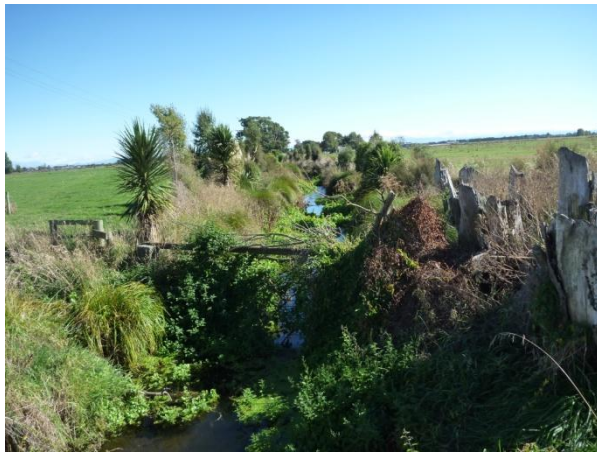
Figure 3.1: Planted buffer on Boggy Creek at Volckman Road.

The four restored sites are Boggy Creek at Volckman Road (Figure 3.1, site 1 Figure 3.5), Harts Creek downstream of The Lake Road (Figure 3.2, site 3 Figure 3.5), Harts Creek downstream of Lochheads Road and Birdlings Brook (Figure 3.3, site 5 Figure 3.5) at Beethams Road (Figure 3.4, site 7 Figure 3.5). Each of these sites have buffer zones that have been planted with native vegetation (Table 3.1). Three of the buffer zones are fenced to exclude stock, and the fourth site is not grazed (Harts Creek at Lochheads Road).

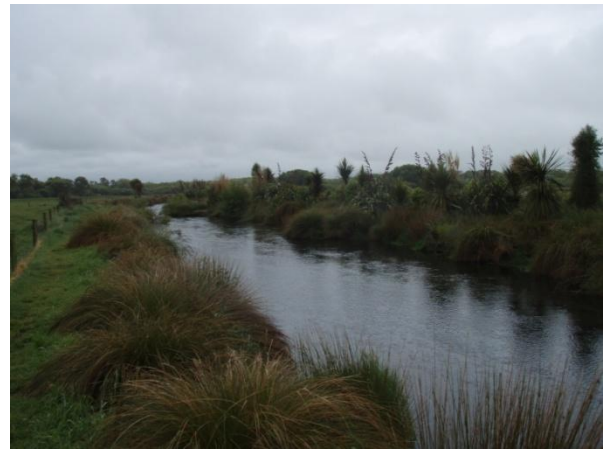
Figure 3.2: Planted buffer on Harts Creek downstream of The Lake Road.

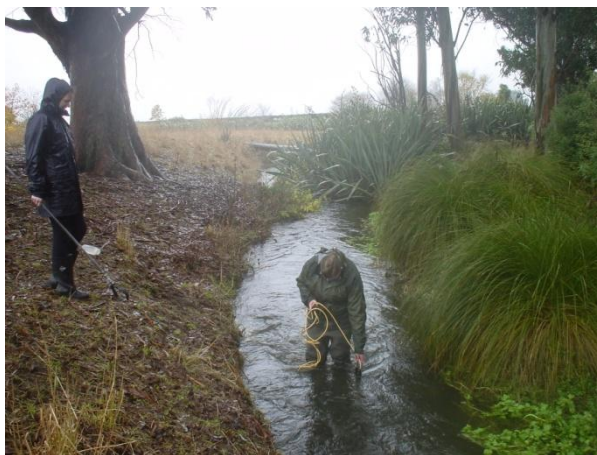
Figure 3.3: Planted buffer on Harts Creek downstream of Lochheads Road. Photo courtesy of Hamish Rennie.

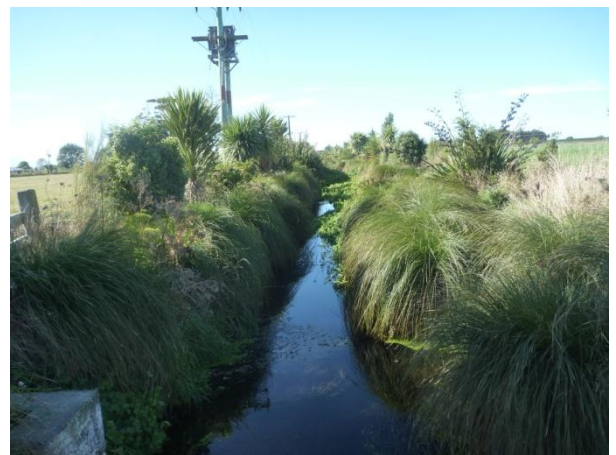
Figure 3.4: Planted buffer on Birdlings Brook at Beethams Road.

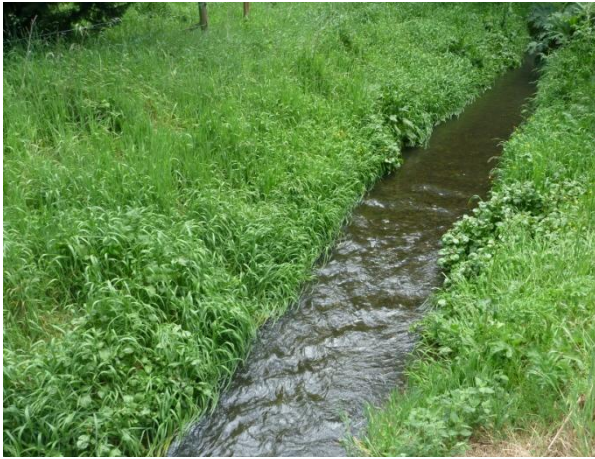
Figure 3.6: Boggie Creek control site at Leeston Road.

A paired control site was established upstream for each planted riparian area. The four paired sites are Boggy Creek at Leeston Road (Figure 3.6, site 2 Figure 3.5), Harts Creek at The Lake Road (Figure 3.7, site 4 Figure 3.5), Harts Creek upstream of Lochheads Road (Figure 3.8, site 6 Figure 3.5) and Birdlings Brook at Feredays Road (Figure 3.9, site 8 Figure 3.5). The control sites had not been planted with native vegetation. The control reaches at Boggy Creek and Birdlings Brook were fenced, but at Harts Creek – The Lake Road and Harts Creek: Lochheads Road fences were not in place. At Harts Creek – Lochheads Road the area adjacent to the stream was not actively grazed during the sampling period, while at Harts Creek – The Lake Road the paddock was actively grazed by cattle who were able to access the stream bed until a fence was constructed mid way through the sampling period in June (Figure 3.7, Figure 3.10).

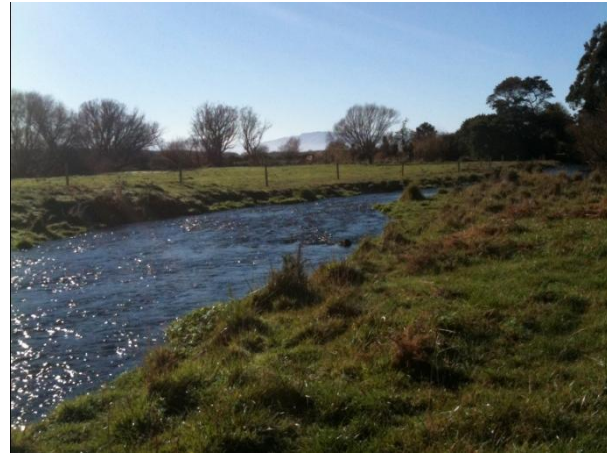
Figure 3.7: Harts Creek at The Lake Road control site in June, after a fence to exclude stock was constructed.

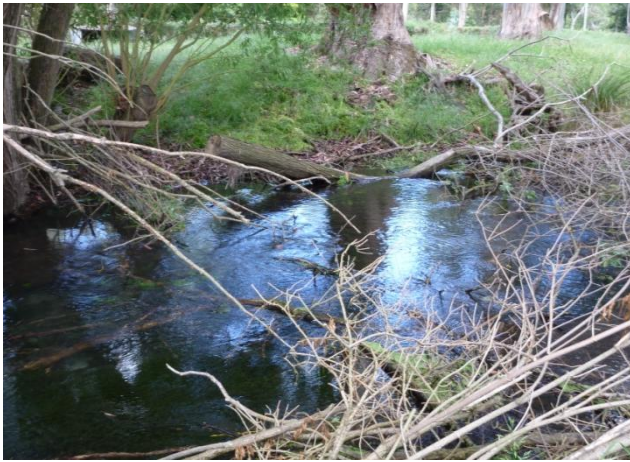
Figure 3.8: Harts Creek control site upstream of Lochheads Road.

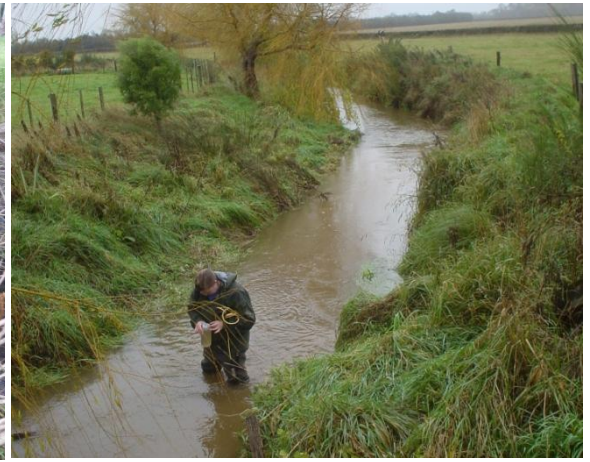
Figure 3.9: Birdlings Brook control site at Feredays Road.  
Photo courtesy of Hamish Rennie.

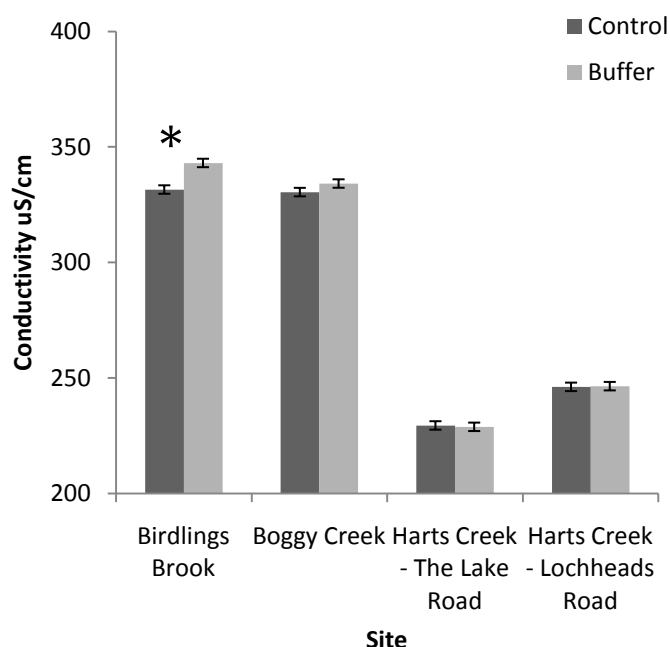
Figure 4.5: Average conductivity ( $\pm\text{SEM}$ ) between control and buffer sites. Significant differences for each pair of control and buffer sites are marked with asterisks (\* LSD test  $p < 0.05$ ).

There was found to be a significant main effect of treatment, ( $\chi^2 = 8.17$ ,  $DF = 1$ ,  $p = 0.008$ ) where conductivity was higher in planted areas. There was also found to be a significant effect of site ( $\chi^2 = 60.60$ ,  $DF = 3$ ,  $p < 0.001$ ) and a significant interaction between treatment and site ( $\chi^2 = 13.67$ ,  $DF = 3$ ,  $p = 0.01$ ) (Figure 4.5). Post hoc pairwise comparisons using Fishers LSD tests ( $\alpha = 0.05$ ) indicated that only the Birdlings Brook pair had a significant difference between the planted and unplanted treatment ( $p < 0.05$ ), where conductivity was higher at the buffered site. There were no significant differences between the planted and non-planted treatments at all other sites ( $p > 0.05$ ) (Figure 4.5).

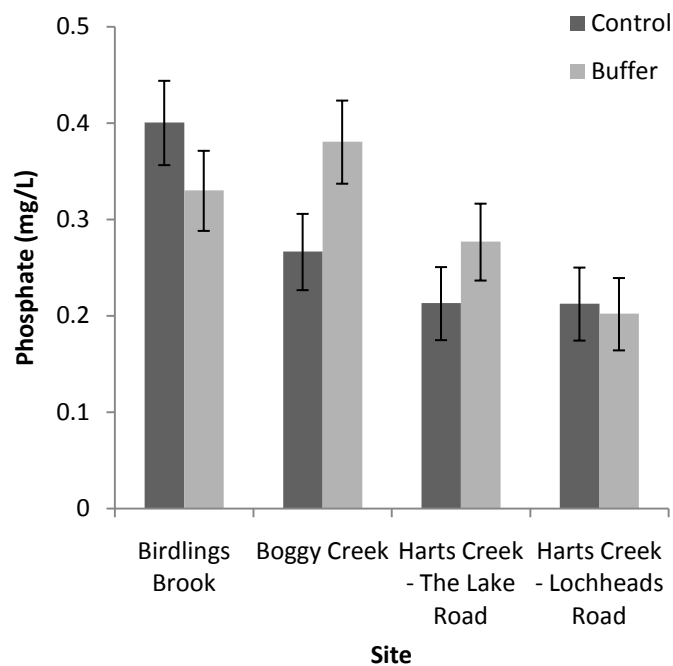
Figure 4.8: Average phosphate levels ( $\pm$ SEM) between control and buffer sites.

There was no significant main effect of treatment ( $\chi^2 = 1.76$ , DF = 1,  $p = 0.196$ ) on soluble phosphate levels. However, a significant difference in phosphate levels was seen between sites ( $\chi^2 = 9.35$ , DF = 3,  $p = 0.042$ ). There was no significant interaction between treatment and site ( $\chi^2 = 6.09$ , DF = 3,  $p = 0.133$ ) (Figure 4.8).

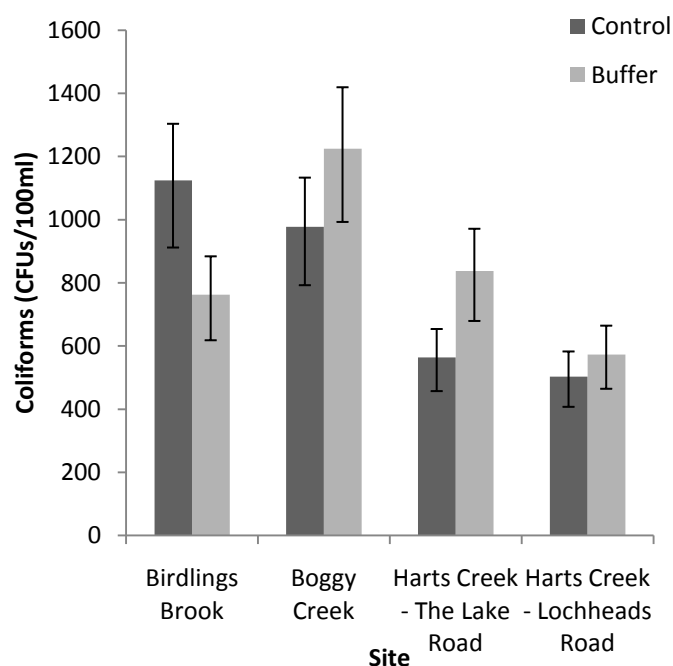
Figure 4.10: Average coliforms ( $\pm$ SEM) between control and buffer sites.

There was no main effect of treatment ( $\chi^2 = 0.55$ , DF = 1,  $p = 0.466$ ) or site ( $\chi^2 = 5.54$ , DF = 3,  $p = 0.161$ ) on coliform levels. There was also no significant interaction between site and treatment ( $\chi^2 = 5.71$ , DF = 3,  $p = 0.152$ ) (Figure 4.10).

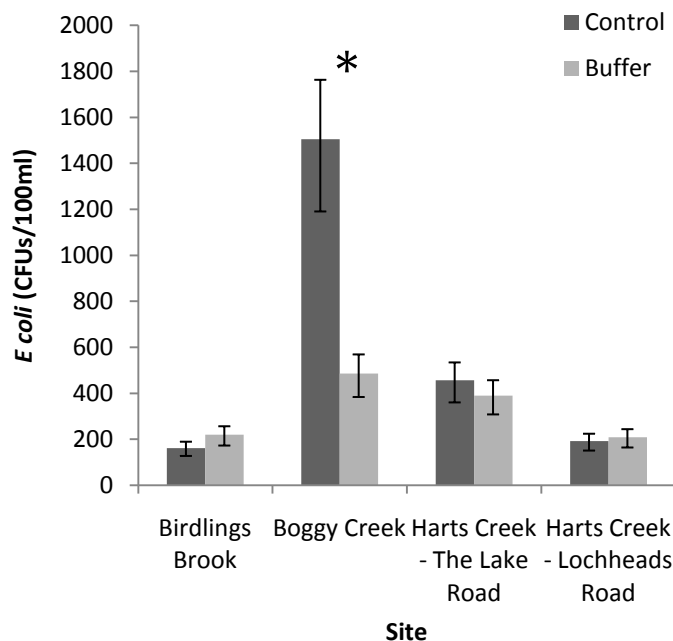
Figure 4.11: Average *E. coli* ( $\pm$ SEM) between control and buffer sites.

Significant differences for each pair of control and buffer sites are marked with asterisks (\*  $p < 0.05$ ).

There was no significant main effect of treatment on *E. coli* levels ( $\chi^2 = 2.83$ , DF = 1,  $p = 0.104$ ). However, there was found to be a significant effect of site ( $\chi^2 = 38.91$ , DF = 3,  $p < 0.001$ ) and a significant interaction between treatment and site ( $\chi^2 = 16.71$ , DF = 3,  $p = 0.004$ ) (Figure 4.11). Post hoc pairwise comparisons using Fishers LSD tests ( $\alpha = 0.05$ ) indicated that only the Boggy Creek pair had a significant difference in *E. coli* levels between the planted and unplanted treatment ( $p < 0.05$ ), where *E. coli* levels were lower at the buffered site. There were no significant differences between the planted and non-planted treatments at all other sites ( $p > 0.05$ ) (Figure 4.11).

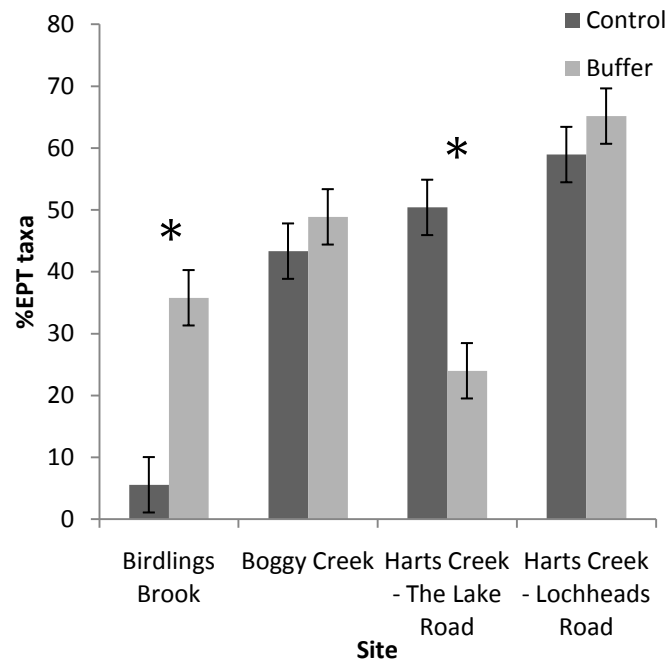
Figure 4.16: Average percentage EPT taxa ( $\pm$ SEM) between control and buffer sites. Significant differences for each pair of control and buffer sites are marked with asterisks (\*  $p < 0.05$ ).

There was no significant main effect of treatment on percentage Ephemeroptera, Plecoptera and Trichoptera (EPT) taxa ( $\chi^2 = 1.51$ ,  $DF = 1$ ,  $p = 0.227$ ). However, there was found to be a significant effect of site, ( $\chi^2 = 89.33$ ,  $DF = 3$ ,  $p < 0.001$ ), and a significant interaction between site and treatment ( $\chi^2 = 40.40$ ,  $DF = 3$ ,  $p < 0.001$ ) (Figure 4.16). Post hoc pairwise comparisons using Fishers LSD tests ( $\alpha = 0.05$ ) indicated that there were significant differences in percentage EPT taxa at the Birdlings Brook and Harts Creek at the Lake Road pairs ( $p < 0.05$ ). At the Birdlings Brook pair, the percentage EPT taxa was significantly lower

at the unplanted site, however at Harts Creek the Lake Road pair, the percentage EPT taxa score was significantly lower at the planted site (Figure 4.16). There were no significant differences between the planted and non-planted treatments at the Boggy Creek and Harts Creek at Lochheads Road pairs ( $p > 0.05$ ) (Figure 4.16).
