BEFORE THE INDEPENDENT HEARINGS COMMISSIONERS

**The Resource consent Applications by Canterbury Landscape Supplies Ltd:**

**Statement of GRAHAM ROUSE and ROSINA ROUSE**

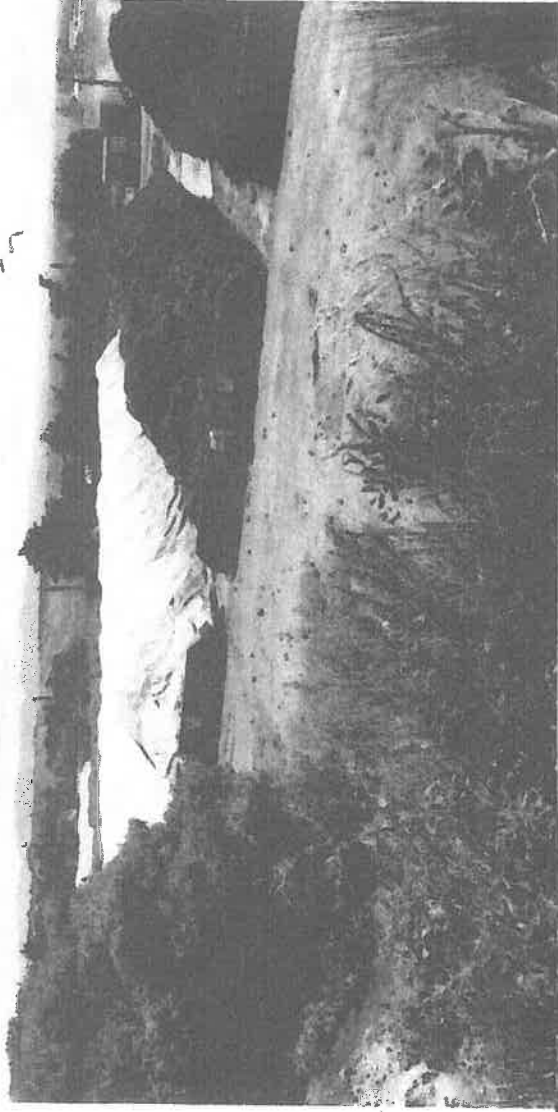
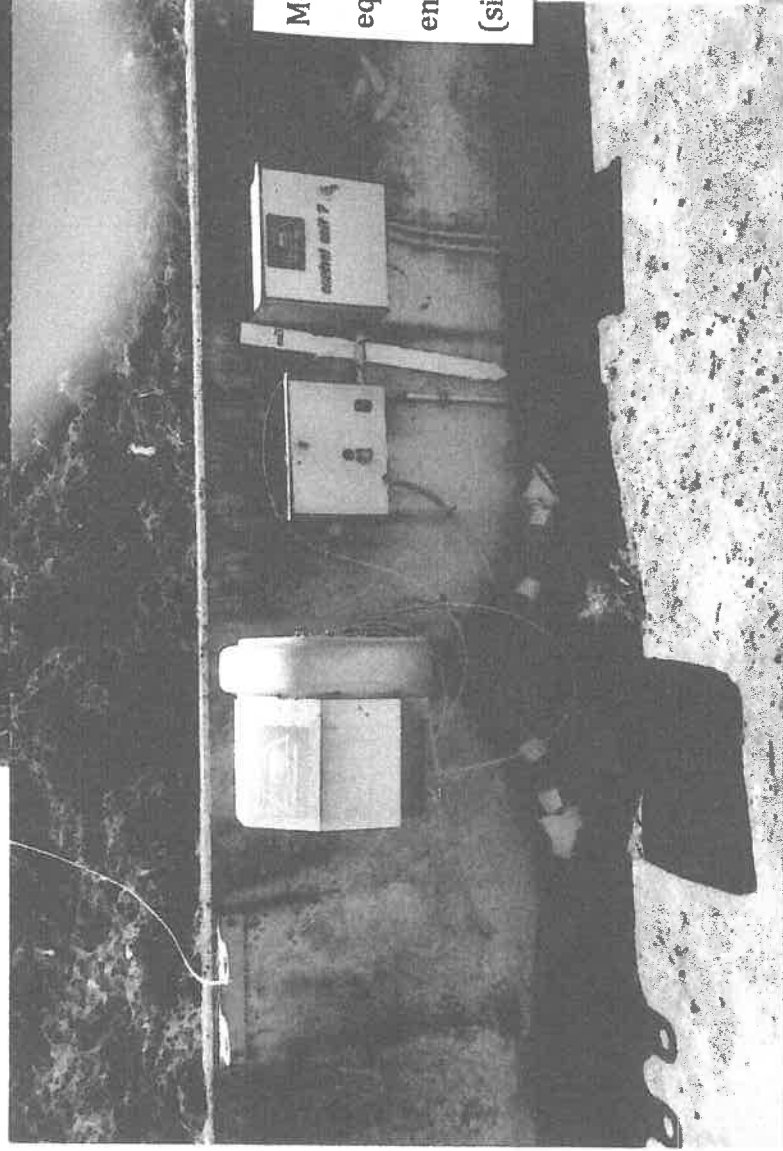
Partial overview of  
Timaru composting  
plant.

56. The Timaru system is sited on a fully sealed, sloping surface. Each windrow is placed on a concrete pad that has two perforated tracks running the full length of each windrow. Below each of these tracks is a chamber facilitating the blowing of air up through the bottoms of the windrows. At the uphill end of each windrow is a computer-assisted monitoring system which monitors the temperature and moisture content of each pile 24 /7. Automatic pumping of air takes place as required. Windrows are 50m in length. The 4 rows in the active compost stage are covered with Gortex (Gore<sup>TM</sup>) covers. If the pumping of air through the bases of the windrows is insufficient, an alarm sounds and the covers are removed. There is an efficient system where leachates and run-off are collected in an underground sump. Refer to photos -Appendix 2

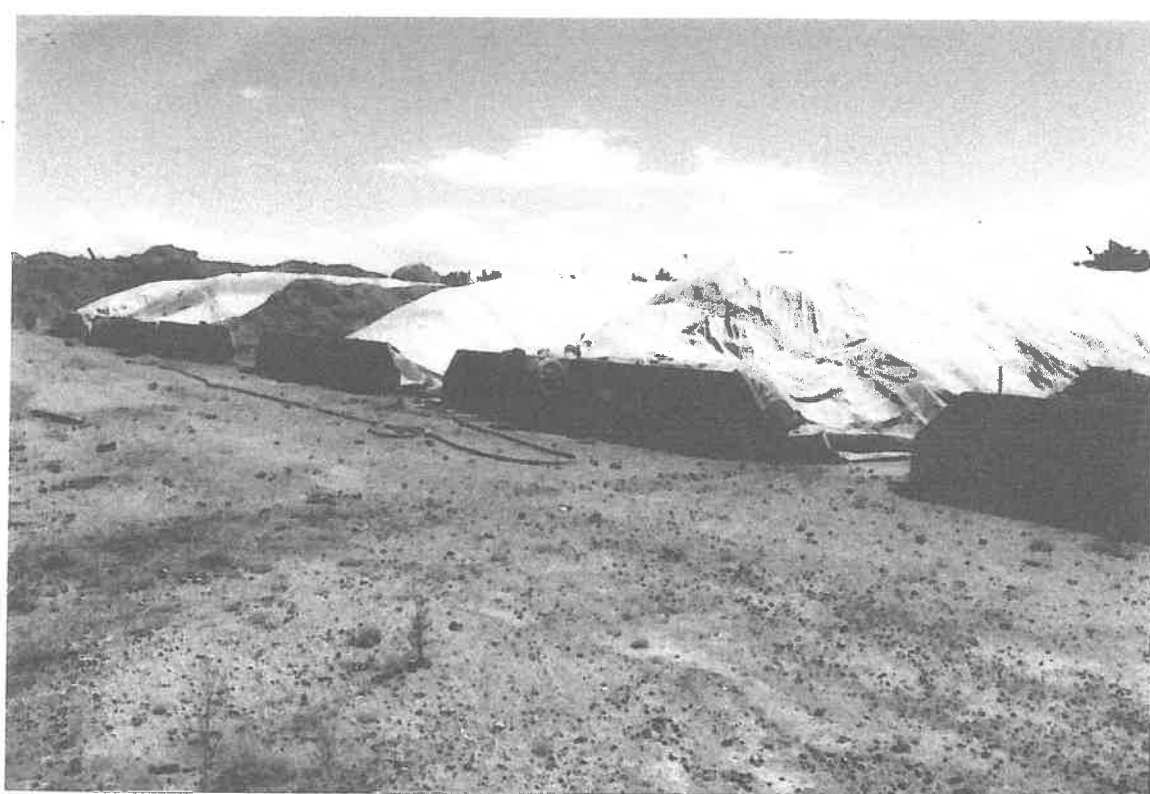
Windrows Covered  
with Gort™ covers.

39. Mitigation methods such as covering odorous material with covers such as Gore<sup>TM</sup> gortex cover system are a possible partial solution but are not part of current management practice. Gore<sup>TM</sup> covers are very successful in Timaru.

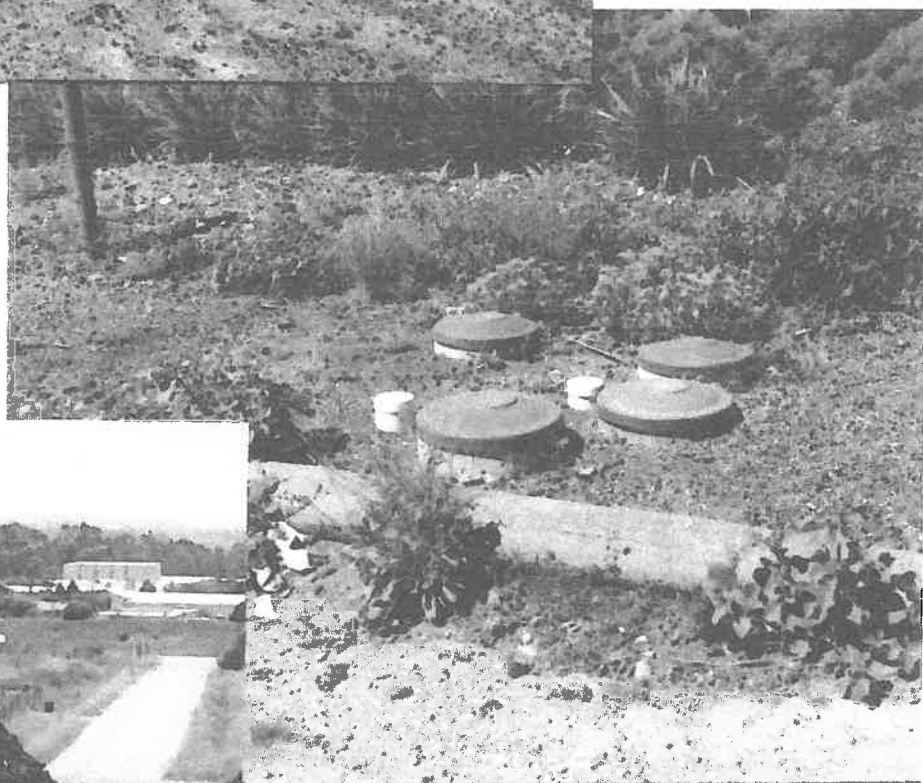
Partial overview of  
Timaru composting  
plant.

Sump for collection  
of leachate.

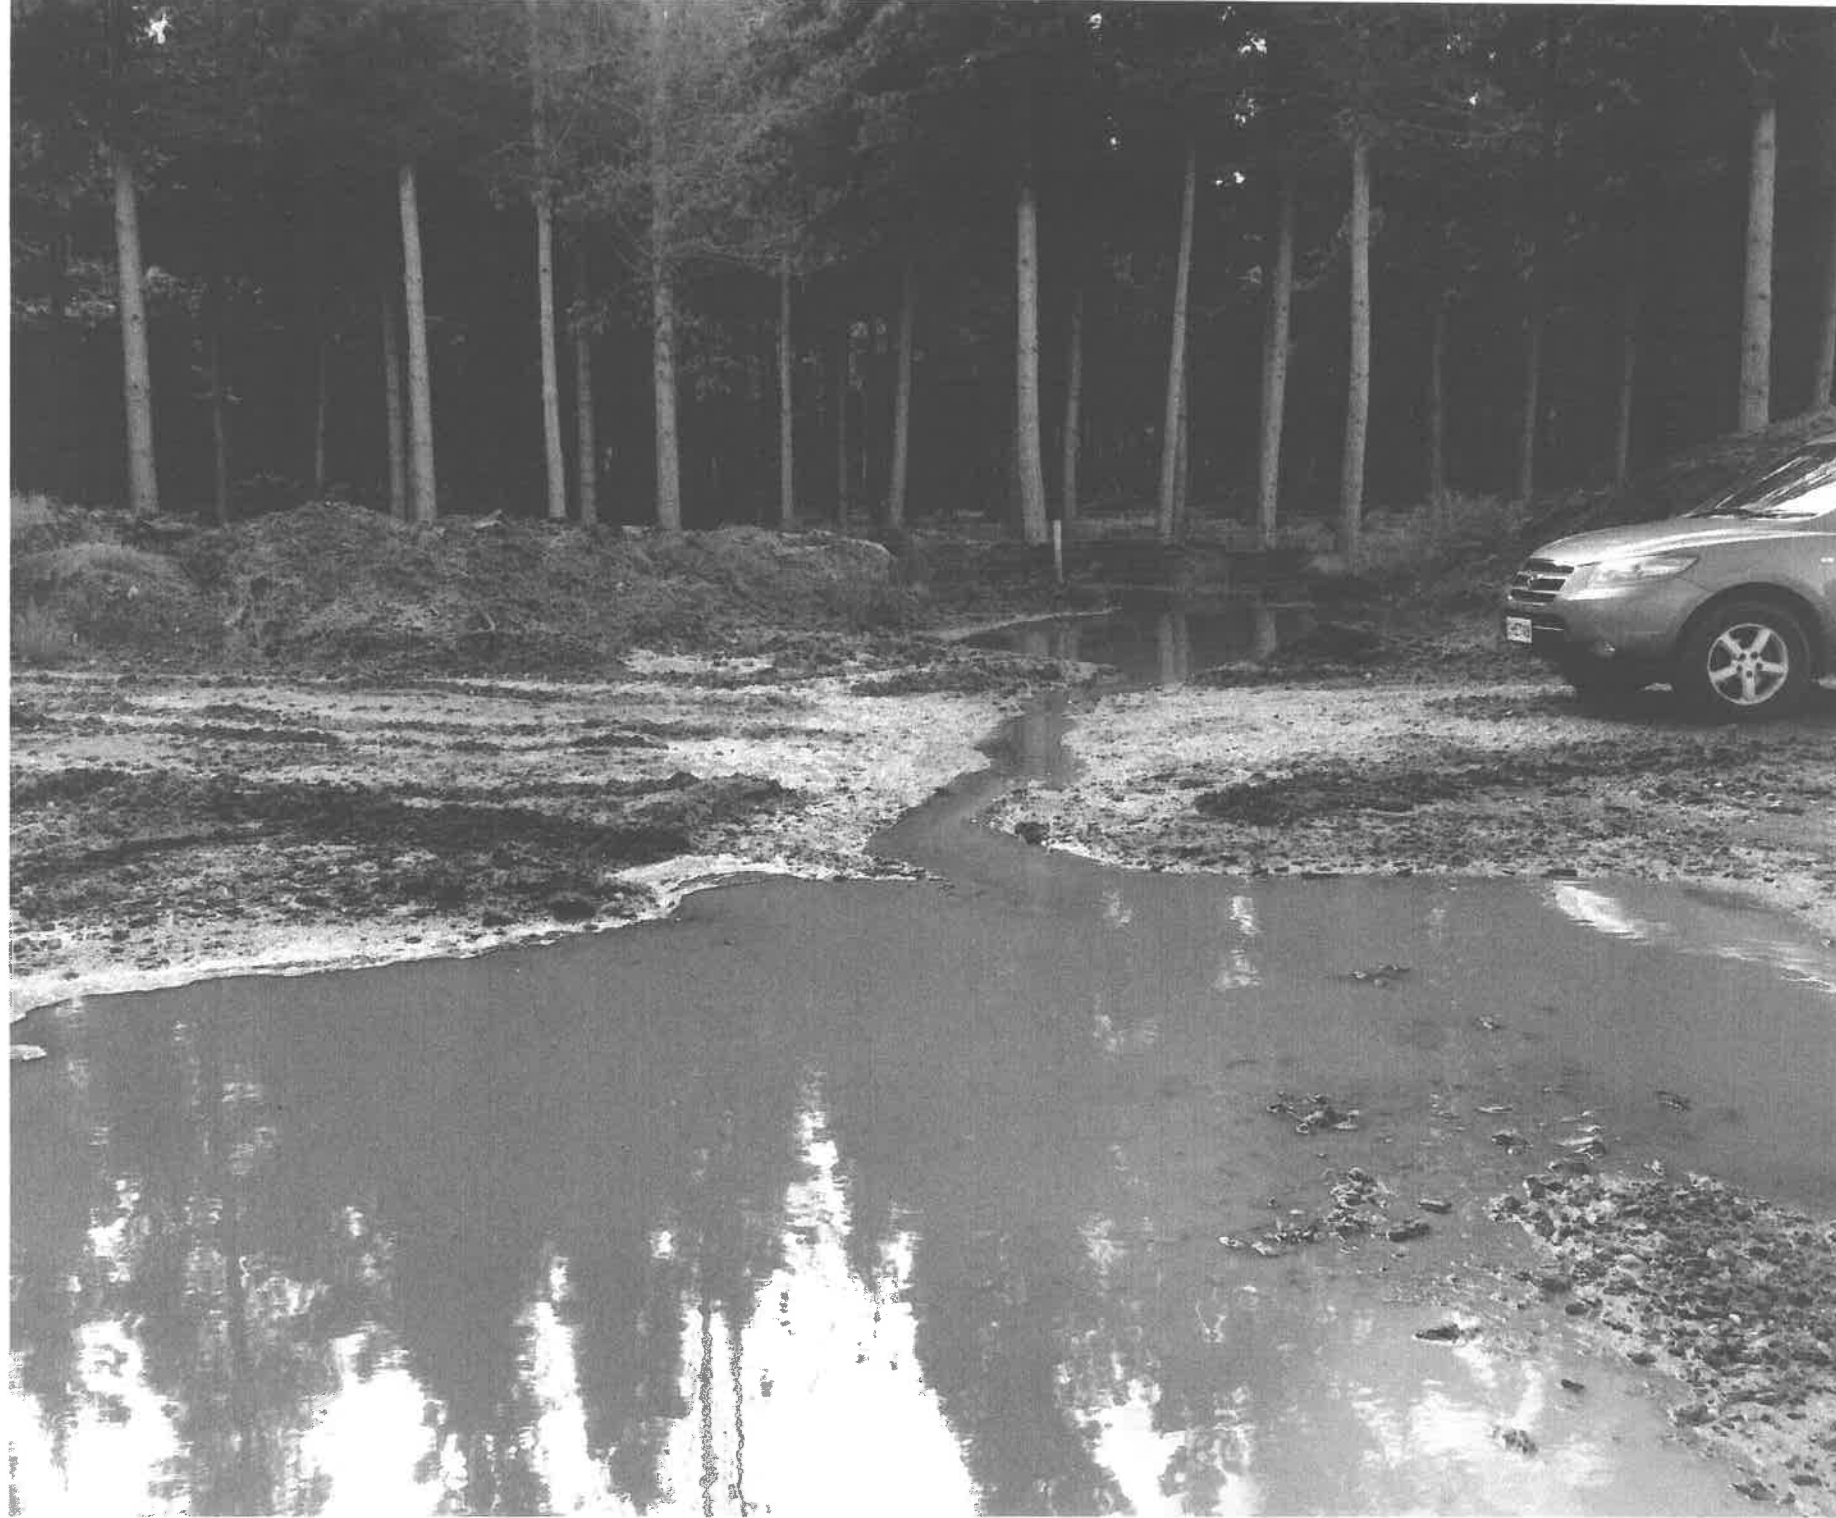
Diversion Road site

Refer Appendix 2: photo dated 22 February 2018 taken 2 days after 75mm rainfall.

28. During our first visit to the Site, Thursday 9<sup>th</sup> November 2017, post Mediation, we were surprised to see the large amount of ponded water, after heavy rain, lying on the surface of the site, filling the ruts made by vehicles, and also in depressions made by vehicular activity.

22/02/2018
