Upper Waitaki Zone Committee Field Trip – Lake Middleton

Friday 17 May 2019

Memo

**Subject:
Lake**

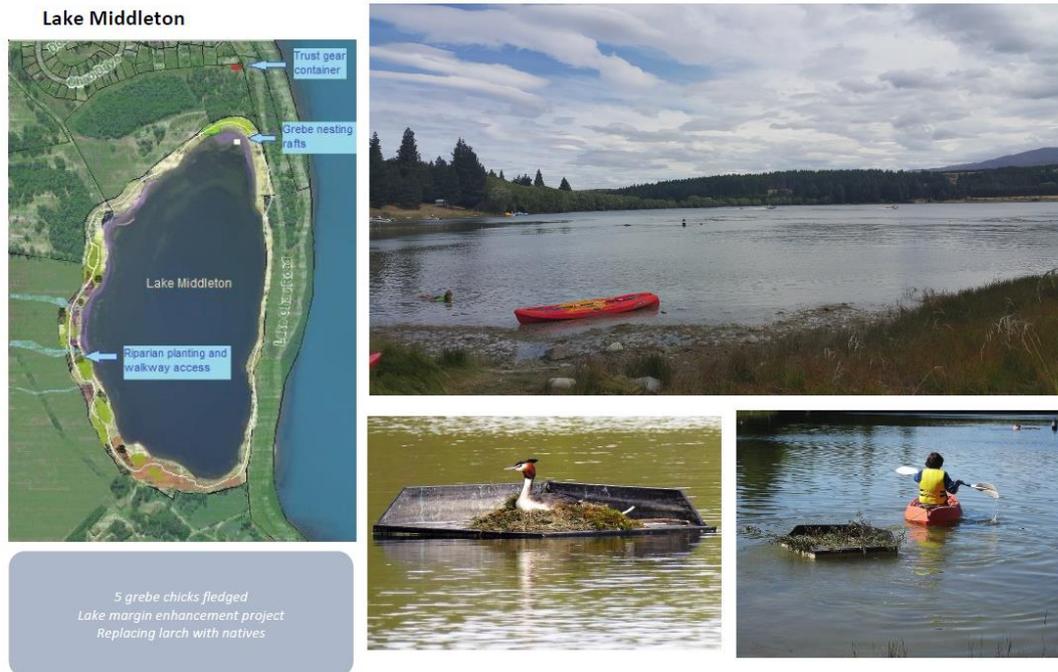
One-page information prepared by Ohau Conservation Trust including a drawing (left) of what enhancement around the lake could look like.

We'd love to see a formed walkway around the lake and riparian enhancement such as planting, removal or thinning of willows and pine trees and making sure that activities in the reserve and surrounding land are not impacting on water quality. The lakes rich wildlife population also needs consideration - we've had grebes breed and raise chicks 3 times in the last 2 years - after many many years of no success at all. All with some small floating nesting rafts. It's great that something so simple is so successful.”
