Assessment of Environmental Effects; Paparua Stockwater Race (PSR) Diversion

Prepared for:
SOL Quarries Ltd

AEL Report No. 172

May 2019

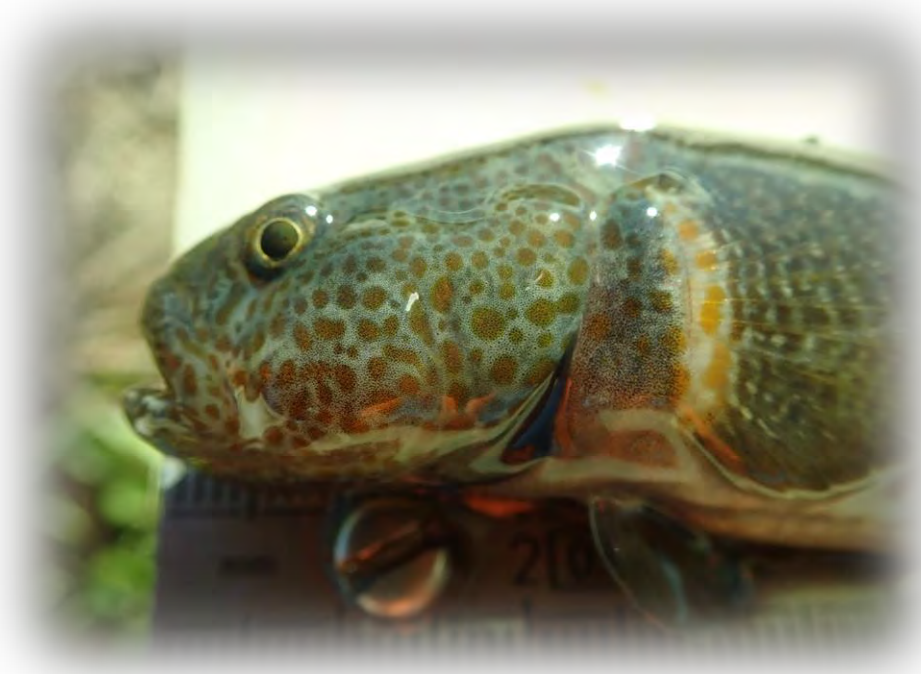
An upland bully (Gobiomorphus breviceps) found in the Paparua Stockwater Race during the ecological survey on 2 May 2019.

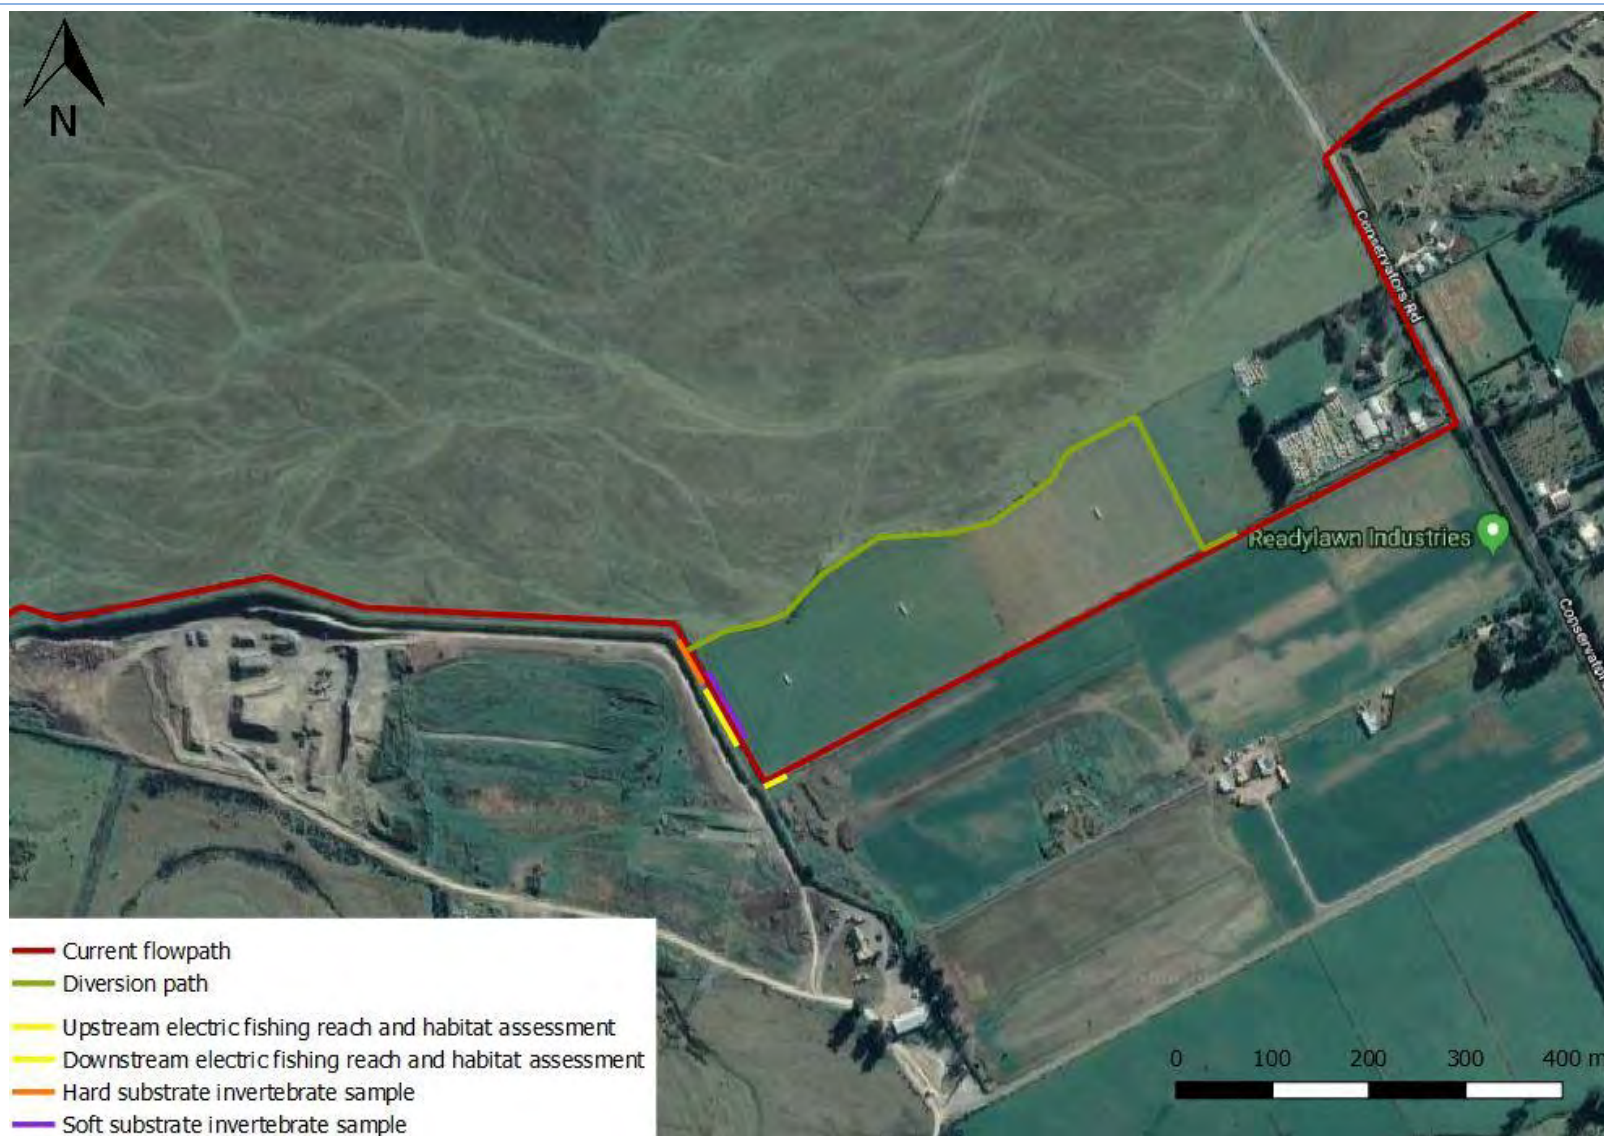
Figure 1. The proposed diversion and the ecological sampling reaches.

Location	Upstream habitat assessment (Fig. 1)											
Habitat parameter	Condition category										SCORE	
1. Deposited sediment	The percentage of the stream bed covered by fine sediment.										1	
	0	5	10	15	20	30	40	50	60	≥ 75		
SCORE	10	9	8	7	6	5	4	3	2	1

Location	Downstream habitat assessment (Fig. 1)											
Habitat parameter	Condition category										SCORE	
1. Deposited sediment	The percentage of the stream bed covered by fine sediment.										6	
	0	5	10	15	20	30	40	50	60	≥ 75		
SCORE	10	9	8	7	6	5	4	3	2	1

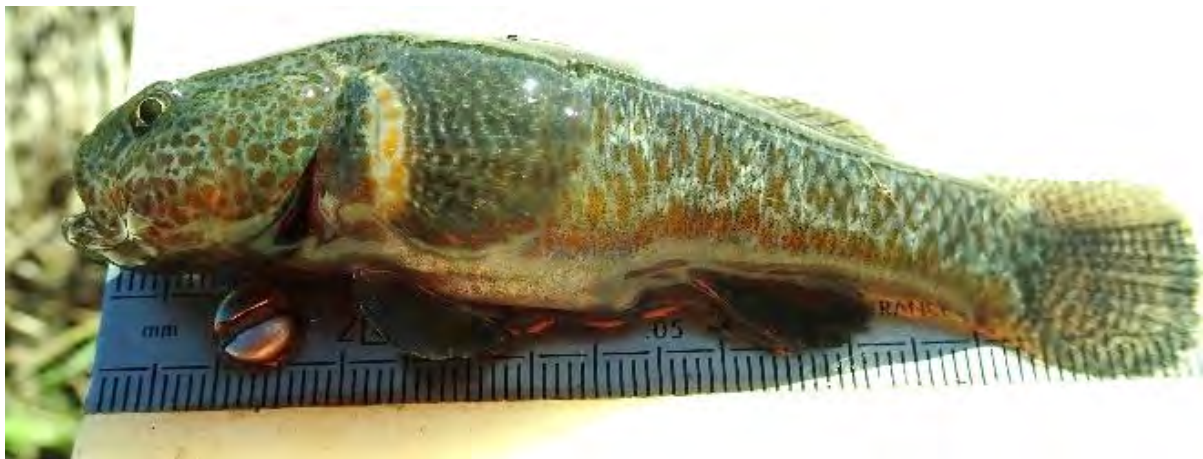
Figure 4. A large and colourful male upland bully caught in the Paparua Stockwater Race.

A single fish species was collected during electric fishing, upland bully (*Gobiomorphus breviceps*). A combined total of 148 individuals were captured from the two electric fishing sampling reaches. This equates to a Catch Per Unit Effort (CPUE) of 9.25 fish/minute (148 individuals/ 16 minutes fishing time). Sizes ranged from 30–94 mm, with most individuals being between 41–55 mm in length (Fig. 3). A small number of particularly large and colourful upland bullies were among the catch (Fig. 4), with a maximum specimen recorded length of 94 mm (T.L).

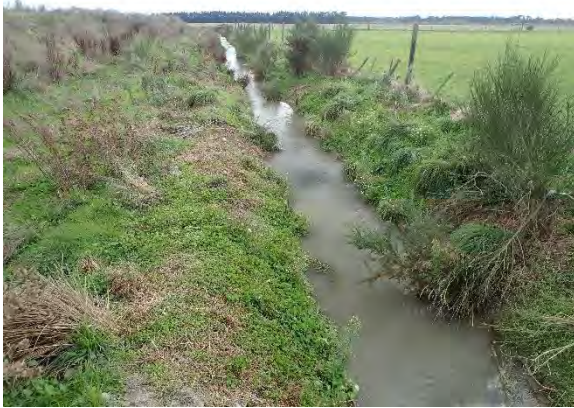
Figure i. Looking upstream (north) at the upstream electric fishing reach. Note that turbidity of water is partially due to surveyors walking in the waterway.

Much of the substrate was covered in fine sediment, particularly within the upstream electric fishing reach. Deposited sediments may limit habitat availability for fish species by filling interstitial spaces between substrate particles (McDowall 1990; McEwan & Joy 2014). The effects of deposited sediments on macroinvertebrates are even more diverse, including: reduced interstitial habitat availability, covering of food supply for species that feed on periphyton, and reduction of interstitial dissolved oxygen (Lenat et al. 1981; Ryan 1991; Quinn et al. 1992). However, during the habitat survey little active bank erosion was observed, indicating that the deposited fine sediment is derived from an upstream location. The PSR sources water from the Waimakariri River, which is high in glacial flour, which can be seen in satellite imagery of the Waimakariri River, and the pond that feeds the PSR (App. II, Fig. iii). This source is likely responsible for much of the deposited fine sediment in the PSR, while the larger particles (gravels, cobbles, and boulders) represent exposed alluvium from historical Waimakariri River outwash. Aerial photographs indicate that much of surrounding landscape in the vicinity of the SOL quarry represents a historical stony channel of the Waimakariri River. Of course, this is the reason why the alluvium quarry is situated there.

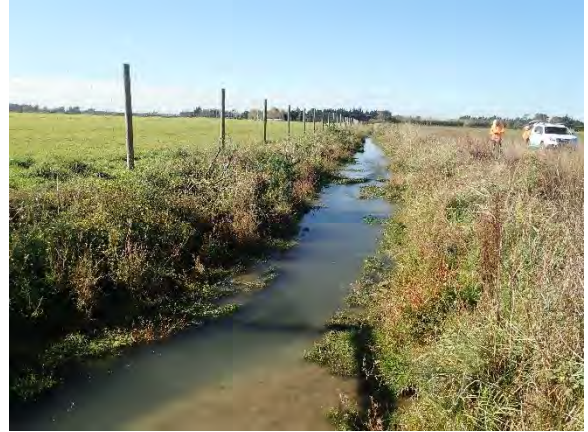
Figure ii. Looking downstream (northeast) at the downstream electric fishing reach. Note that turbidity of water is partially due to surveyors walking in the waterway.

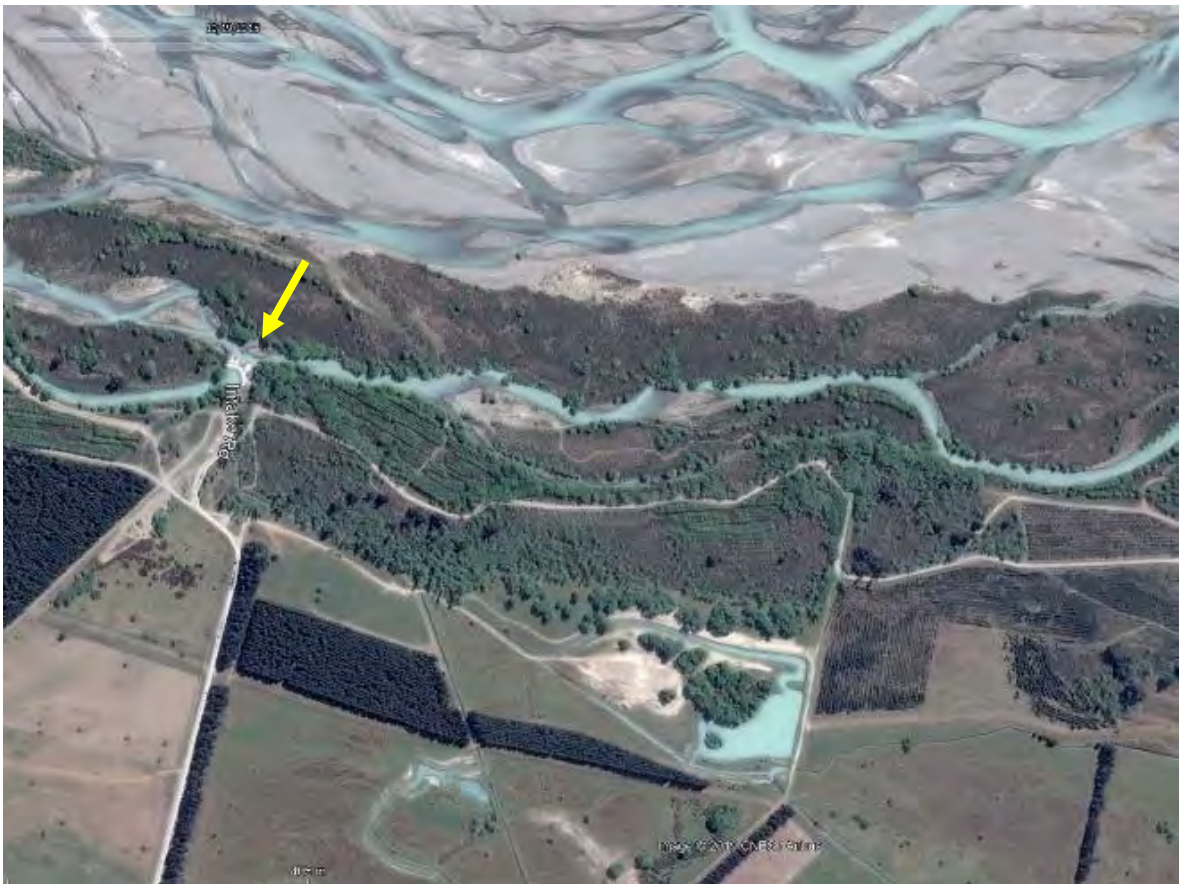
Figure iii. The source of the PSR (arrowed), including the pond and the Waimakariri River. Note the milky colour caused by glacial flour.

The Paparua Stockwater Race (PSR) sources water from the Waimakariri River, via a coarse-sediment settlement pond. The Waimakariri River in turn rises in the southern alps, and its hydrology is principally controlled by its upper basin (Cowie et al. 1986), and is partially glacial fed. For this reason, the river, and therefore the PSR, carries a natural high fine-sediment load called 'glacial flour'. The purpose of the PSR is primarily to supply drinking water for stock, with the surrounding land use used primarily for agriculture. The race is typical of an artificial utility-based waterway; highly channelised, lacking any natural meanders, perennial in flow, with riparian vegetation consisting mostly of grass, with some exotic shrubs present.
