Appendix Three - Andrew Craig Landscape Architect Ltd (*'Craig'*)

- Photographs
- Landscape Advice – Visual Effects

For: Silver Fern Farms Management Limited - Pareora
Date: 7 September 2016
Prepared by: Andrew Craig – *Landscape Architect*
Subject: Consent Application – Coastal Permit
Consent Number: CRC071504 – CRC163849

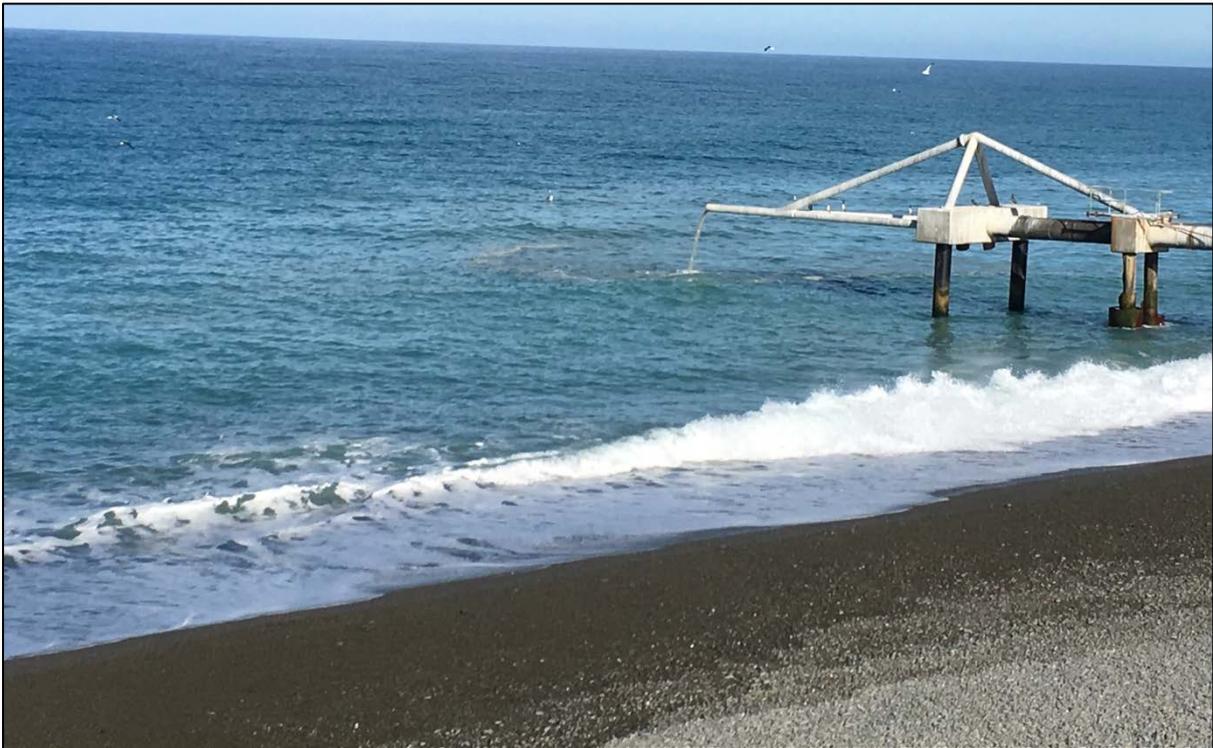
Photograph 1 *Relatively minor discharge with light colour effect*

- f) Currents where it is understood that most run northward long-shore.
- g) Colour of the discharge which may vary from time to time depending on its content, concentrations and overall volume – see **Attachment photographs 1 – 3**. It is understood that colour comprises shades of brown and is no longer informed by the presence of blood, thereby resulting in a remedial effect.

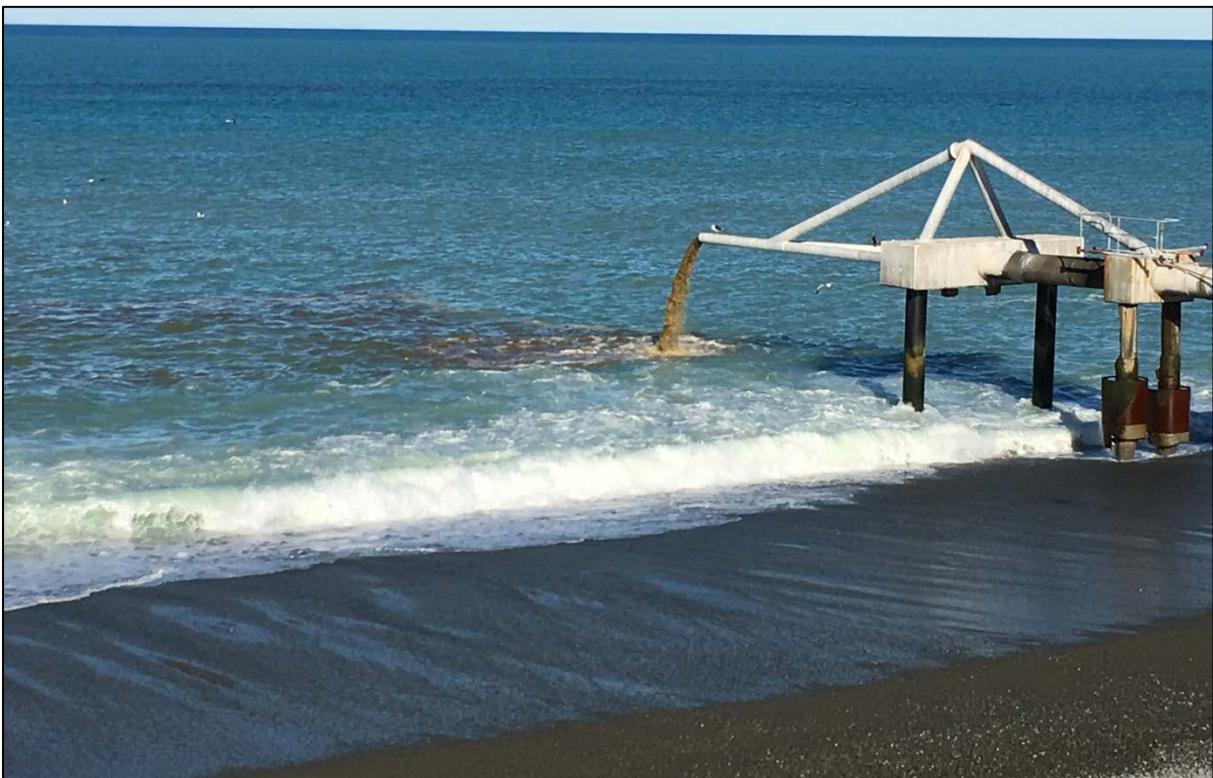
Photograph 2 *Note that the breaking waves do not appear to be affected by colouration.*

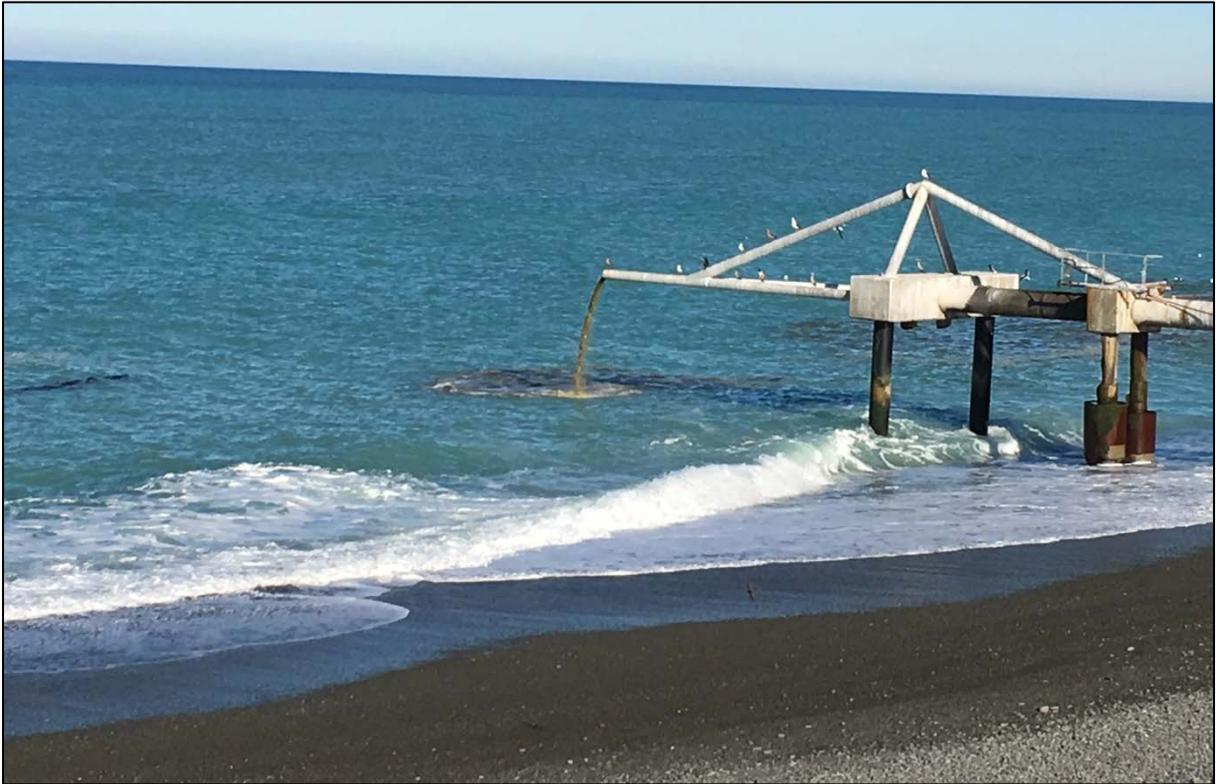
Photograph 3 *Moderate discharge with little apparent visual effect*

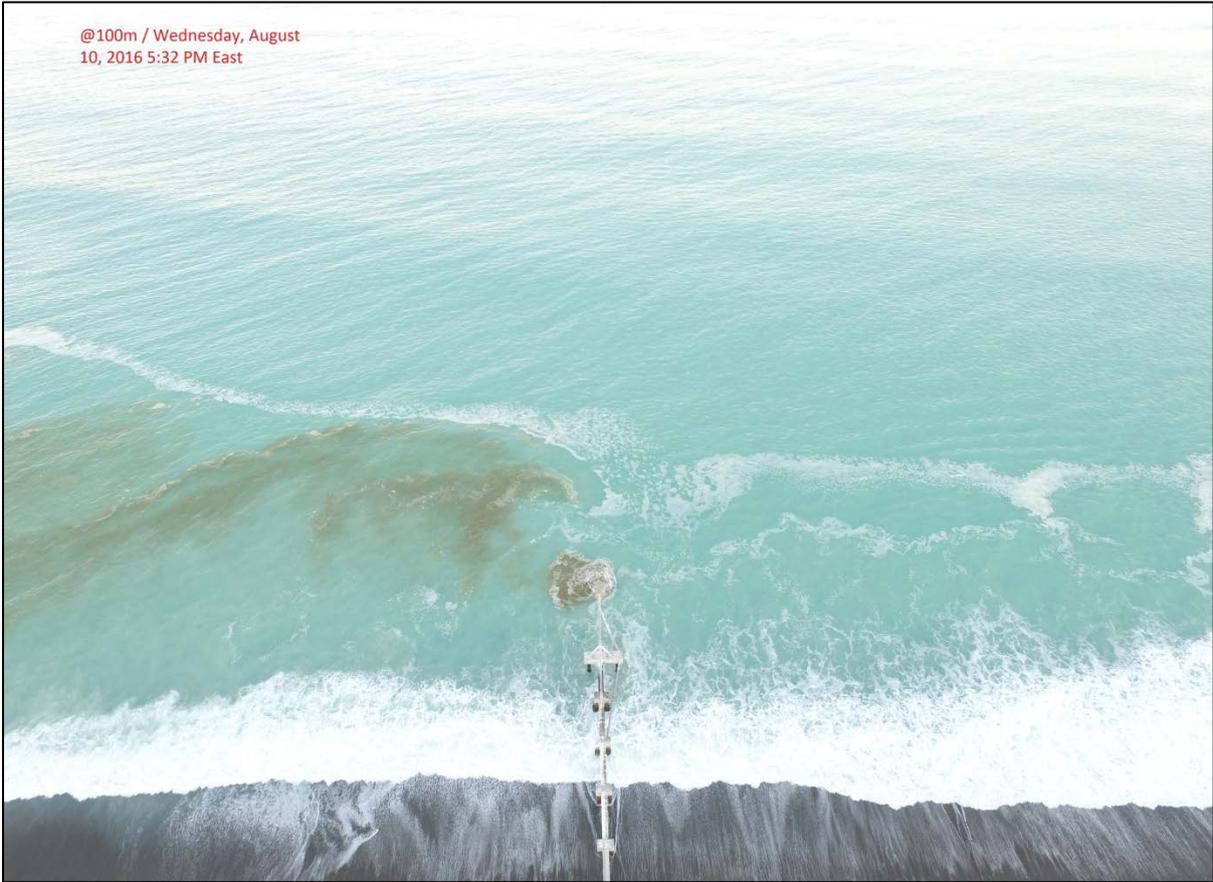
Aerial Photograph 1 *Of the ocean outfall showing the northward drift of discoloured water.*

- d) The location of the viewer in relation to the site variables listed earlier – for example, in relation to the direction long-shore currents to or from the viewer – see **Attachment aerial photographs 1 & 2.**

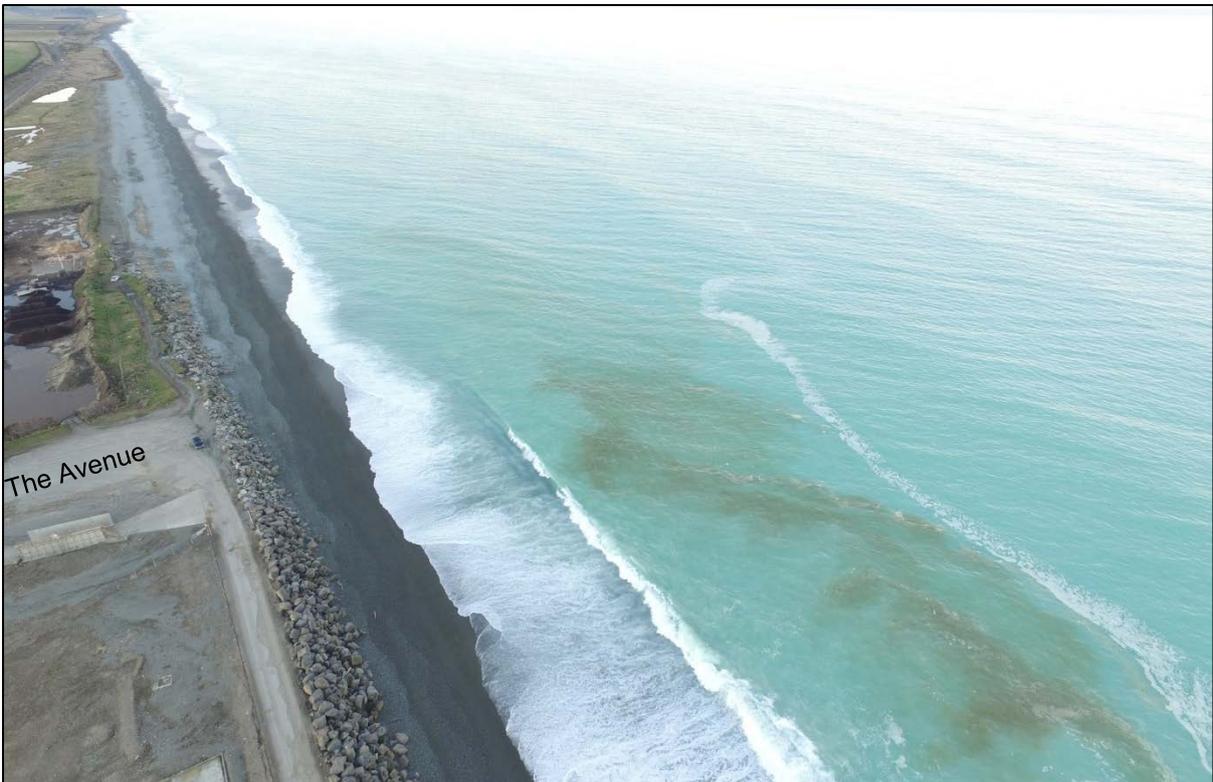
Aerial Photograph 2 *Looking north from above the outfall the long-shore current carries discolouration to a point opposite 'The Avenue' – a distance of around 190 metres.*

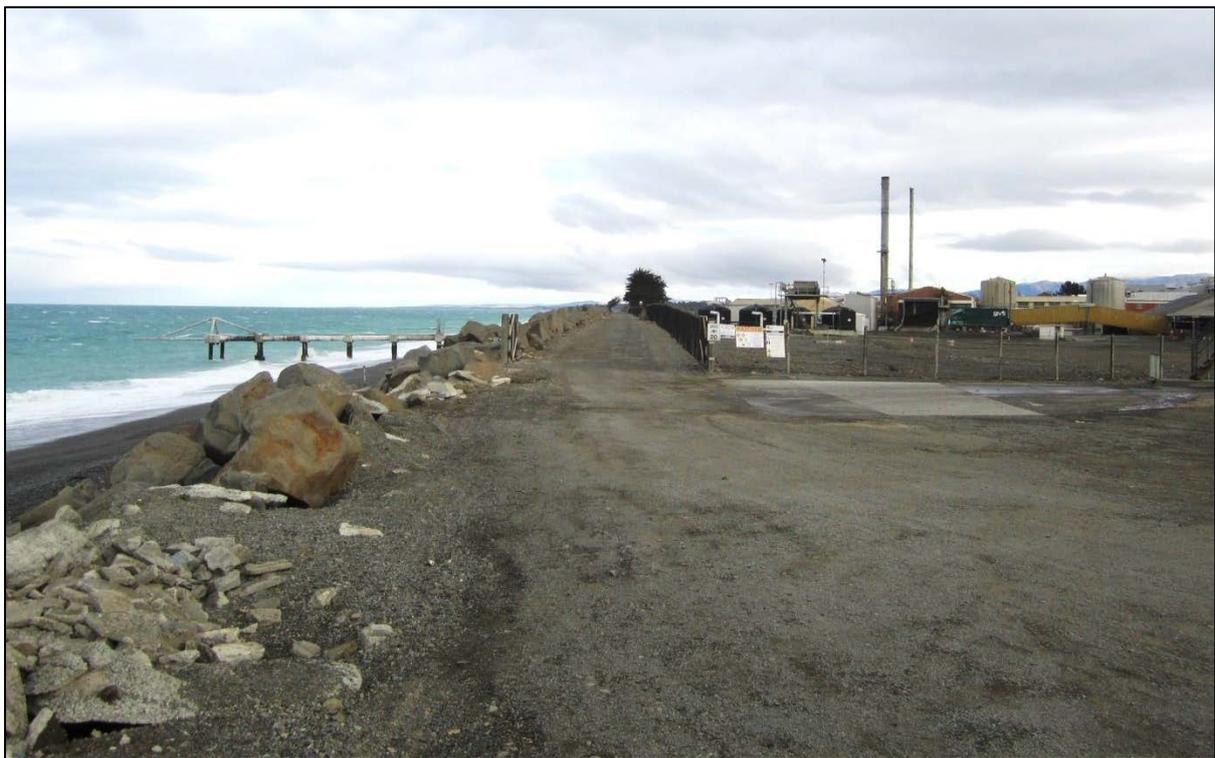
Figure 1 *Looking south to the ocean outfall pipe as viewed from opposite 'The Avenue'. No water was being discharged at the time the photograph was taken.*

The purpose of this landscape advice is to consider the visual effects arising from the discharge of waste water to sea via an outfall pipe – see **Figure 1** photograph.

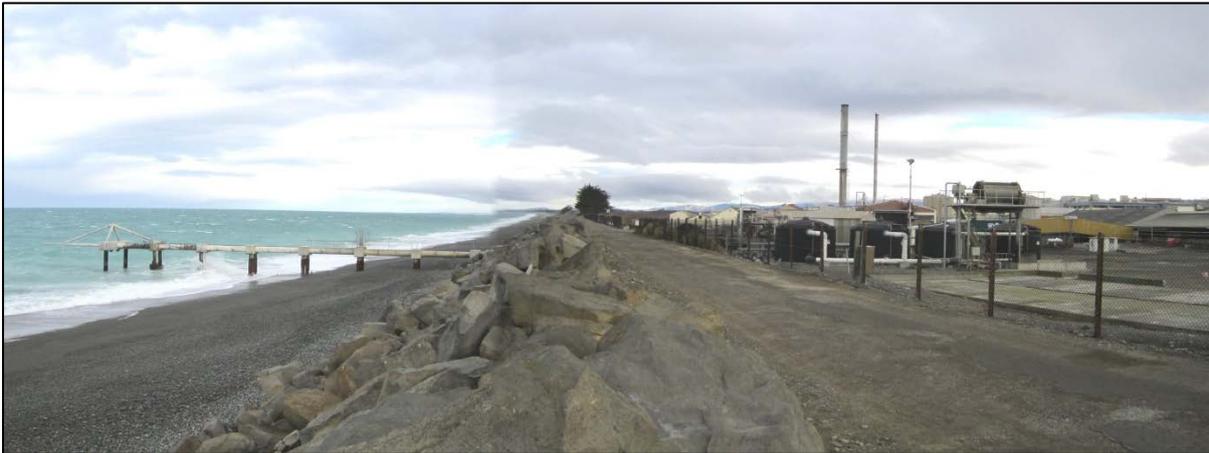
Figure 2 *General view of the site looking south. The outfall is evident at the left hand side of the photograph. The rather poor amenity of the site is also evident.*

The landscape in the immediate vicinity of the site is dominated by the coastline and meat processing plant. The former is general natural in character while the latter is very much physical. Consequently there exists a high degree of contrast between the two – see **Figure 2** photograph.

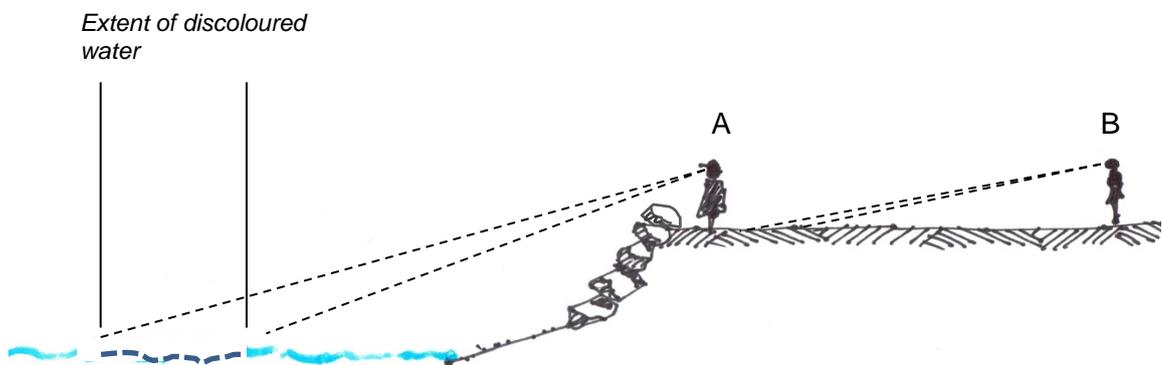
Figure 3 *Schematic cross section diagram showing the effects on views arising from intervening land form at Pareora. Viewer A is able to see the full extent of discolouration whereas viewer B cannot due to intervening landform. This will change as water levels fluctuate with the tides.*

- a) Elevation of the viewer in relation to the sea – in this case being either on the beach or above the rip rap embankment. The higher the elevation the more will be seen. At lower elevations the effects of foreshortening occur. This is where views across a surface appear compressed and therefore less extensive than what they would look like in a birds-eye view.
- b) The distance of the viewer from the affected area – where any vantage point more than around 60 metres of the outfall is unlikely to appreciate visual effects. This takes into account that views can only be had from the public road and beach.
- c) The presence of intervening landform. The effect of this as shown in the **Figure 3** diagram demonstrates in principle that views of the affected water will be curtailed by local landform conditions.
