TARA STREAM ECOLOGICAL REPORT

PREPARED FOR: CANTERBURY COAL (2013) LTD

DATE: SEPTEMBER 2016

REPORT NUMBER: 34-2016-B

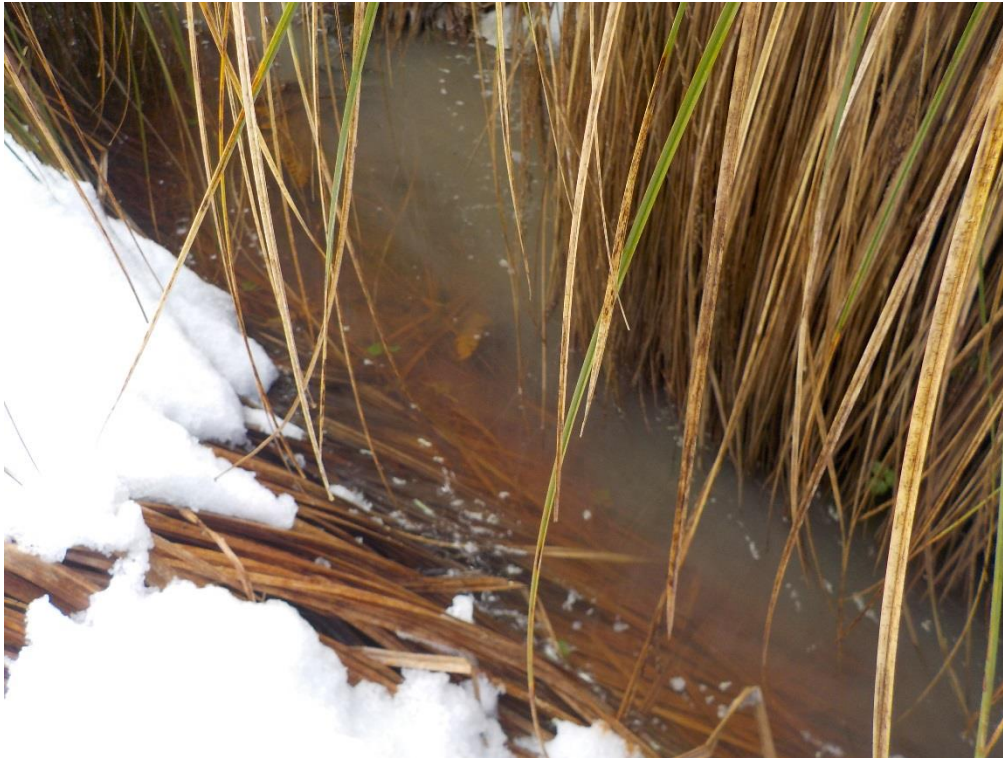
The water course at Site 1 was between 0.2 m and 1.0 m wide. The channel banks were low in areas where the channel was wide, and high (up to 0.5 m) where the channel was narrow. Water depth was restricted to 0.1 m or less. The narrow channel sections were generally fully covered by vegetation and could not be easily seen whereas some of the wider channels were visible. The active channel appeared to meander along the site and multiple channels were present in some areas. Stream flow was obvious throughout the site. The water was generally clear, although a true left bank tributary was turbid with suspended sediment in runoff from forestry roading (Figure 2). The stream bed appeared to be free of periphyton and the majority of the bed was covered with leaf debris from *Carex* plants and pine needles. Riparian vegetation was dominated by *Carex*, blackberry and gorse with occasional pine trees (Figure 3). The stream bed in all areas was composed of fine sediments often of a depth greater than 0.4 m.

Figure 2: Tara Stream at Site 1 with overhanging Carex and turbid inflow from a true left bank tributary.

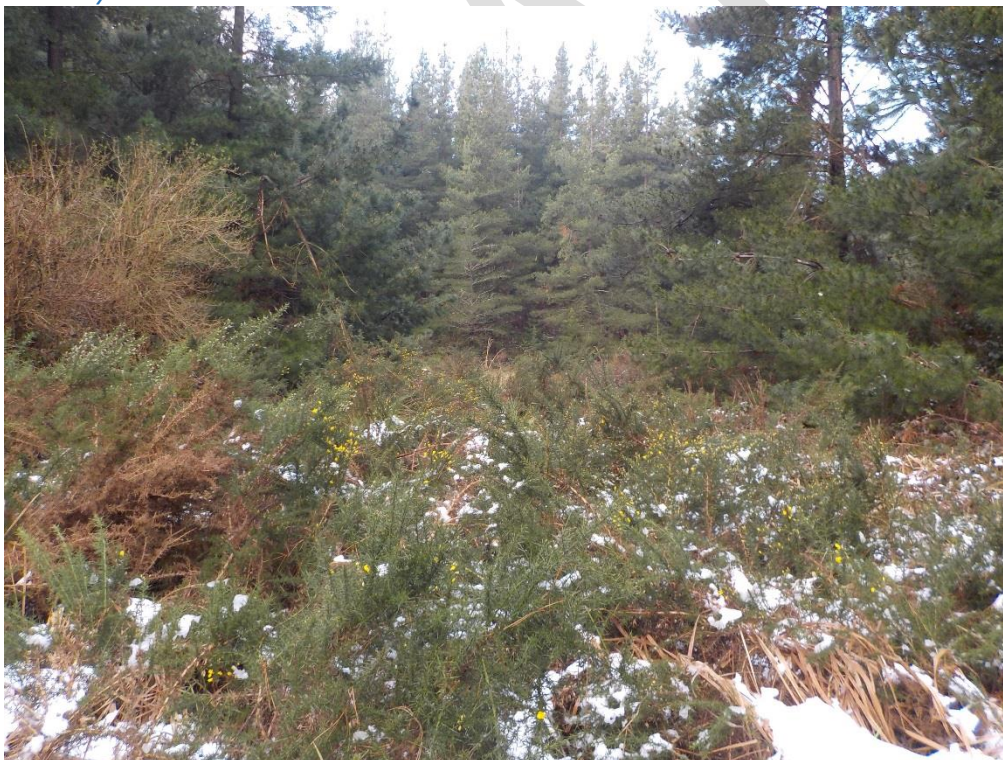
Figure 3: Tara Stream, downstream view at Site 1 showing riparian zone dominated by gorse and Carex.

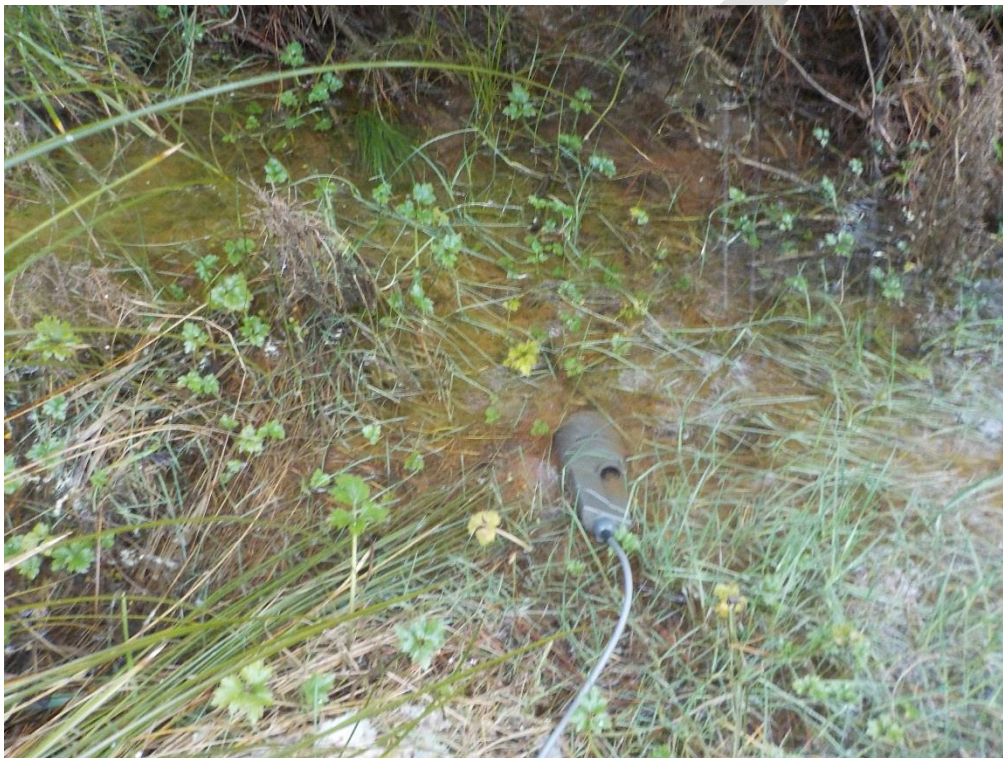
area with sediment creating a wide wetland area for approximately 20 m upstream of the culvert. Within this area there were a series of shallow channels that flowed among the large *Carex* tussocks. Channels were generally shallow (>0.1 m deep) and width varied between 0.2 m and 1.5 m (Figure 4). The widest channel occurred in the upper part of this site where the stream entered the wetland area. The water was clear, but did not appear to be flowing in all areas. When the submerged vegetation and water was disturbed it rapidly became turbid with the suspension of orange coloured fine sediment. This orange colour material did not appear to be an iron floc (Figure 5) and settled quickly after being suspended.

Figure 4: A wide stream channel at Site 2, Tara Stream

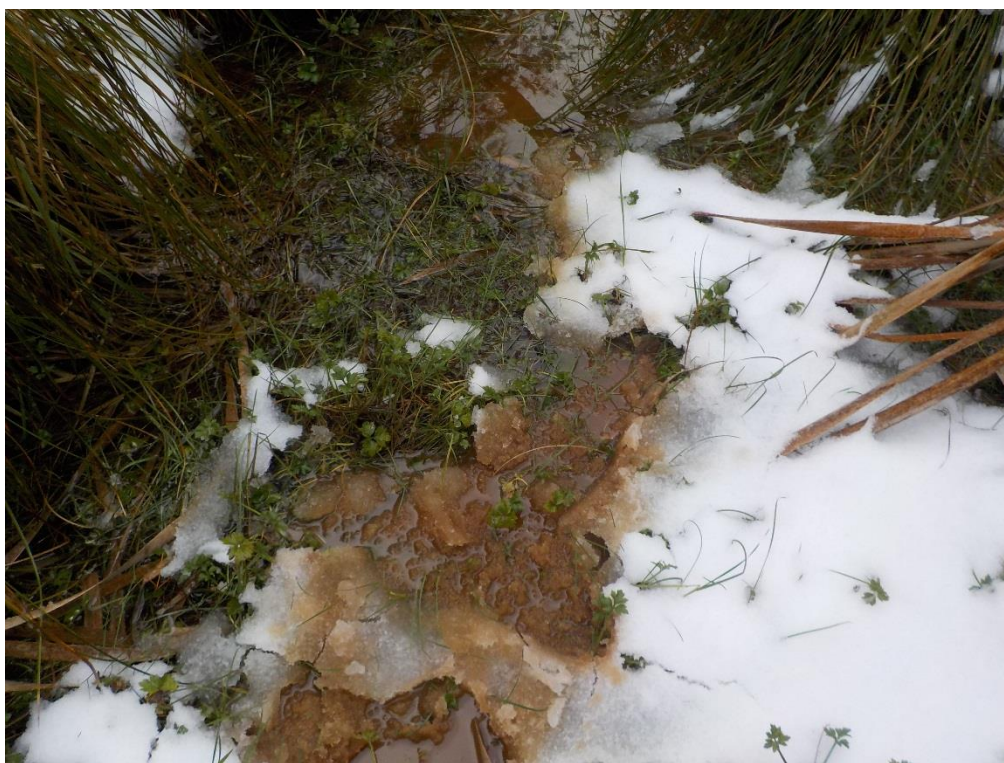
Figure 5: Orange stained water in a stream channel at Site 2, Tara Stream.
