Kaikōura Plains Recovery Project

Critical source areas and overland flow paths

Managing them on your property

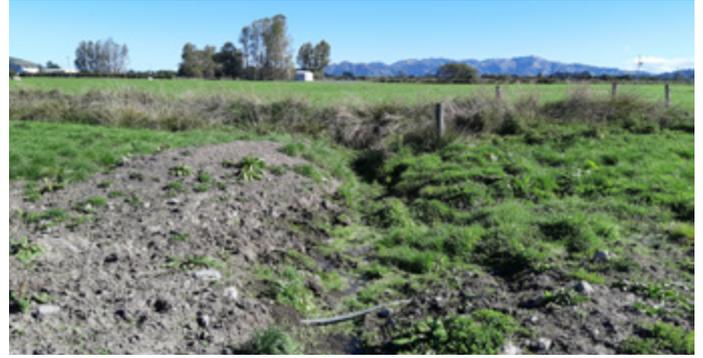
Overland flow path - a critical source area for sediment and nutrient runoff into adjacent waterways

OLFPs are a major form of CSAs, often forming in low-lying parts of farms such as gullies and naturally low/hollow places, where runoff accumulates. This runoff is then carried into nearby waterways or wetlands.

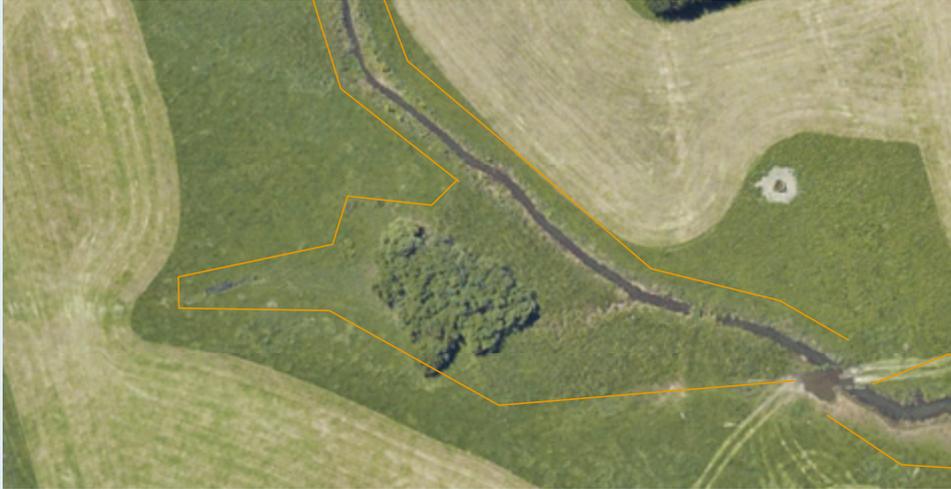
<p>Location and size</p>	<p>Montegues wetland, Rorrison's Road. Critical source area of 1,845m².</p>

<p>Farm type</p>	<p>Small sheep and beef farm, with a dairy grazing lease</p>
<p>Issue</p>	<p>Overland flow path identified, running alongside Warrens Creek, which then flows into Lyell Creek/Waikōau</p>
<p>Level of vegetation before intervention</p>	<ul style="list-style-type: none"> • Willows • cutty grass (native - <i>Carex geminata</i>) • large leafed pohuehue • garden species (a climbing rose, flowering bulb species) • creeping buttercup • various pasture species.
<p>Actions undertaken</p>	<ul style="list-style-type: none"> • Stock removed and area fenced off (stile built over fence for easy foot access) • willows poisoned October 2018 • water testing carried out summer 2019/2020 – inadequate testing available due to drought conditions.
<p>Outcomes</p>	<p>Cutty grass regeneration began immediately following fencing and was abundant within 12 months, increasing in cover in the spring and summer months, providing good filtration. Drought conditions resulted in unsatisfactory water results, so additional planting has not been carried out to date (October 2020).</p> <p>Keeping stock out has unfortunately been a challenge, however this has improved with additional and upgraded fencing.</p> <p>The climbing rose and flowering bulb garden species are to be removed.</p> <p>The site will also receive some 'in-filling' of suitable native species to provide biodiversity benefits and increasing aesthetic value for the landowner and neighbouring community.</p>

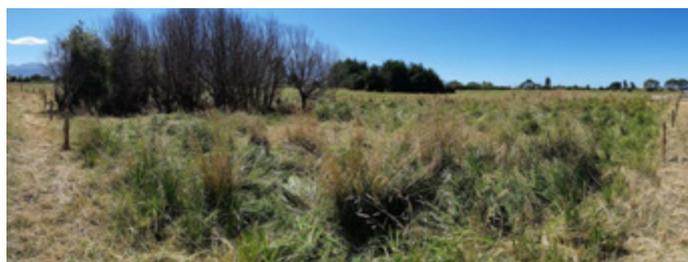
Montegues wetland before minimal intervention

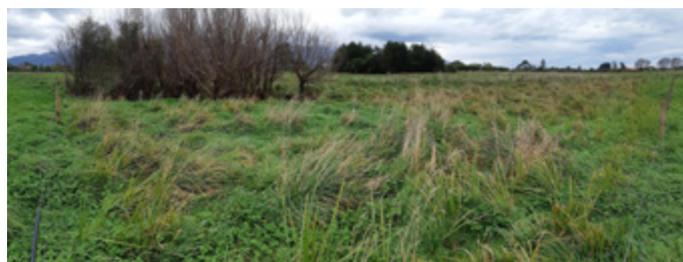
Montegues wetland after intervention with riparian buffer strip providing filtration

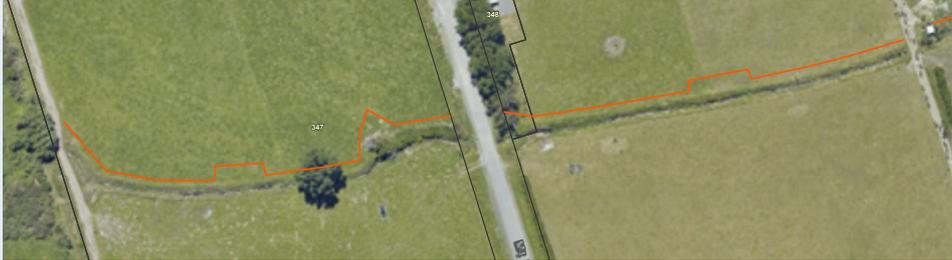
<p>Location and size</p>	<p>Maghera Farm and Lyell Creek/Waikōau OLFP remediation, Mt Fyffe Road. Critical source area of 3,800m². Area includes the riparian margin that was already fenced off and additional area that was identified for better riparian management.</p>

<p>Farm type</p>	<p>Dairy farm</p>
<p>Issue</p>	<p>The site is an OLFP remediation site which takes in 12 CSAs, so is one of the most concentrated areas located during the stream walk. It sits alongside 507 linear metres of spring-fed stream, flowing into Lyell Creek/Waikōau.</p>
<p>Level of vegetation before intervention</p>	<ul style="list-style-type: none"> • Poplar trees • cutty grass (native - <i>Carex geminata</i>) • creeping buttercup • various pasture species.
<p>Actions undertaken</p>	<ul style="list-style-type: none"> • Fenced 615 linear metres • planted 500 sedges, shrubs, and trees (all eco-sourced native species) • filter strip of low vegetation retained on the outside of taller plant species • volunteer planting day with Environment Canterbury and Fonterra • to date, around \$7,400 of funding has been received from Environment Canterbury for 'on-the-ground actions for freshwater', as recommended by Kaikōura Water Zone Committee. Funding used for fencing, plants and plant guards.

<p>Outcomes</p>	<p>A targeted approach to reducing CSAs was possible here thanks to the great tools available in the Lyell Creek/Waikōau catchment recovery recommendations report by NIWA, and additional stream walk data.</p> <p>The targeted and simple actions undertaken will improve freshwater quality in time, with only a small amount of pasture repurposed for filtration purposes.</p>

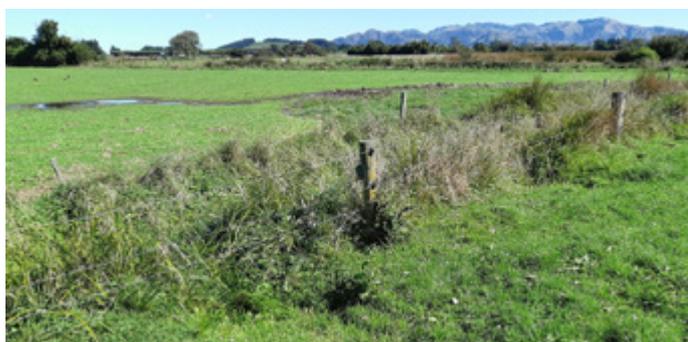
Maghera Farm before intervention

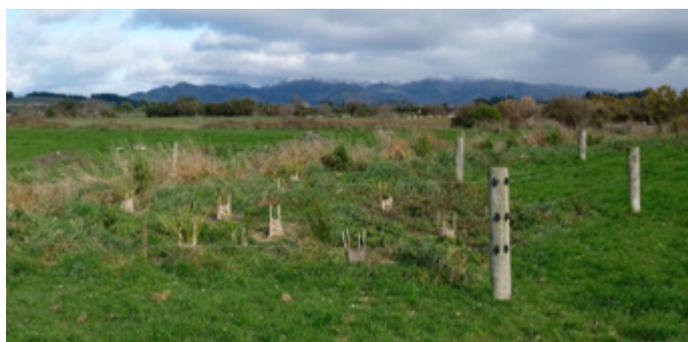
Maghera Farm after intervention
