Memorandum

Woodstock Quarry Landfill Stability Analysis

This memorandum presents the results of geotechnical stability analyses of the landfill materials that are proposed to be used for backfill of Woodstock Quarry.

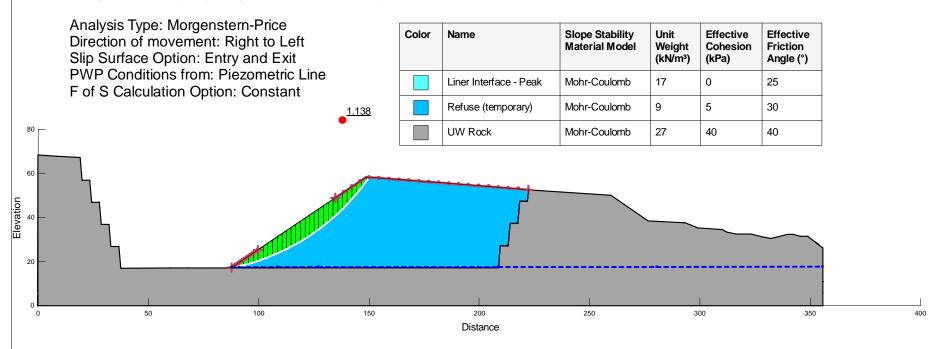
Woodstock Quarry Stability Assessment - Figure 46

Analysis: Static (Temporary Waste Pile 1:1.5 slope) with liner

Temporary fill slopes See Figures 46 to 54 in Attachment A	Static with GW at 0.3m above excavation surface	Elevated GW	SLS 150-yr PGA (0.22g)	SLS(a) 500-yr PGA (0.35g)	ULS 2500-yr PGA (0.63g)
Target Factor of Safety (FOS)	1.5	1.2	1.0	1.0	1.0
1:1 slope	0.92	Not Modelled			
1V:1.5H slope					
	1.15	Not Modelled	0.77	0.63	Not Modelled
1V:2H slope	1.43	Not Modelled	0.91	0.74	Not Modelled
1V:2.5H					
	1.74	Not Modelled	1.05	0.83	Not Modelled

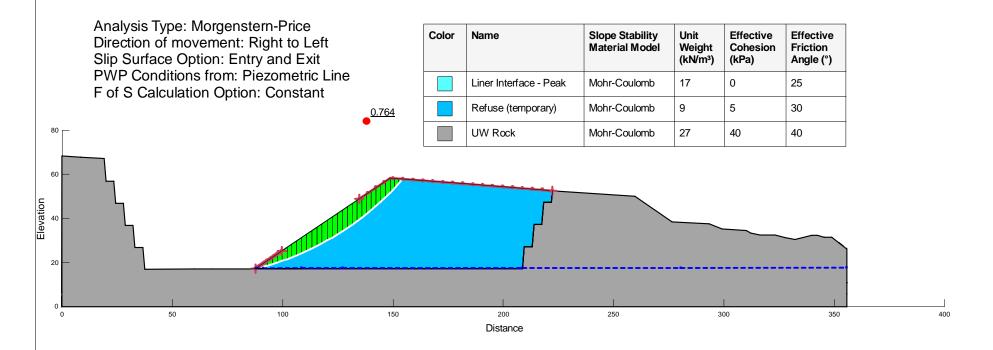
Analysis: Seismic PGA 0.22g (Temporary Waste Pile 1:1.5 slope) with liner

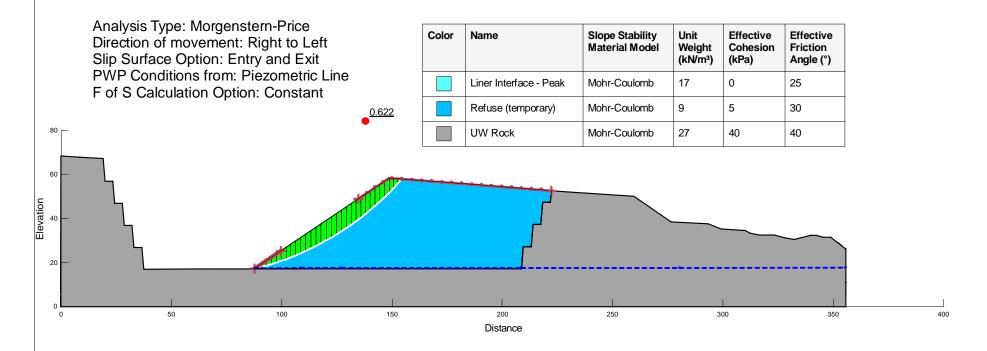
Analysis: Seismic PGA 0.35g (Temporary Waste Pile 1:1.5 slope) with liner

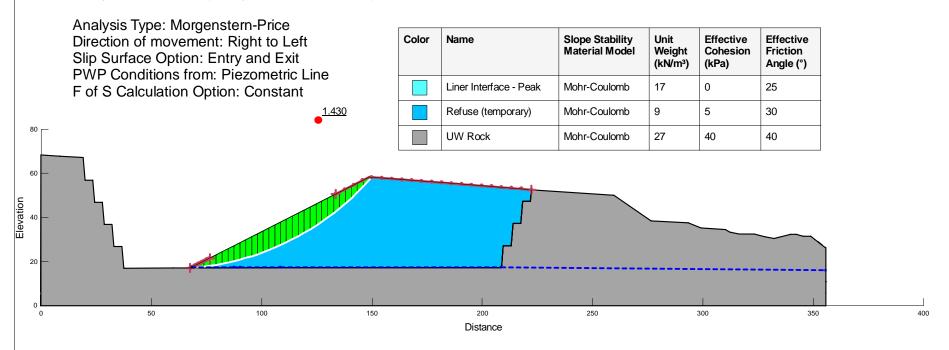
Woodstock Quarry Stability Assessment - Figure 49

Analysis: Static (Temporary Waste Pile 1:2 slope) with liner

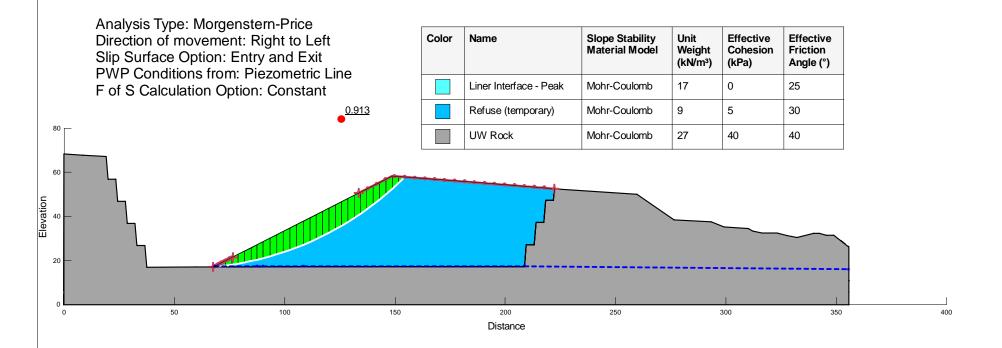
Analysis: Seismic PGA 0.22g (Temporary Waste Pile 1:2 slope) with liner

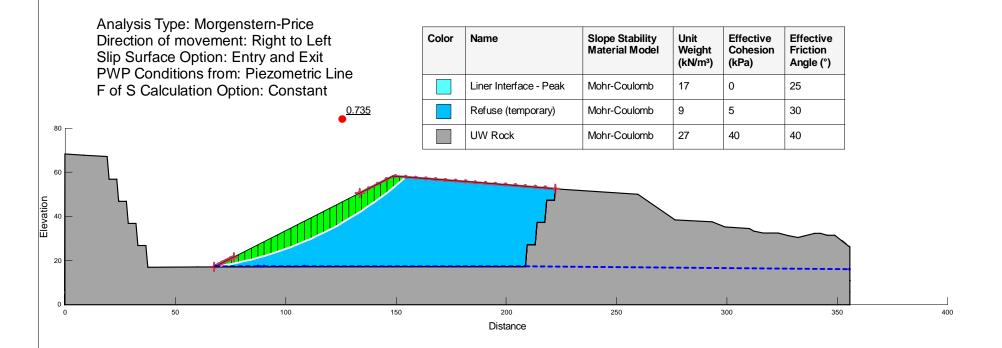
Analysis: Seismic PGA 0.35g (Temporary Waste Pile 1:2 slope) with liner

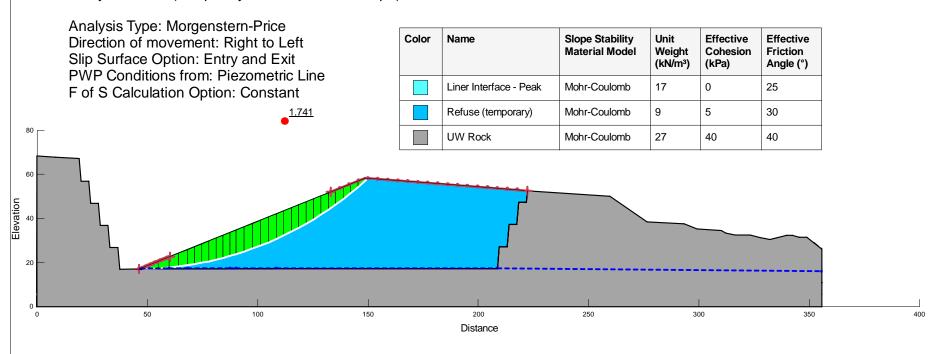
Woodstock Quarry Stability Assessment - Figure 52

Analysis: Static (Temporary Waste Pile 1:2.5 slope) with liner
