## **Woodstock Landfill**

# **Ecological Assessment Report**

# Ecological Assessment

**534 Trig Rd, Viewhill**

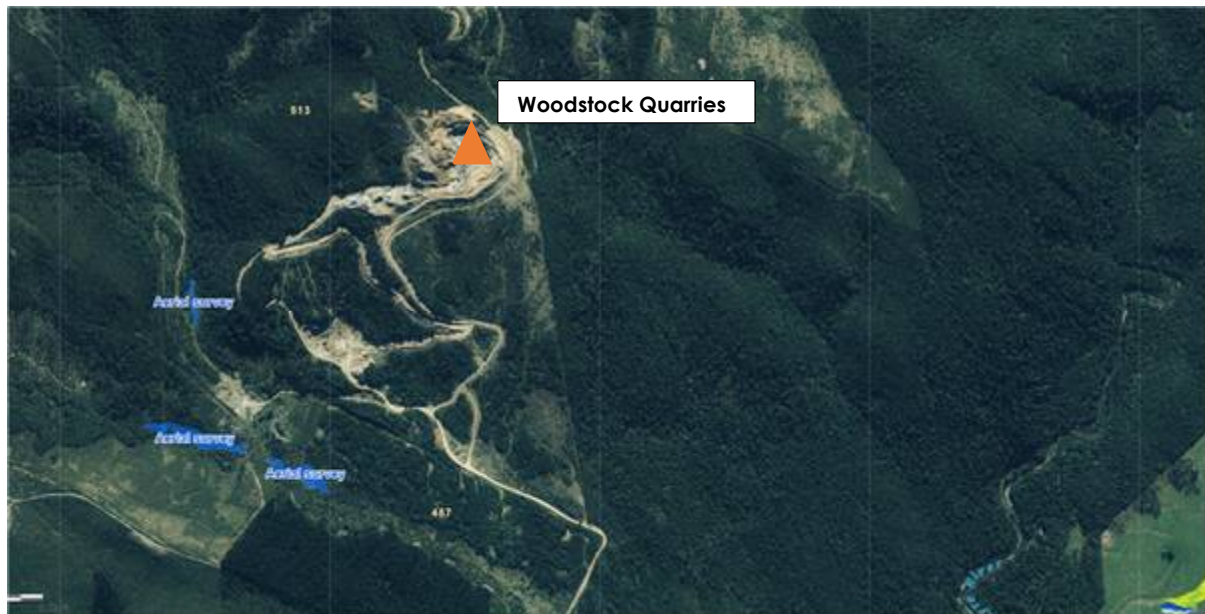
Figure 2: ECan mapped wetlands (ECan: Maps of Canterbury)

During the desktop review the Environment Canterbury (ECan) Wetland layer, indicated three wetlands present on-site (Figure 2). These wetlands were delineated from aerial imagery. During the site assessment, only one wetland could be confirmed on-site under the Landcare Research vegetation tool for wetlands (Figure 3).

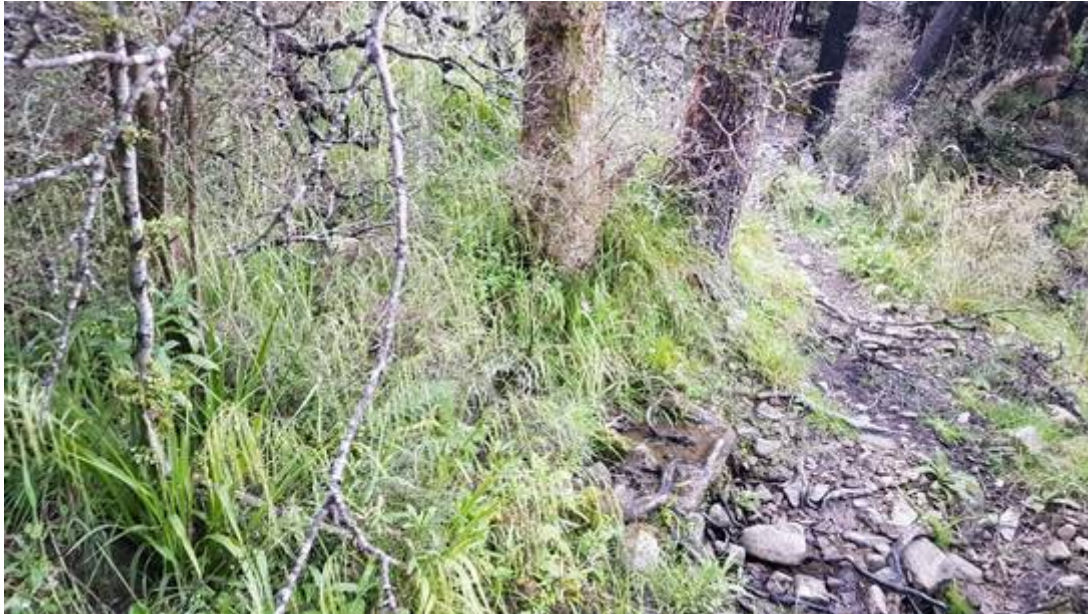
Figure 4: Floodplain between two creeks

During the time of the assessment, the most northern wetland as indicated by the Ecan layer comprised of a floodplain between two creeks (Figure 4). During high rainfall events, this area will get temporarily inundated. Due to the topography and stream gradient, this will occur for only a short period of time. During the time of assessment, flood debris and alluvial soil was present in this area and did not have typical wetland plant species.

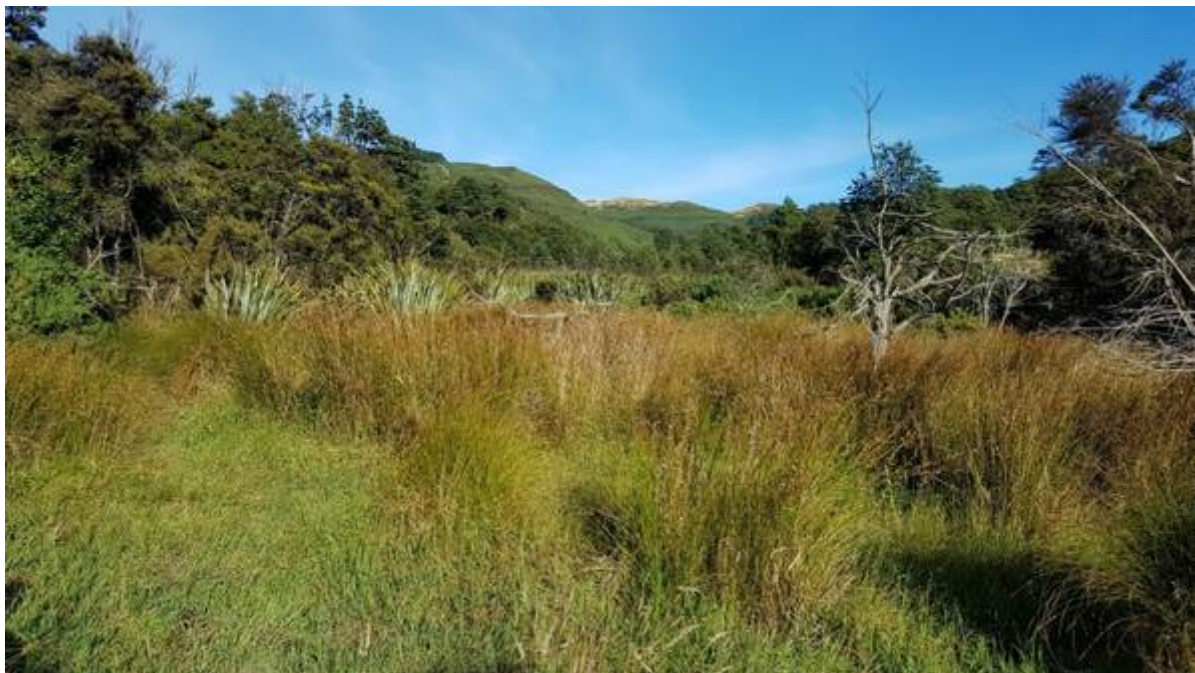
Figure 5: Delineated wetland

The wetland identified and delineated during the site assessment comprised of *Phormium tenax* (swamp flax), *Machaerina juncea* (bare twig-rush) and *Macherina rubiginosa* (soft twig rush) (Figure 5). Based on this ecological assessment, it seems that there is no hydrological linkage between the quarry and the wetland. The wetland is fed by surface water runoff from the surrounding areas. This can be confirmed by completing a hydrological assessment.

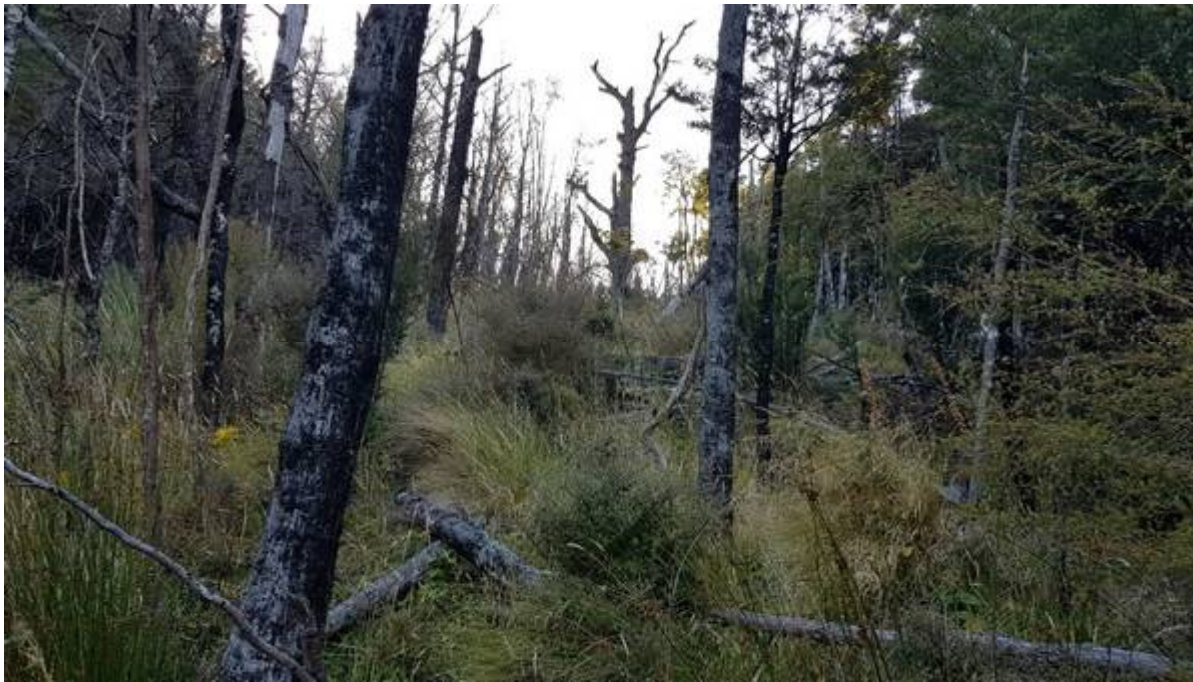
Figure 6: Dispersal zone.

The area where existing surface water dispersal has been directed to, had no signs of erosion. Water dispersed across an area of approximately 20m wide and 30m down slope (Figure 6). The area of dispersal comprised of pioneer wetland plant species and dead mature beach trees were evident as a result of wet feet. All evidence of saturated soil disappeared approximately 120m from the bank of the Woodstock Stream (Figure 7). During the time of the assessment there were no evidence indicating sedimentation from the surface water dispersal in the Woodstock Stream. The Woodstock Stream was a hard bottomed permanent stream. The stream had an average width of 2m and depth of 30cm. Instream habitat was diverse and comprised of riffle, run and pool sequence. The reach was well shaded with native vegetation and undercut banks and aquatic macrophytes provided cover.

- The following ecological actions are recommended to ensure that the potential ecological effects associated with the works can be adequately managed:
  - A site-specific Aquatic Monitoring Program for the Woodstock Stream should be compiled for the site which aims to manage potential impacts associated with surface water dispersion area. Macroinvertebrate Community Index (MCI) sampling should occur bi-annually. These samples should be collected both upstream and downstream of the dispersal area. This will allow the results to be compared and provide an indication of sedimentation. Water clarity measurements should also be undertaken at the same locations.
  - No lizard management is required within the proposed expansion area (Figure). The red shaded area indicates no likely lizard habitat and has been previously cleared.

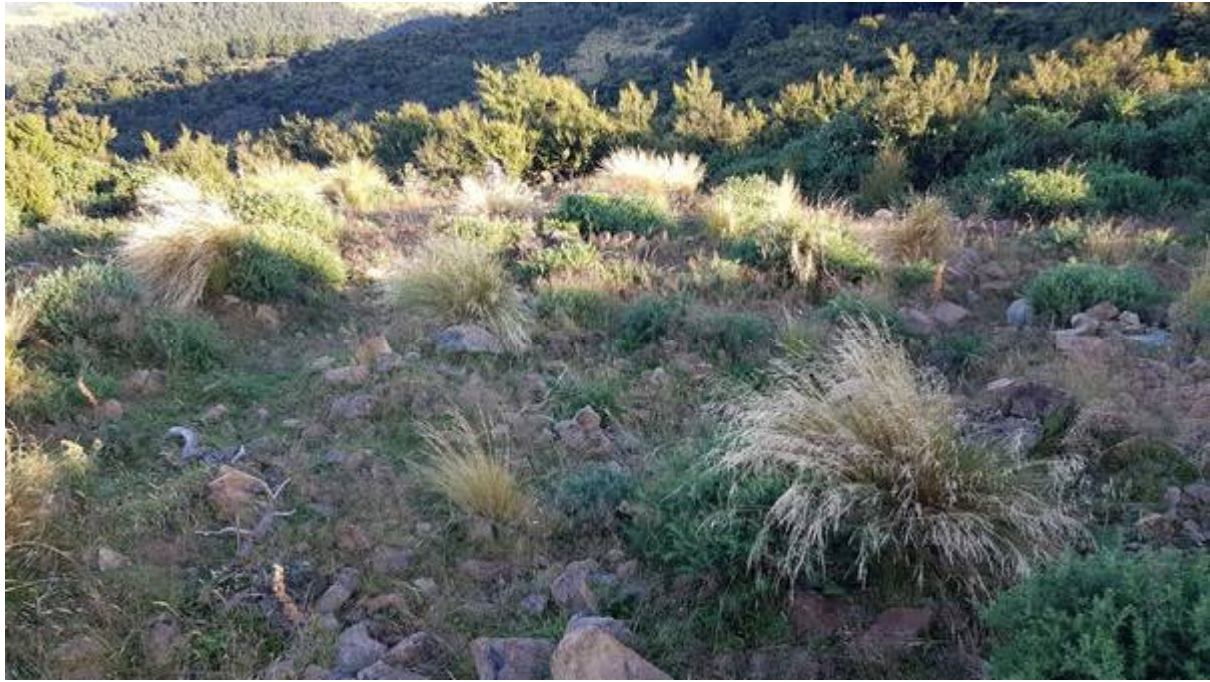
*Figure 9: Typical habitat of the expansion site*

Generally, the habitat within the expansion area is not suitable for the lizards that might be present on-site (Figure 9). During the site assessment, no lizards were found during manual habitat searches. No lizard management will be required within the proposed expansion area (Figure 10). The red shaded area indicates no lizard management. This is due to the historical clearing of the vegetation and not being suitable to sustain a lizard population. Recommendations in terms of lizard management will be discussed later in this report.

However, it is advised that a lizard monitoring program is implemented to determine the presence of lizards. This should be implemented using a variety of sampling techniques including Artificial Cover Objects (ACOs, manual habitat searches and nocturnal spotlighting.
