TRANSPOWER

22 February 2011 Christchurch earthquake Key findings and lessons learned

30 June 2011

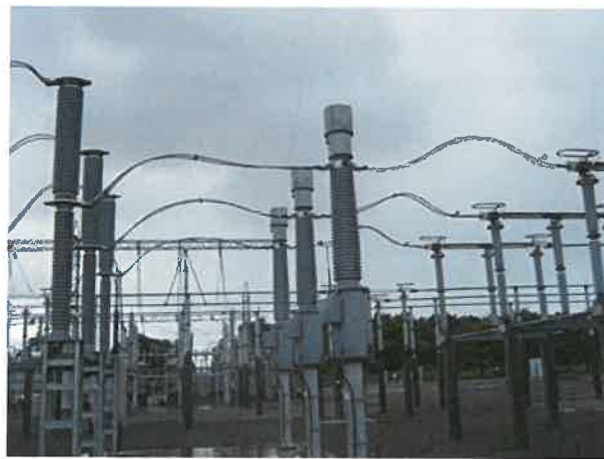
Figure 11 : Undamaged 220 kV breaker bay (photo: Transpower)

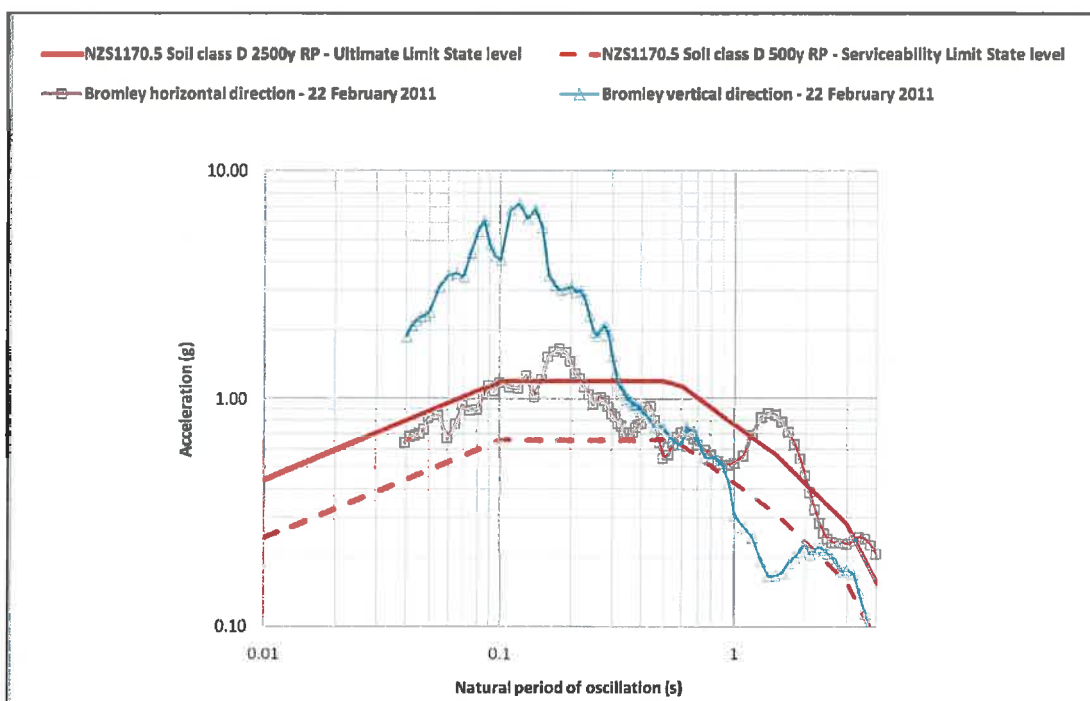
Transpower's Bromley substation, the nearest substation to the 22 February 2011 earthquake epicentre (5km), experienced very strong horizontal and vertical ground shaking. GNS recordings at Pages Road pumping station (1.5km from Bromley substation with same ground conditions) provide a good indication of the level of acceleration experienced at the substation. The earthquake *response spectra* correspond to Transpower's current *ultimate limit state* level (*return period 2500 year*) for the 0.0 to 0.3s period range, refer Figure 30 below.

Figure 30 : 22 February 2011 earthquake - Bromley substation. Response spectra at 5% of critical damping (from GNS) compared with NZS1170.5 ULS and SLS requirements for the site

At Bromley no significant damage to the buildings was sustained and, as described above, some switchyard equipment failed. Spares were available and the failed equipment was replaced promptly, which is tolerated by Transpower policy for *ULS* events. Equipment failures reduced the *security* contingency to n instead of $n-1$; again this is tolerated by the seismic policy. Hence buildings and equipment met the current performance criteria at *ultimate limit state level*.

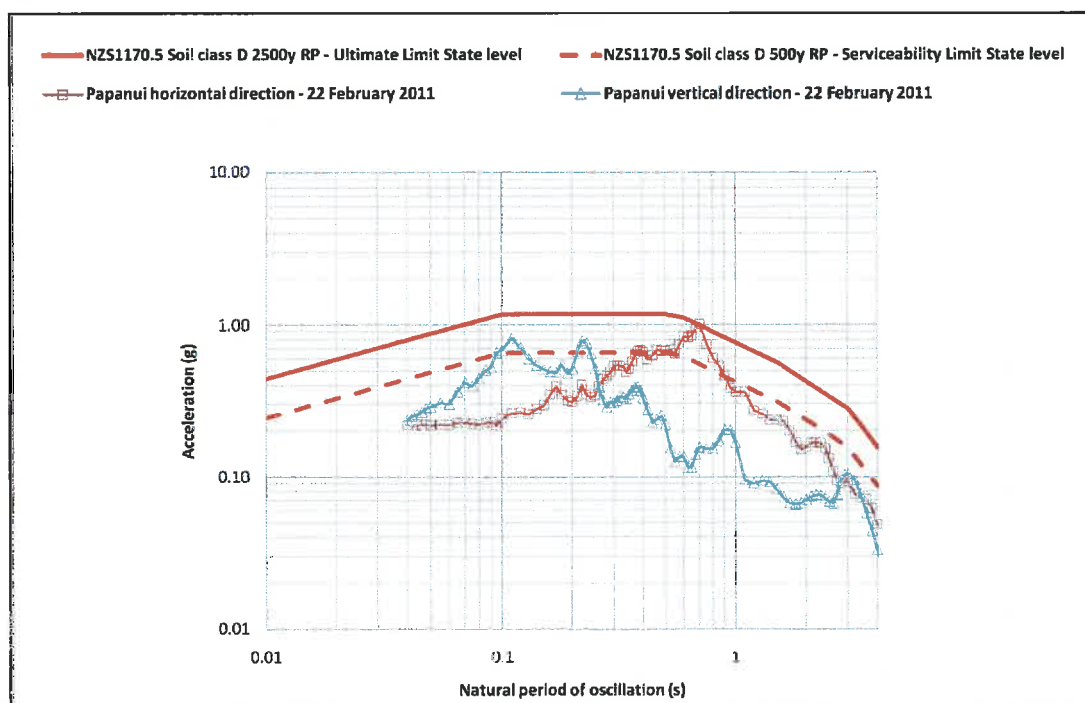
Figure 31 : 22 February 2011 earthquake - Papanui Substation. Response spectra at 5% of critical damping (from GNS) compared with NZS1170.5 ULS and SLS requirements for the site

During the 22 February 2011 earthquake, the substations north and west from the CBD (Papanui, Addington, Islington) generally experienced shaking corresponding to Transpower's current *serviceability limit state level* (*return period* 500 years) for the 0.0 to 0.3 second period range. Figure 31 above shows the *response spectra* at Papanui substation (4km north of the CBD). Although not necessarily designed for this level of earthquake loading, the substations structures and equipment performed well and met the current performance criteria at *serviceability limit state level* with the exception of the spurious transformer trip at Addington substation.
