# **CANTERBURY COAL MINE**

**TIPS, DAMS AND VOIDS**

**PRINCIPAL HAZARD MANAGEMENT  
PLAN**

CAN-TEC-PHMP-003

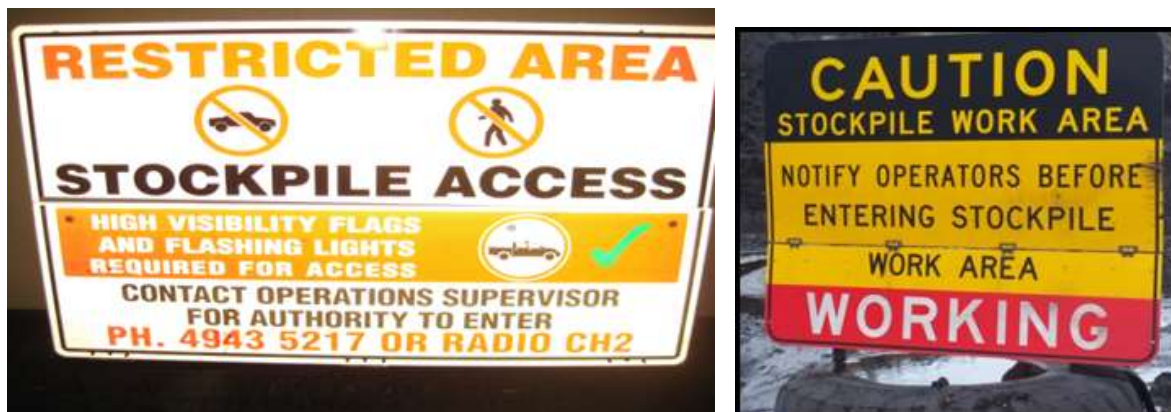
**Figure 1: Example of signage restricting unauthorised access to stockpile area**

Signage (**Figure 1**) and barricades (maybe in form of bollards or traffic cones) shall be in place on all approaches and access points to reduce the risk of harm to people.

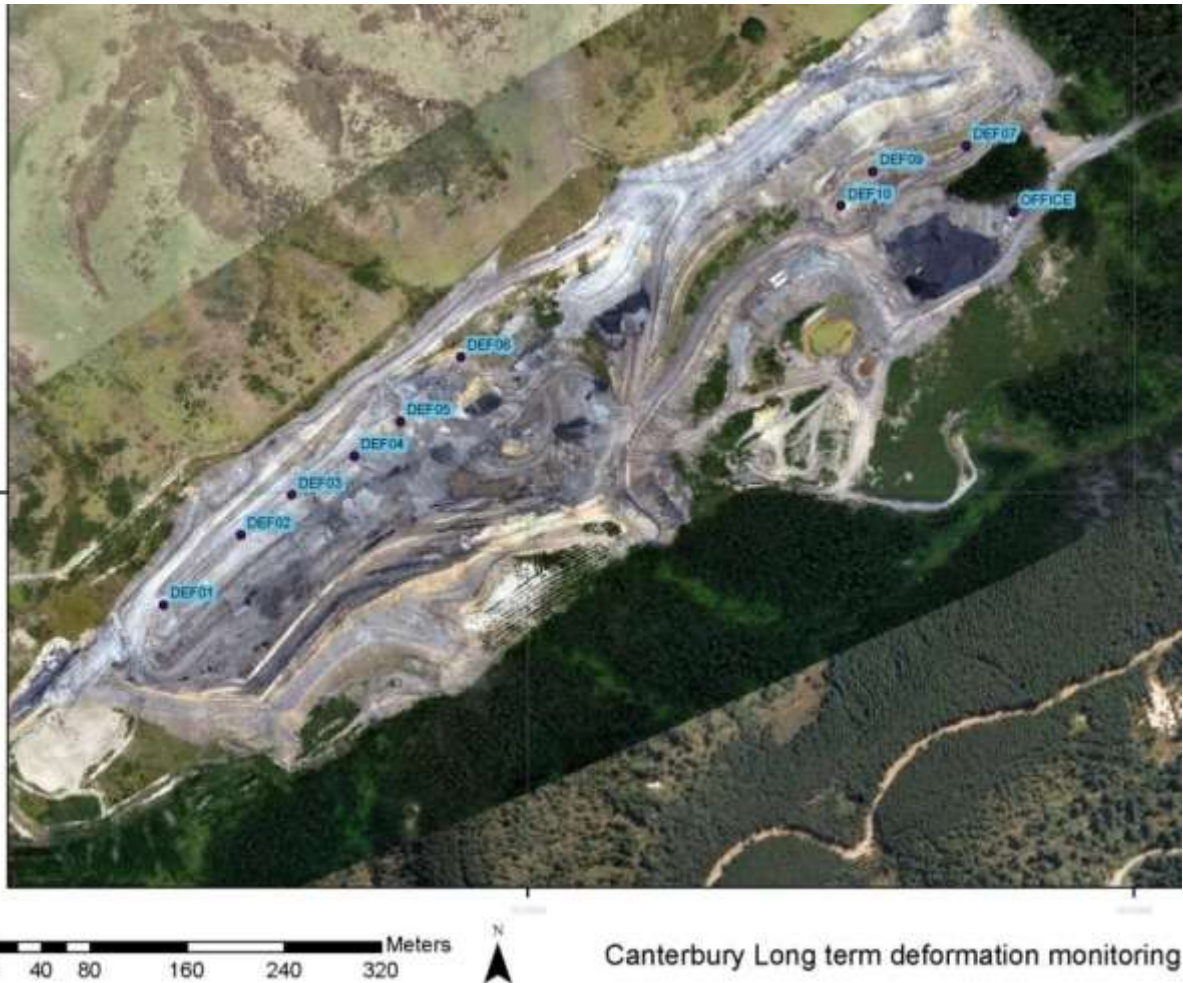
**Figure 2: Canterbury Coal mine long term deformation survey markers installed 1<sup>st</sup> July 2013 to record potential ground deformation within the footwall (DEF01-06), overburden tips/ELF area (DEF07-10) and site office**

A network of long term deformation survey marks were installed 1<sup>st</sup> July 2013 by BTW South Survey across the Canterbury Coal mine site (**Figure 2**). The aim of these surveys marks is to monitor long term stability of the high wall located in the Footwall geotechnical domain and the overburden Tip/ELF. These marks are located above the crest of the current Footwall (DEF01 - DEF07) and along the base of the present overburden Tip/ELF (DEF07, DEF09, DEF10). An additional deformation survey mark is also positioned at the site of the old mine office, 60 m southeast of the present overburden placement area. Survey data is acquired using a static GPS with readings likely to have an estimated error  $\pm 0.015$  m (Mike Borthwick, LandPro Ltd, pers. com.).
