Woodstock Quarries Ltd

Woodstock Quarry RFI - response to geological questions

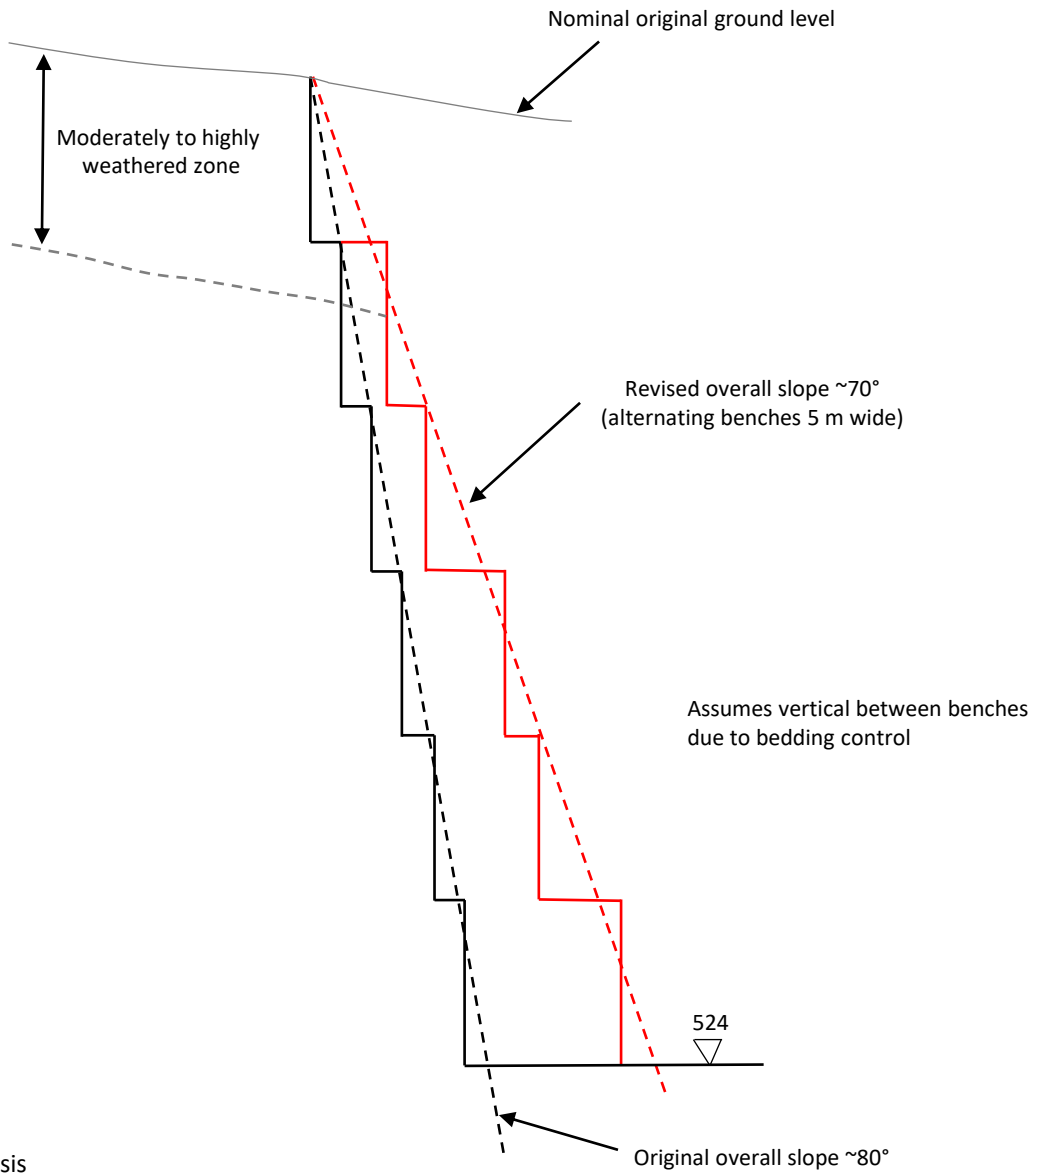
Woodstock Quarry – Revised Pit Slope Design

Design Basis

1. 10 m vertical between benches
2. Bench width 2 m and 5 m alternating
3. Overall slope ~70°

Q22 Several sections of the report suggest that the proposed bench width of 2 m in the cut highwalls may prove insufficient to control the release of rockfall from a safety perspective. Those sections of the report referring to the cut slope design and require clarification or amendment are provided below:
