Woodstock Quarries Ltd
Attention Darryn Shepherd
12 May 2022

Woodstock Quarry RFI - response to geological questions (Revised)¹

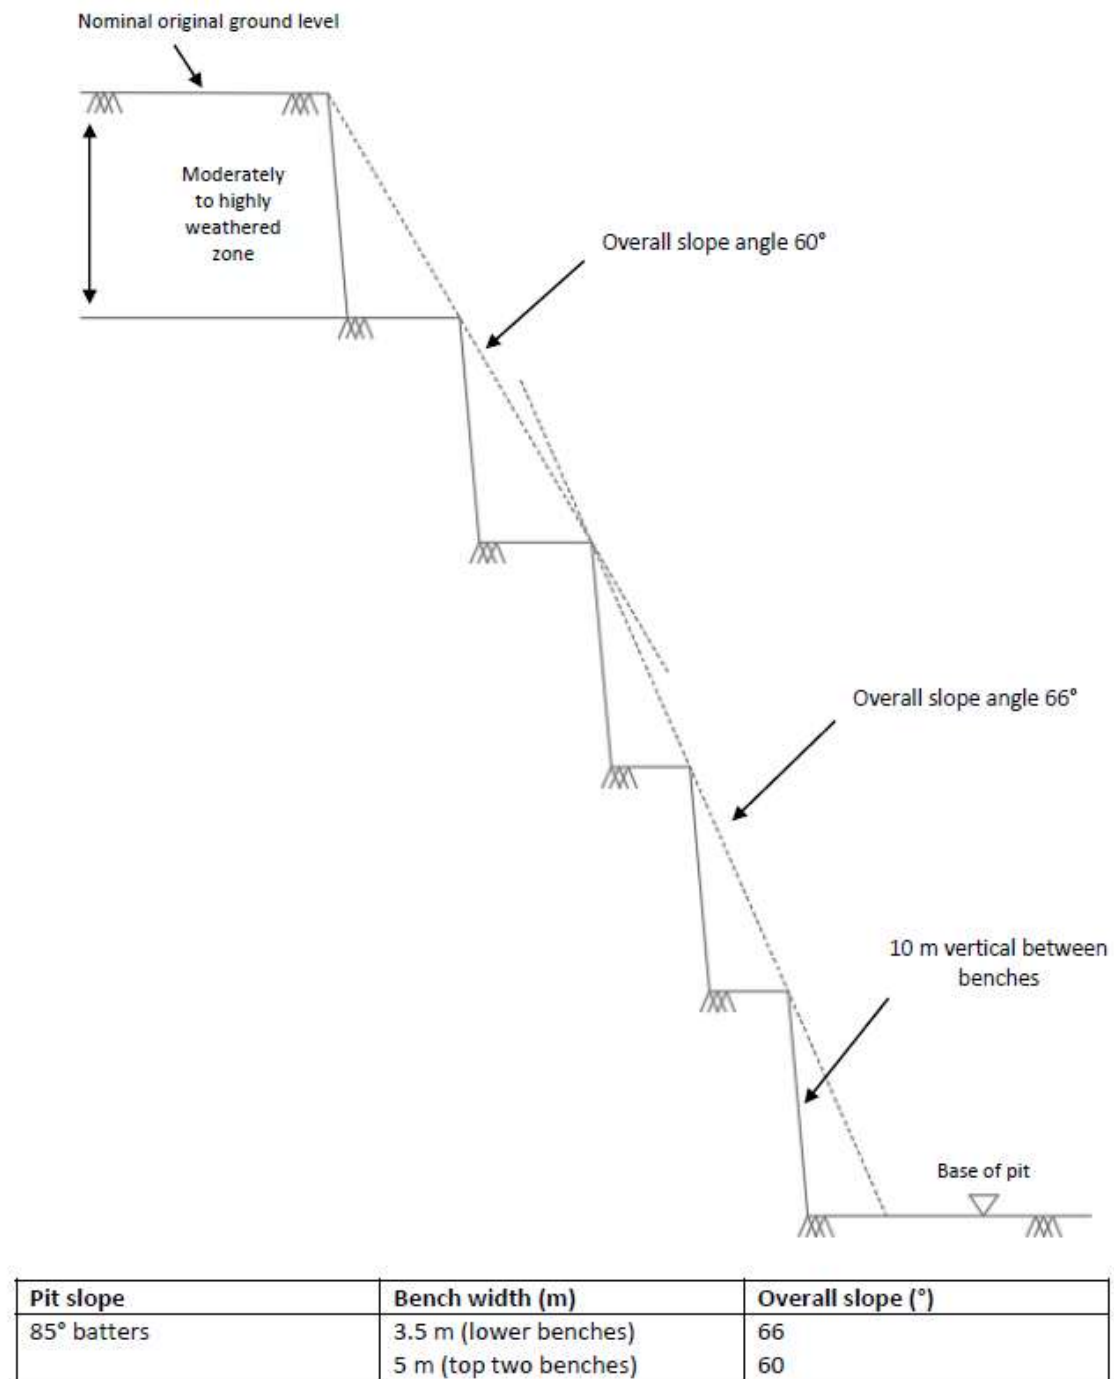
Figure 1: Woodstock Quarry pit slope design concept for south-facing rock slopes

Two revised slope designs are shown in Figures 1 and 2:

For the north wall (south, southeast and southwest facing slopes) the interbench batters are proposed to be cut at 85°, and for the east-facing slopes (west wall and temporary faces) 75° batters are proposed. For all slopes, the two top benches are planned to be 5m wide, and the lower benches 3.5m. These can be widened during excavation if the conditions encountered require a design change.

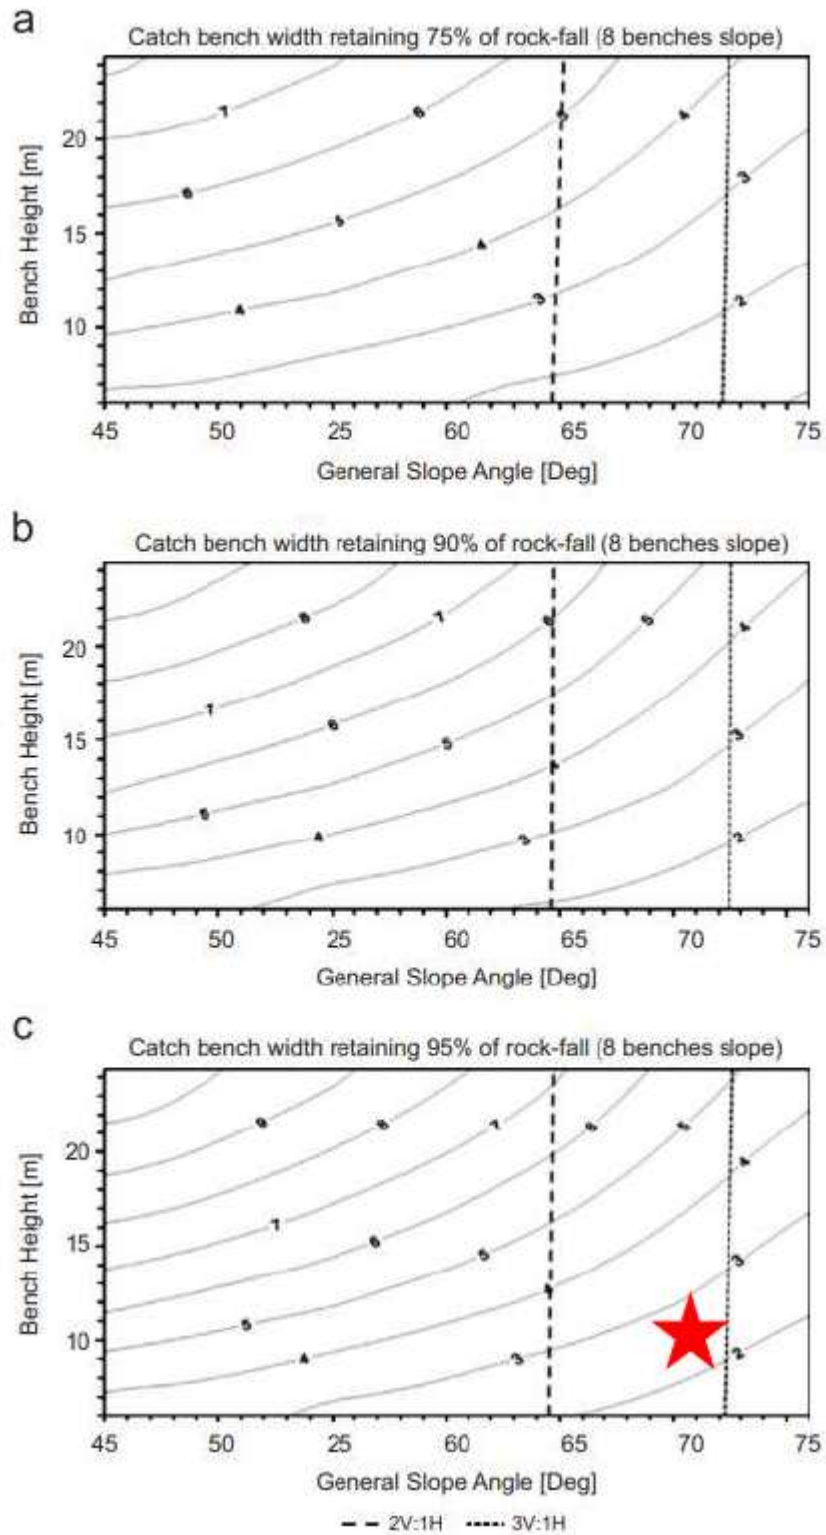
Figure 3: Catch bench design charts for 8-bench hard rock quarry to catch (a) 75%, (b) 90% or (c) 95% of rocks. [From Alejano et al (2007) Figure 16]

The proposed 3.5m bench width is based on design charts developed by Alejano et al (2007)³. We used the charts for an 8-bench slope as this is the maximum expected in the quarry. As shown by Figure 3, the bench width indicated as necessary to capture 95% of any ongoing rockfall is 2.5m.

For this reason, Alejano et al (2007) further recommend that the bench width should be increased to allow for breakback (partial loss) of the outer edges of the benches and other uncertainties; they suggest this 'backbreak correction' should be 0.5 m for pre-split benches, 1 m for carefully blasted good-quality rock masses, and 2 m for less carefully blasted average-quality rock masses. We have assumed an additional 1m for the Woodstock Quarry benches, making the minimum bench width 3.5m.

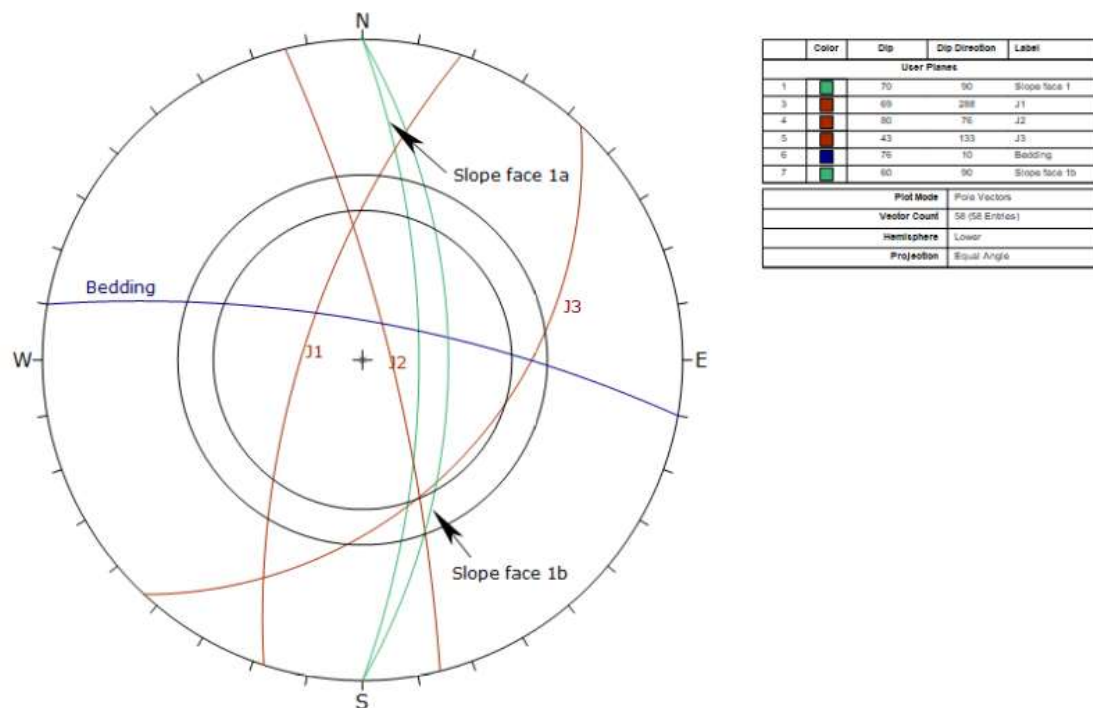
1. East-facing slopes:

Batters: Slope 1a = 70°, Slope 1b = 60°

These slopes are formed perpendicular to bedding. Kinematic assessment shows potential for J2/J3 controlled wedge instability in slopes steeper than 60° and for B/J3 wedges in slopes steeper than 30°.

Reducing the slope angle by widening the benches reduces the potential for wedge failures controlled by the J2 and J3 joints. Wedges between J3 joints and bedding remain a potential failure mode for small scale instability of batters.

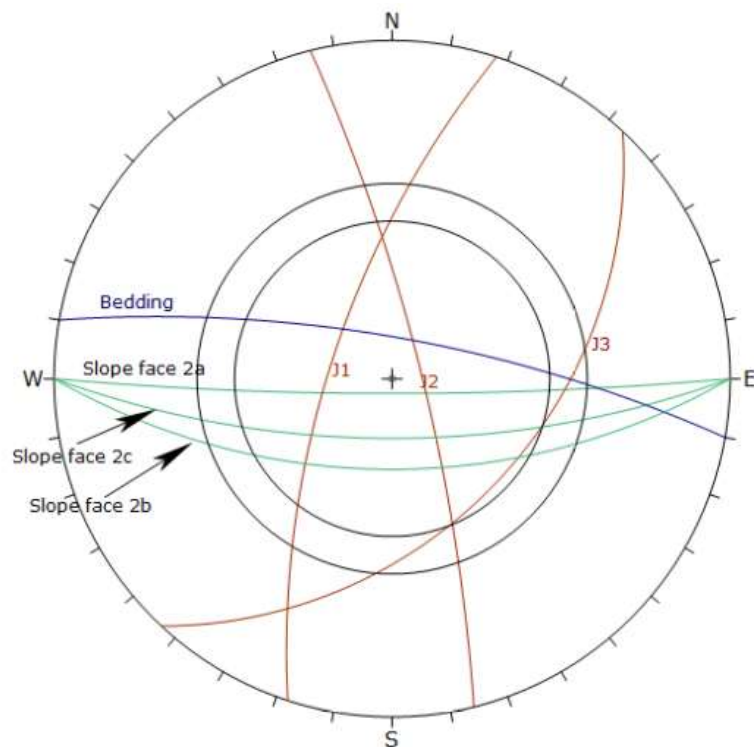
2. South-facing slopes:

Batters: Slope 2a = 85°; Slope 2b = 60°; Slope 2c = 70°

Color	Dip	Dip Direction	Label
User Planes				
2		85	180	Slope face 2a
3		69	286	J1
4		80	76	J2
5		43	133	J3
6		76	10	Bedding
7		60	180	Slope face 2b
8		70	180	Slope face 2c
Plot Mode				
Vector Count			58 (58 Entries)	
Hemisphere			Lower	
Projection			Equal Area

The slopes are formed subparallel to bedding and are expected to be controlled by the bedding planes or bedding plane shears. Toppling from bedding is the dominant potential failure mode. A wedge between joint sets J2 and J3 is feasible. Reducing the slope angle makes no significant difference.

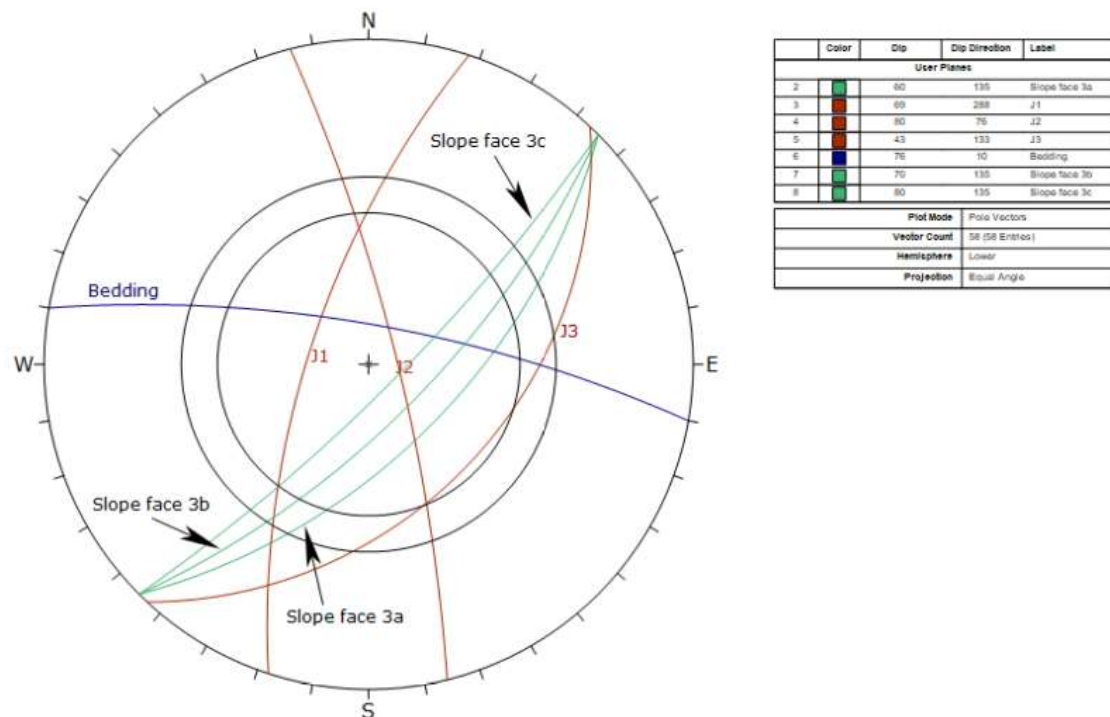
3. SE-facing slopes:

Batters: Slope 3a = 60°; Slope 3b = 70°; Slope 3c = 80°

All three slopes show potential for localised wedge failures controlled by joint sets J2 and J3 and potential for planar failures controlled by joint set J3. Wedge topple away from bedding and J1 joints is feasible. Reducing the batter slopes has no significant benefit

Proposed overall slope ~65° (85° batters, 3.5m wide benches)

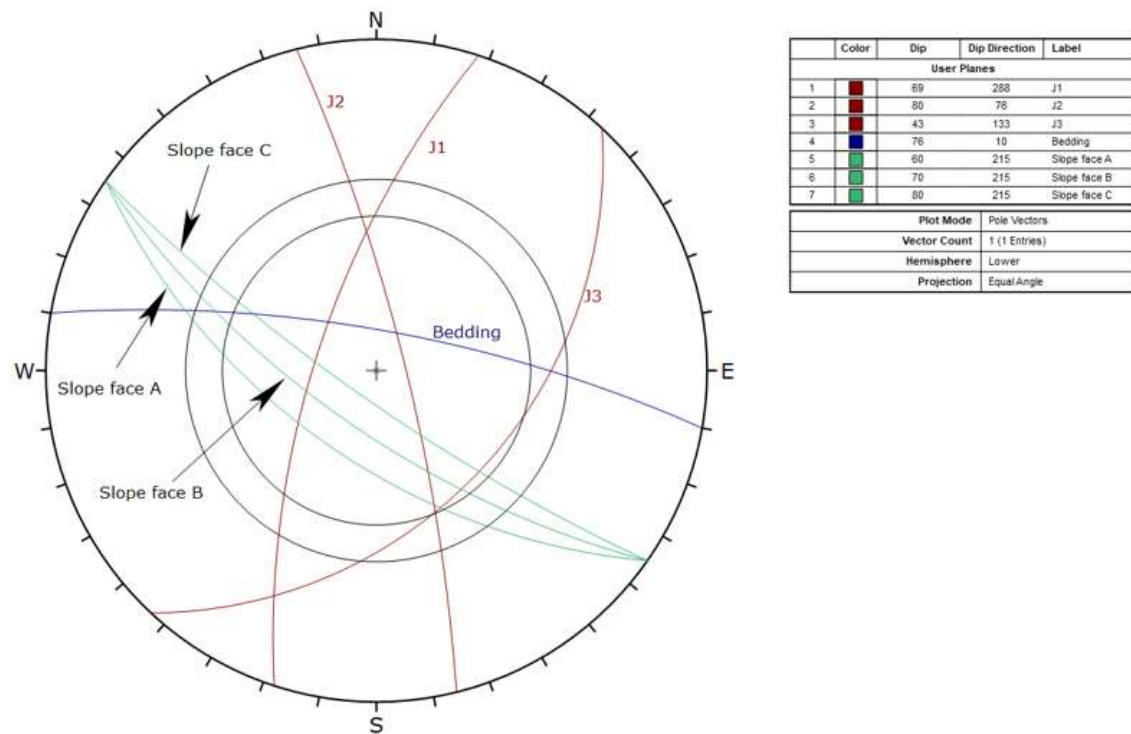
4. SW-facing slopes

Batters: Slope 4a = 60°; Slope 4b = 70°; Slope 4c = 80°

These slopes were not previously assessed. All three slopes show potential for wedge topple failures controlled by (away from) bedding and joint set J2. Bedding strike is more than 20° different from the strike of the face indicating low potential for direct bedding-controlled topple.

Possibly marginal potential for oblique wedge topples controlled by bedding and joint set J1.
