## Subject: WESTERN AUSTRALIAN WATER CORPORATION EMBANKMENT STABILISATION PROJECT OVERVIEW

### WA WATER CORPORATION

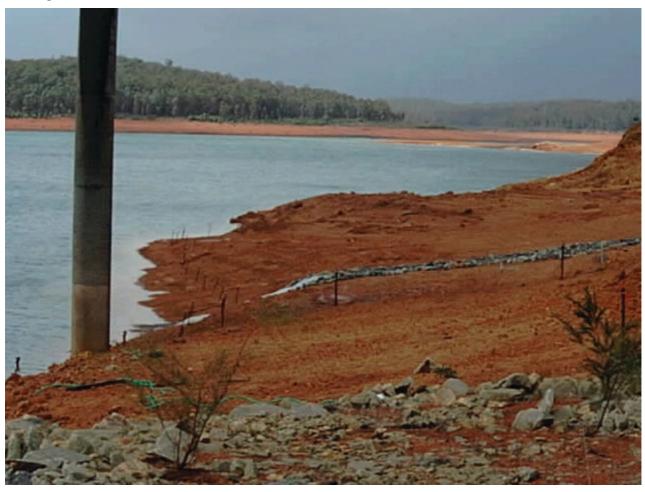
#### Picture 1

Due to the lack of rain in SW Western Australia the dams are at a record low (see picture 1). The large areas of exposed bank are being environmentally eroded through wind, water and wave action.

This erosion is creates a major turbidity problem.

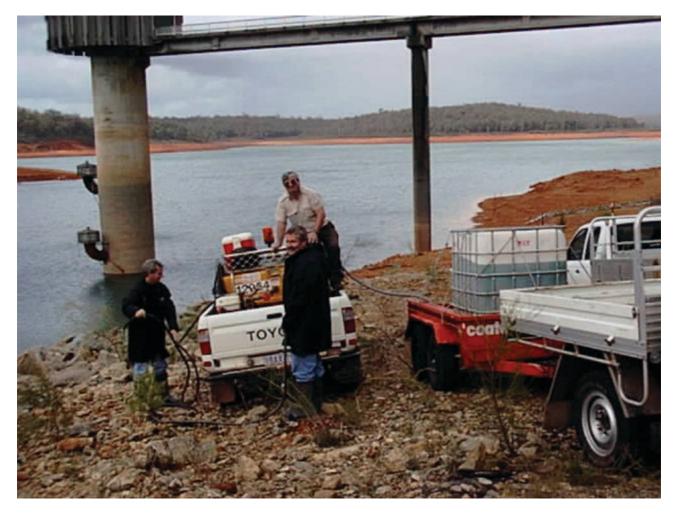
Picture 2.

As a trial we sent 1000 litres of RT9 Solution to Nth Dandalup dam and sprayed a 2400 m2 section of embankment. (see picture 2 & 3)

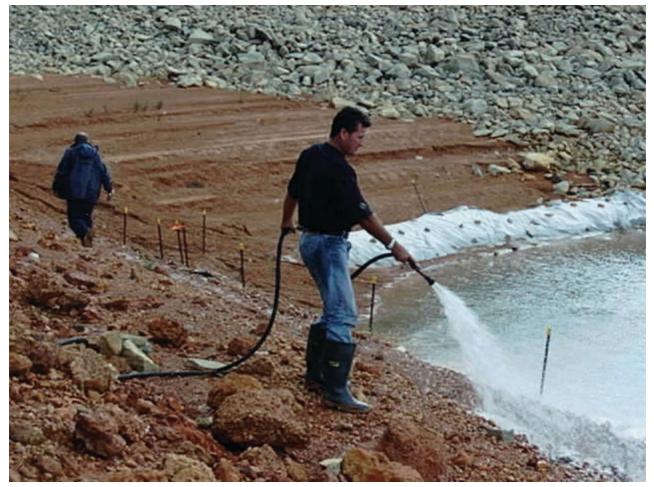
Picture 3

Half way through the spray it absolutely poured with rain, where we had applied the product there was an instant result being that no fines were being washed down the bank, all small puddles were crystal clear and all water running into the dam was also crystal clear. This was compared to adjoining untreated areas where the fines were running down the hill into the water and all small puddles were very muddy.
