The Proposed Canterbury Air Regional  
Plan.

**STATEMENT OF MICHAEL BENJAMIN CARVALHO VINCENT FOR AND ON BEHALF OF  
HERITAGE NEW ZEALAND POUHERE TAONGA.**

# Repairing and Rebuilding Historic Chimneys after an Earthquake

## Fire Safety and Heritage Places

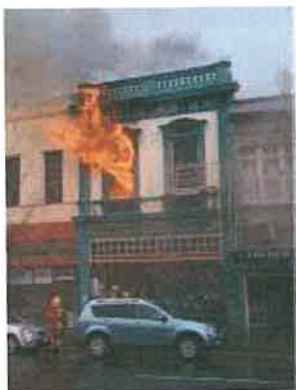
**Fire at No. 389 Princes Street, Dunedin.**

Fire damaged the listed heritage building at No 389 Princes Street on 17 August 2011.

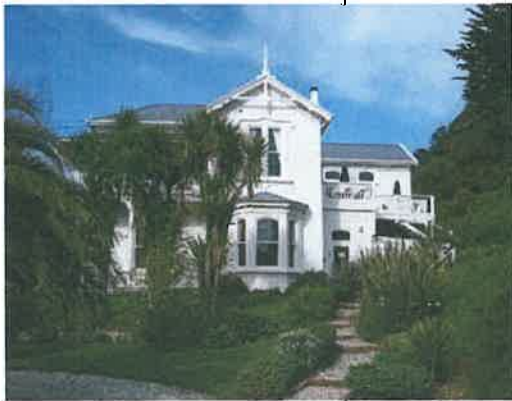
**Sennan House**  
Photo, Simon Ward

**Sennan House** in Picton is a two-storey Italianate styled villa built in the late 1880s. It is a registered Category II historic place under the *Historic Places Act* 1993 and is constructed of native timbers with extensive balconies and veranda. The interior has elaborate panelling with a large staircase and ornate pressed tin metal ceilings at ground floor level. Sennan House has had a number of changes with alterations for both private housing and accommodation since the 1950s. In 2002 the upper storey was converted into three separate accommodation apartments with the ground floor retained as a private living area.<sup>22</sup>

During the consent process for the new accommodation spaces in 2002, the territorial authority considered that the upper level floor and associated fabric would require fire rating. At the time, the owners were concerned about the potential impact of this requirement on the pressed tin metal ceilings. Following discussions with the NZHPT and the territorial authority, design proposals involving the installation of a hardwired type 2 fire alarm system, means of escapes, and upgrading the fire resistance of timber-panelled doors were accepted. This package of fire safety work meant that Sennan House complied with the Building Act as “nearly as is reasonably practicable.”

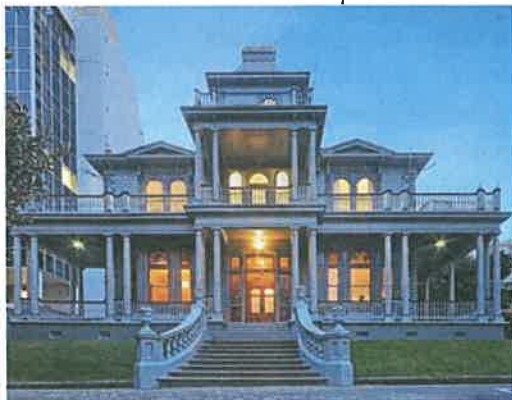
**Antrim House**  
Photo, Grant Sheehan

**Antrim House** was built in 1904 as the home of the Hannah family. After the death of Hannah and Robert Hannah, it was converted into a hotel. On 18 July 1940, the building was damaged by fire as a result of a guest who stored hot ashes from a fireplace in an upstairs cupboard. The building was repaired following the fire and was purchased by the Government in 1949 for use as a hostel for young men in the public service. After the closure of the hostel in 1977, Antrim House was given to the NZHPT for its national headquarters and the building was renovated in 1981.<sup>23</sup>

While alterations to Antrim House have been rare since 1981, in 2007 the NZHPT applied for building consent to remove the external fire escape and stairs. These were considered a falling risk due to inadequate barriers and as providing a potential route for intruders and possible arson attempts. A fire report was

prepared by an architect and this was reviewed by a specialist fire engineer. The fire report and associated review found a number of aspects of Antrim House that did not meet the requirements of Acceptable Solution C/AS1 and therefore the Building Code. These aspects included that the building does not have separated fire cells for each floor with a protected stairway and access to the exterior, and both exit doors open by swinging to the inside.

Both the architectural and fire engineering reports agreed that the installation of a fire cell and changes to the doors would adversely impact upon the heritage values of Antrim House. Further, the reports found that the aspects of non-compliance relating to the fire cells and exterior doors were compensated by the sprinklers, smoke detectors and manual alarm systems which were all in excess of the requirements of Acceptable Solution C/AS1. Therefore, it was found that the primary requirement of the Building Code of life protection was satisfied and that Antrim House, as a heritage building, was protected to a reasonably practicable level.

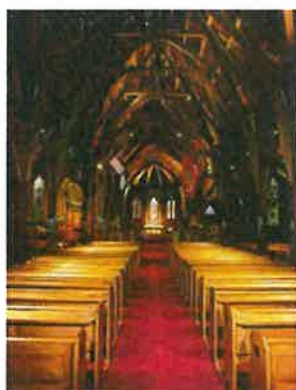
Interior of Old Saint Paul's Cathedral, Wellington

Old St Paul's Church (registered Category I historic place), Wellington, is fitted with a fire sprinkler system which has been installed in an unobtrusive way and in sympathy with the historic values of the building. The sprinkler installation is not obvious when the public view the ceiling from ground level

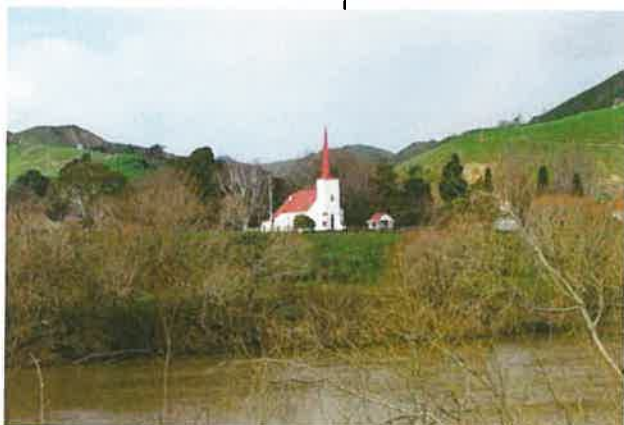
St Mary's Church  
Registered Category I historic  
place, Upokongaro, Whanganui  
River

St Mary's Church at Upokongaro faces fire safety issues that confront many heritage buildings (including wharehenui) in the rural environment.<sup>63</sup> St Mary's is registered as a category I historic place and a conservation report for the building has been prepared to assist in the long-term management and preservation of the church.<sup>64</sup> The conservation report included provision for fire safety measures including fire suppression and warning systems.
