Amendments	Aerial Photo	S.N.185 A/3	2/99	Approved	Environment Canterbury Rating District Works Programme 2001/2002 Rangitata River	Catch No. 6930000 File No. Surv Data
	Base Sheet	S.N.185 A/3	2/99			
PLAN ORIGIN E N E N	Surveyed	N.F. Daniels	6/00		Original Scale 1:8000	Level Datum
	Designed					
	Compiled					
	Checked					
	Recommended					<b>13,033m02</b> 2 of 13

# ENGINEERING JOB SETUP SHEET

RESPONSIBILITY	EDDY	JOB NUMBER	005	EKAN
JOB NAME	SOUTH	CAPITAL WORK	Y (N)	LOCATION CODE
JOB DESCRIPTION:		BRANCH - SH1		
REPAIR MAIN SOUTH BRANCH RETURN BANK. TO 1.5m BELOW EXISTING BANK. 400m CHANNEL

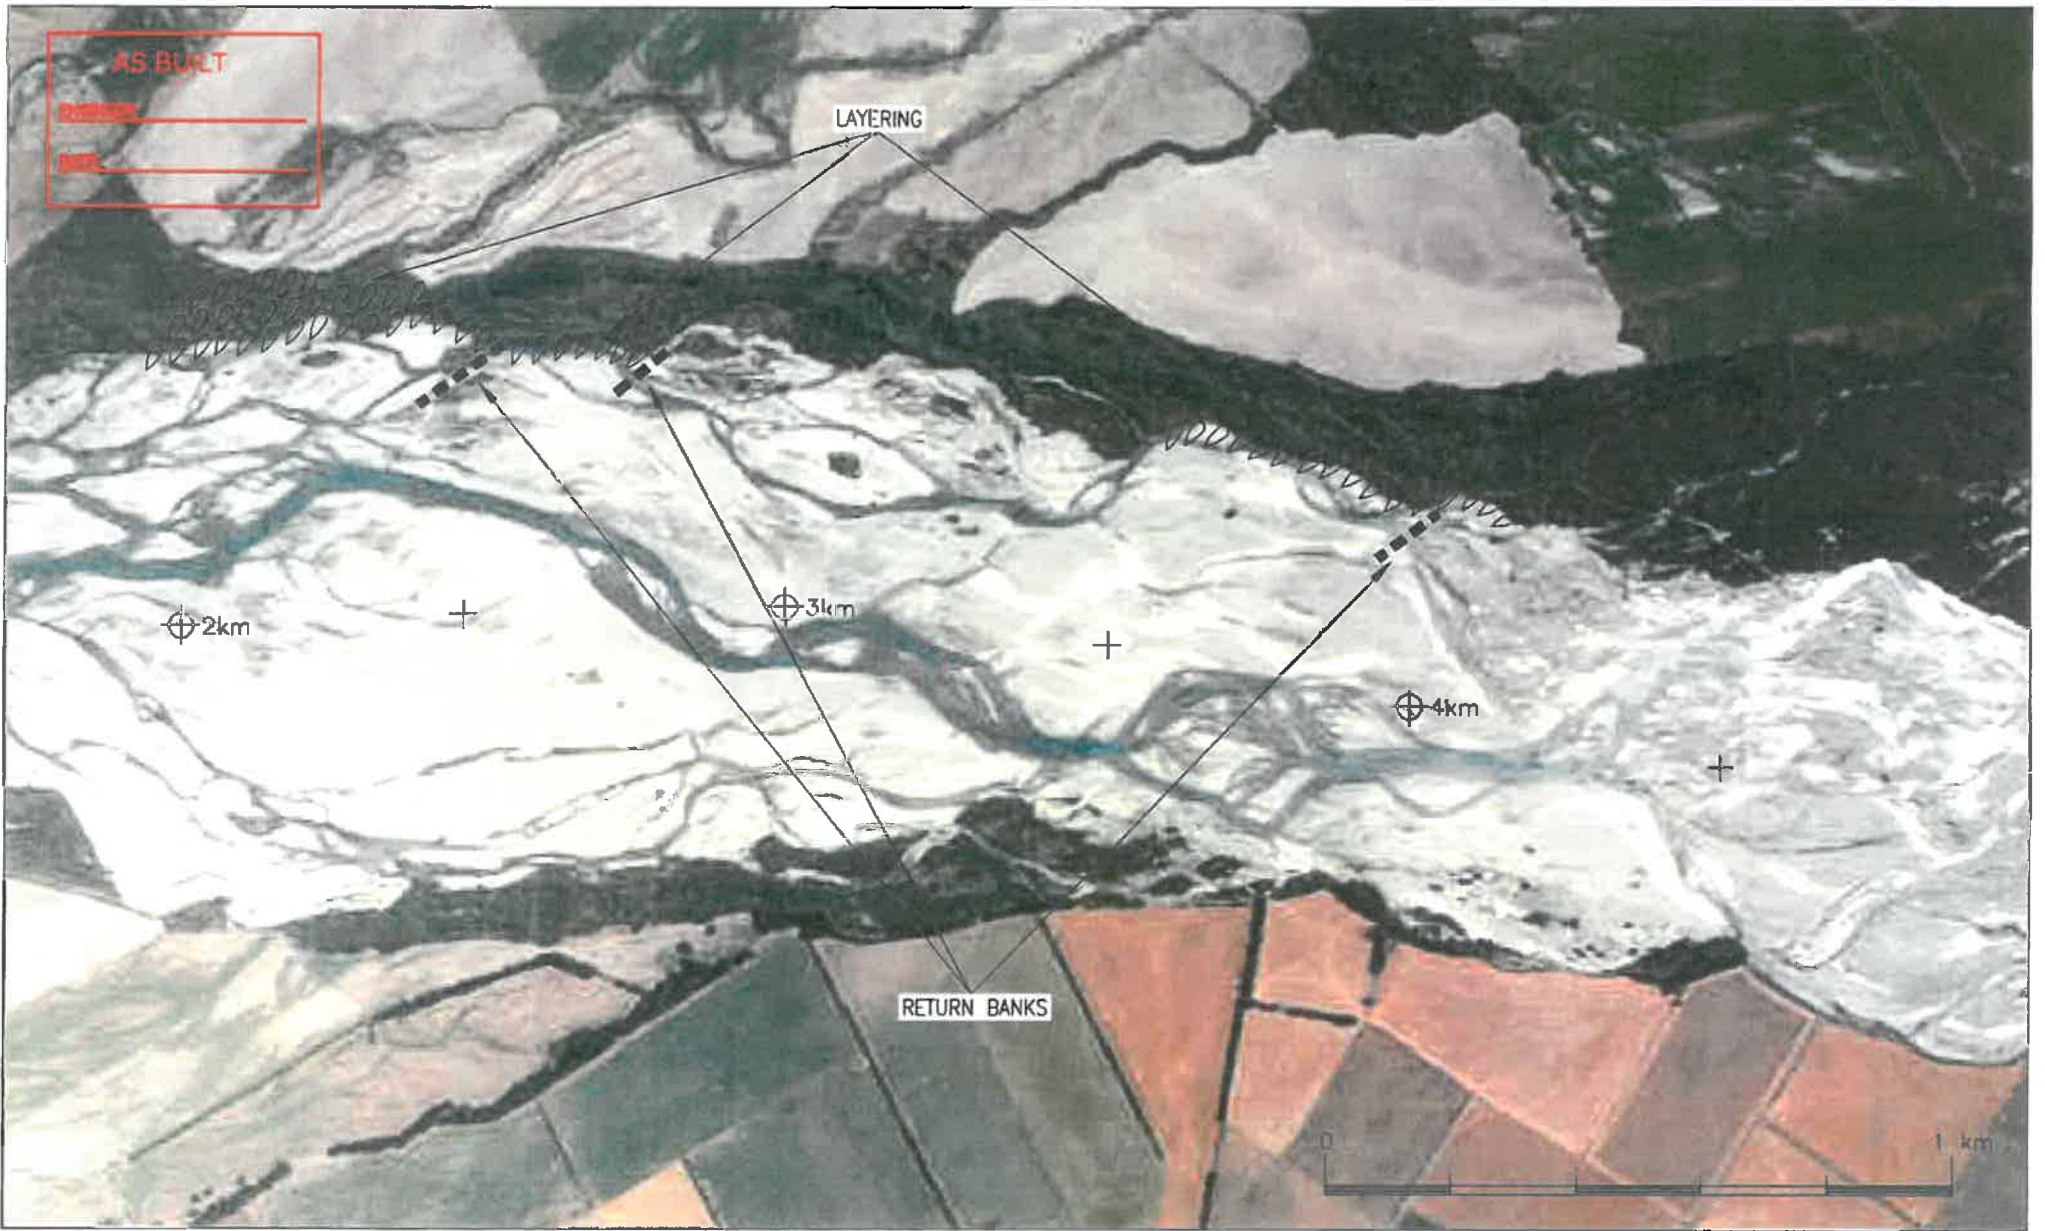
R-BANK LEVEL. RL = 1.5m Below EXISTING  
 TW = 4m  
 FRT 6:1  
 REAR 1:1
