Assessment of Environmental Effects; Paparua Stockwater Race (PSR) Diversion

Prepared for:
SOL Quarries Ltd

AEL Report No. 172

May 2019

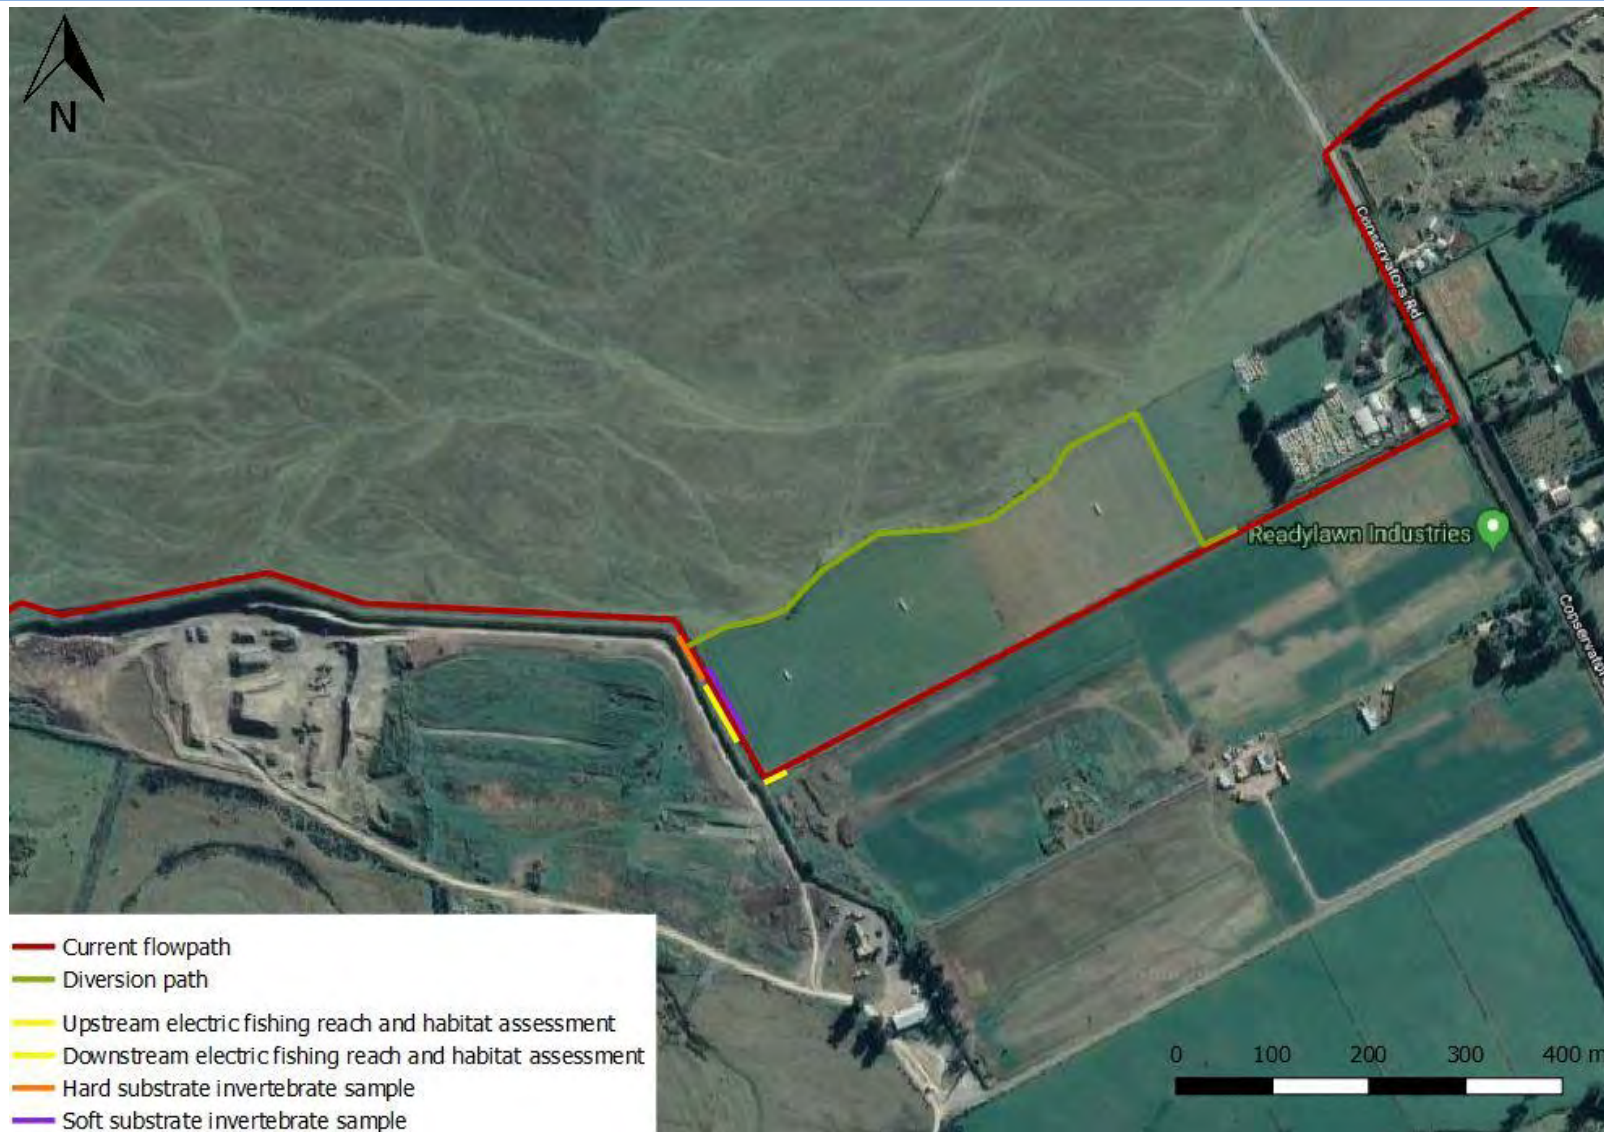
Figure 1. The proposed diversion and the ecological sampling reaches.

| Location | Upstream habitat assessment (Fig. 1) | | | | | | | | | | | |

| Location | Downstream habitat assessment (Fig. 1) | | | | | | | | | | | |

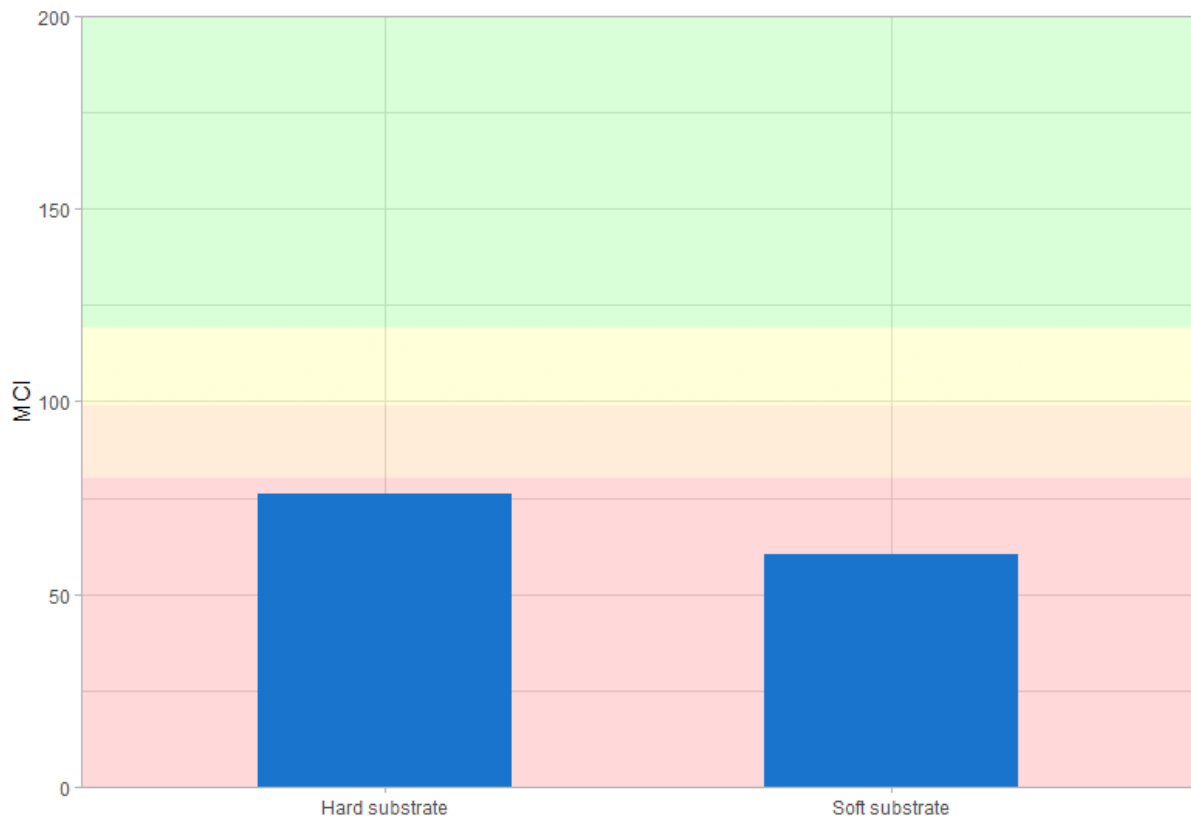
Figure 2. The calculate MCI values for the hard substrate and soft substrate macroinvertebrate samples. Background coloured to indicate the MCI levels of stream health as defined by Stark and Maxted (2007): Excellent = >119, Good= 100–119, Fair = 89–99, Poor = <80.

A complete taxa list for the two macroinvertebrate samples can be found in App. III, Table i. Both collected macroinvertebrate samples were composed of common species, with none of the collected species holding a New Zealand conservation status (Grainger et al. 2018). Both samples were dominated by snails, representing approximately 45% of the macroinvertebrate abundance in the hard substrate sample, and 83% of those in the soft substrate sample. Both samples scored low for the MCI (stream health) metric (Fig. 2), with both samples reflective of a waterway in poor health, as defined by Stark and Maxted (2007). Also reflecting poor health was the low total percentage of EPT taxa identified in each sample, with the % EPT values for hard substrate and soft substrate samples being 3.4% and 2.4% respectively.

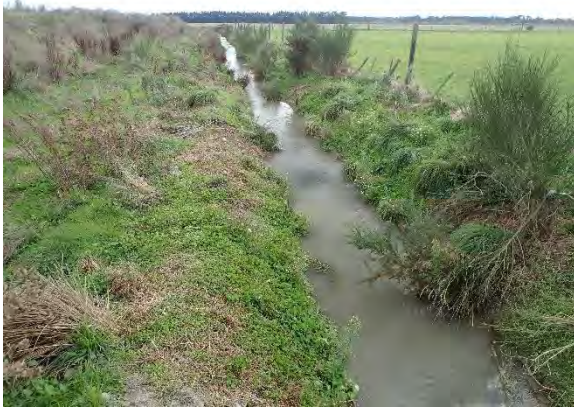
Figure i. Looking upstream (north) at the upstream electric fishing reach. Note that turbidity of water is partially due to surveyors walking in the waterway.

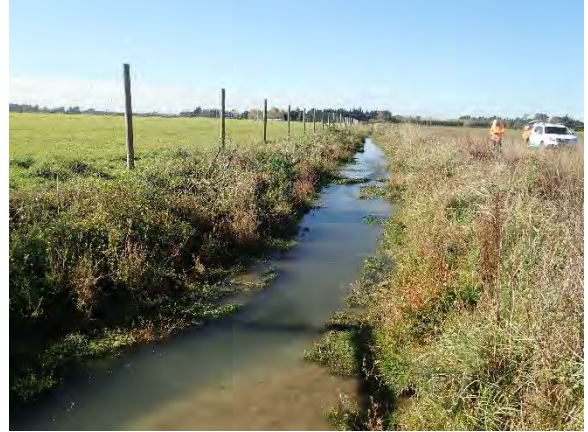
Figure ii. Looking downstream (northeast) at the downstream electric fishing reach. Note that turbidity of water is partially due to surveyors walking in the waterway.

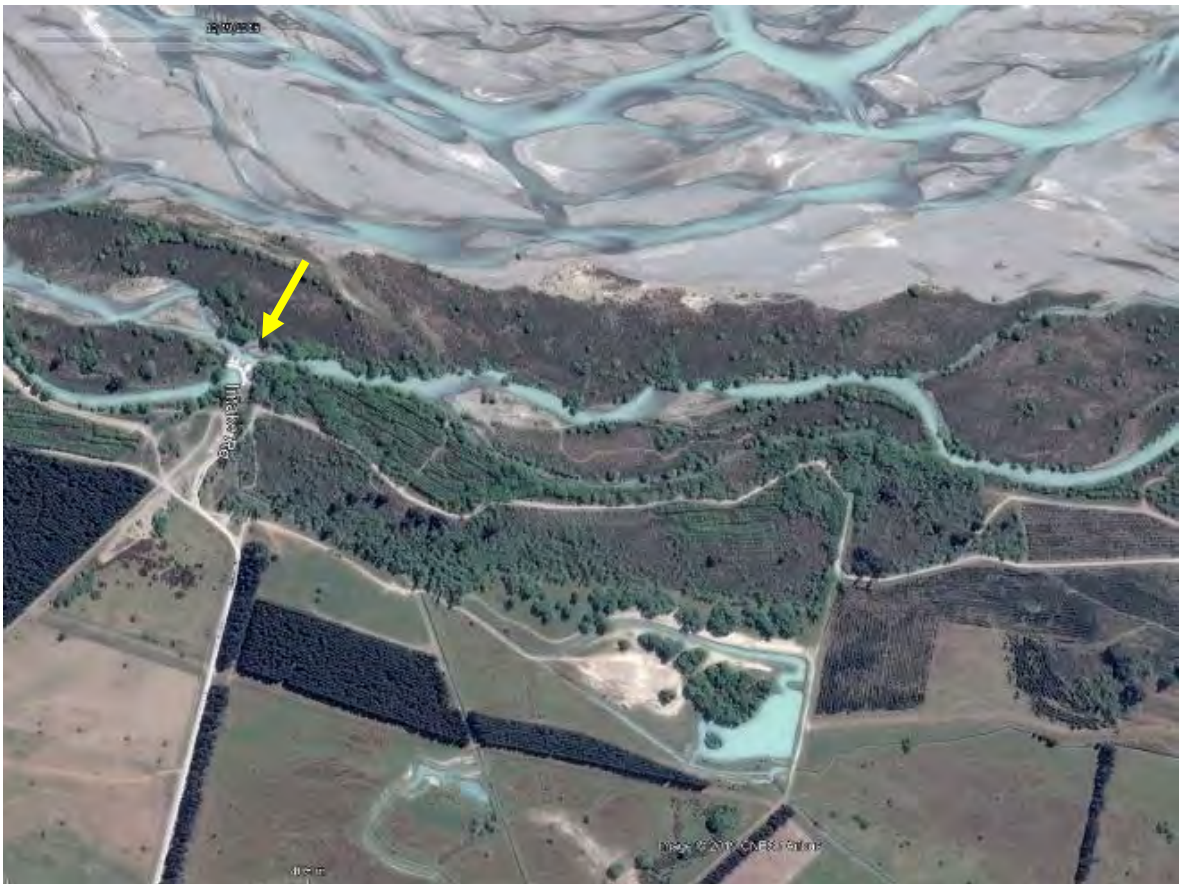
Figure iii. The source of the PSR (arrowed), including the pond and the Waimakariri River. Note the milky colour caused by glacial flour.
